Technical Memorandum
Anacostia Tributary Streambank Erosion Pilot Study
Phase I
Upper Beaverdam Creek Subwatershed

Prepared for:
Maryland Department of the Environment

Prepared by:
Department of Environmental Programs
Metropolitan Washington Council of Governments

June 2004

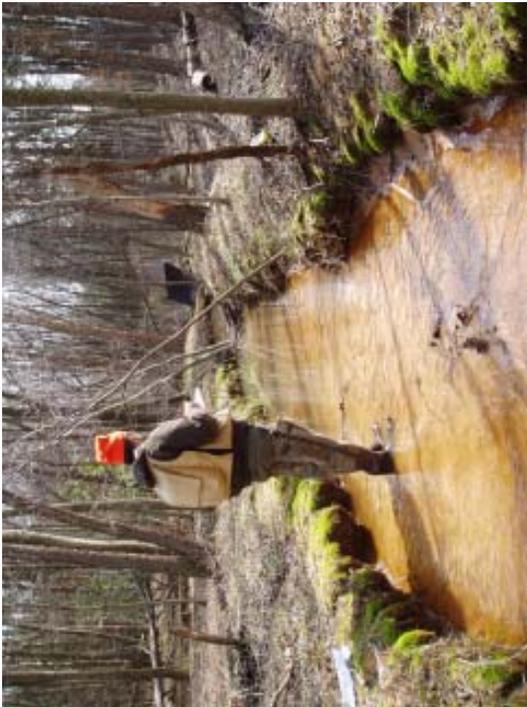
Figure 5: Location - Approximately 500 Feet Upstream of Springfield Road (X-1): Stable Streambank

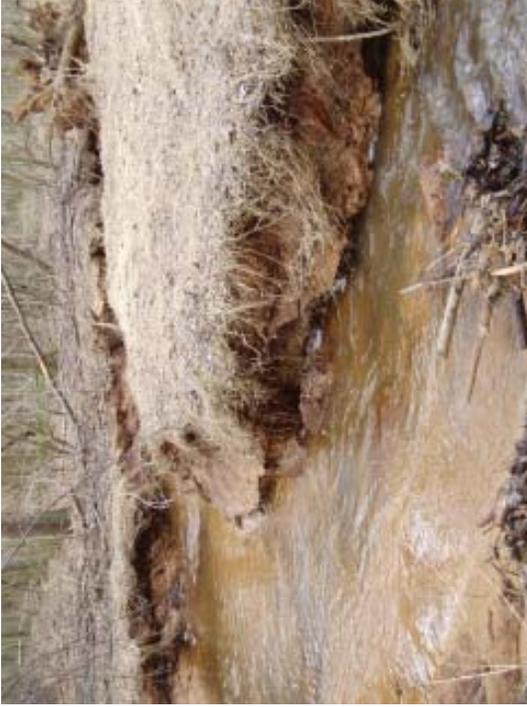
Figure 6: Location - Approximately 1,100 feet Downstream of Springfield Road (Near X-5): Moderate/Severe Streambank Erosion

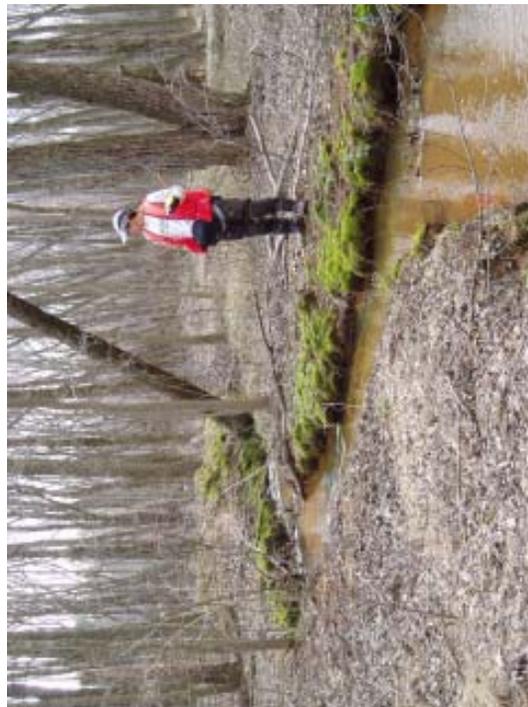
Figure 7: Location : Approximately 2,400 feet Downstream of Springfield Road (X-8): Stable Streambank

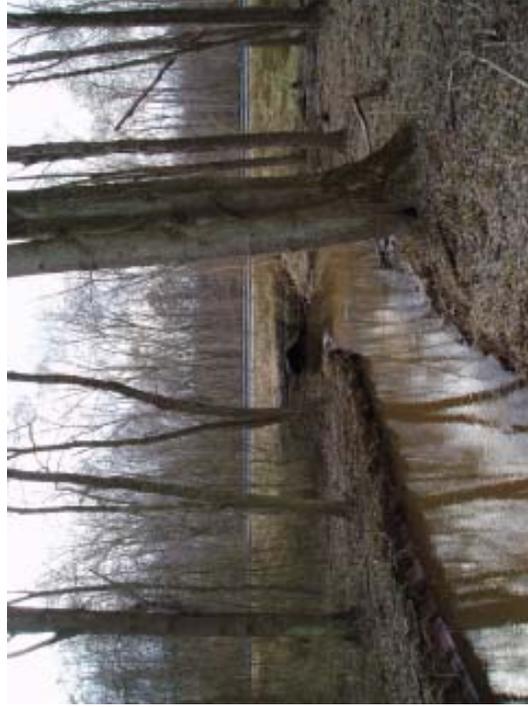
Figure 8: Location: Approximately 100 Feet Upstream of Soil Conservation Road (Near X-13): Slight Streambank Erosion

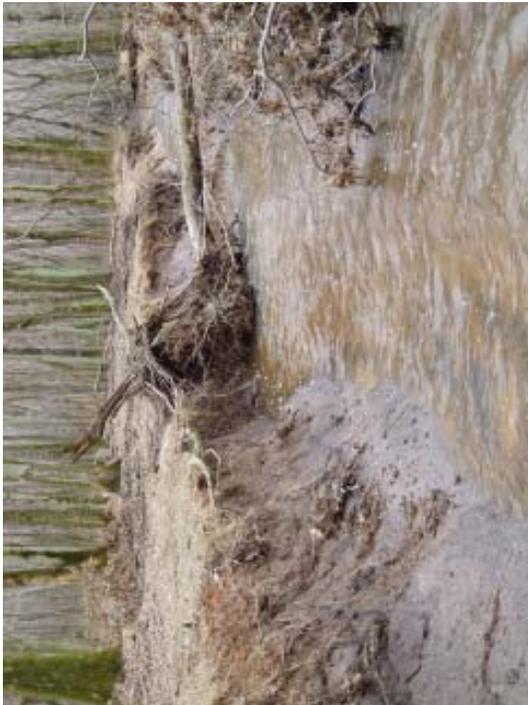
Figure 9: Location: Approximately 1,300 Feet Downstream of Soil Conservation Road (X-17): Moderate/Severe Streambank Erosion

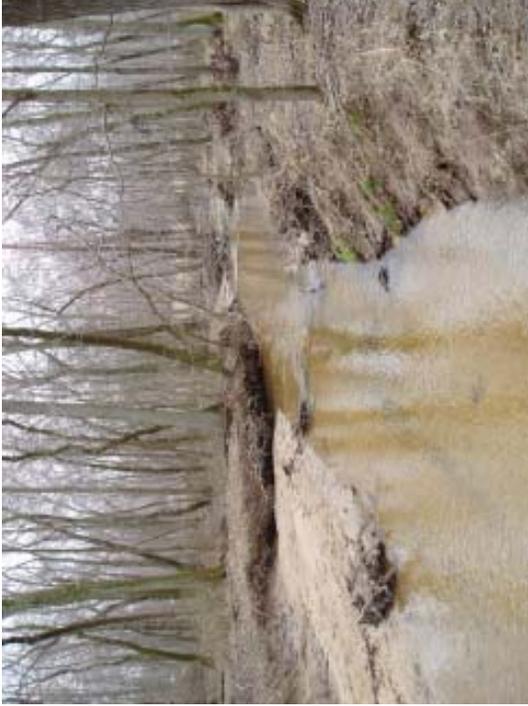
Figure 10: Location: Approximately 800 Feet Upstream of Baltimore Washington Parkway (X-20): Slight/Moderate Streambank Erosion

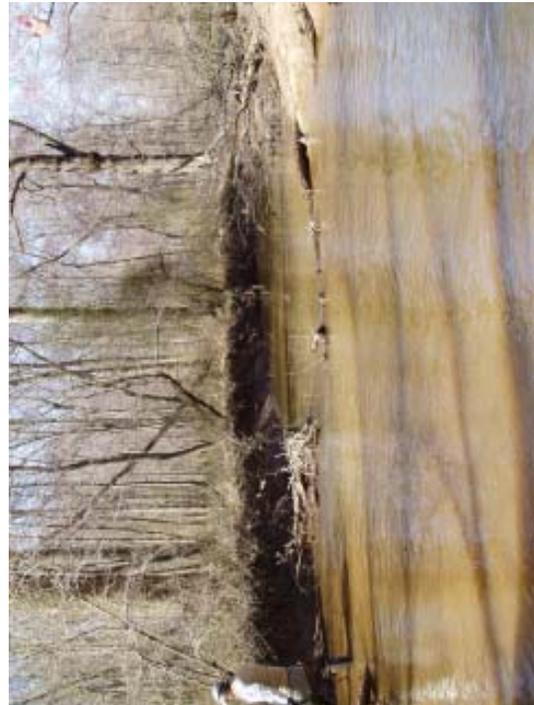
Figure 11: Location: Approximately 1,700 Feet Downstream of Beaverdam Road (X-26): Slight/Moderate Streambank Erosion

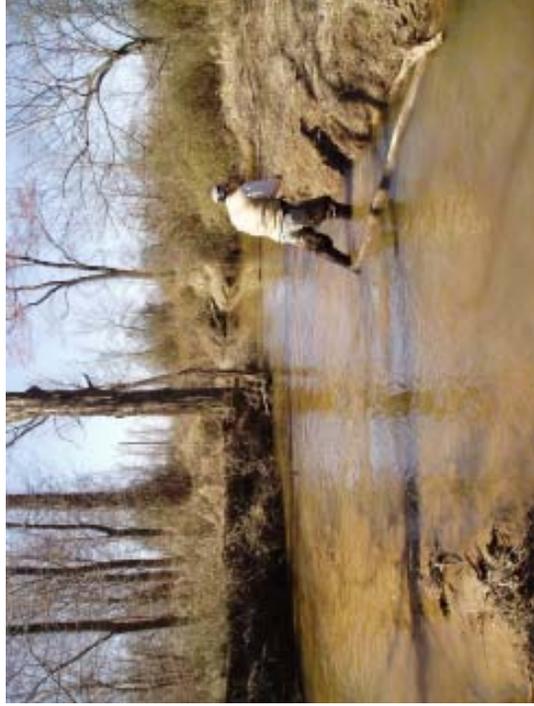
Figure 12: Location: Approximately 900 Feet Upstream of Research Road (X-34): Slight Streambank Erosion

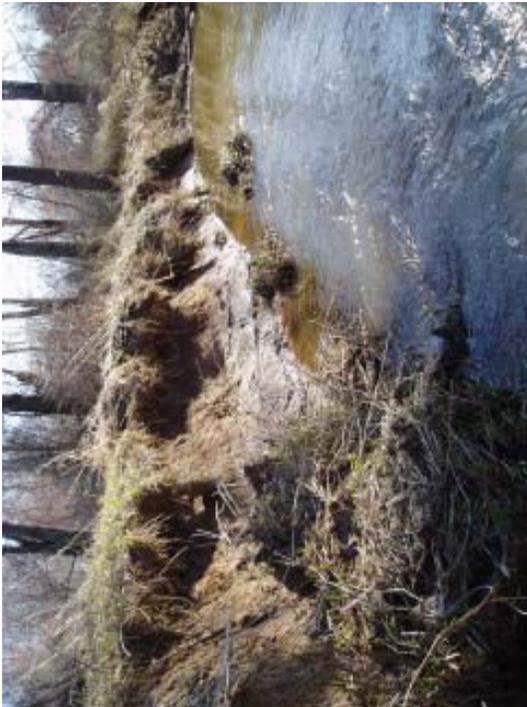
Figure 13: Location: Approximately 1,500 Feet Downstream of Research Road (X-38): Severe Streambank Erosion

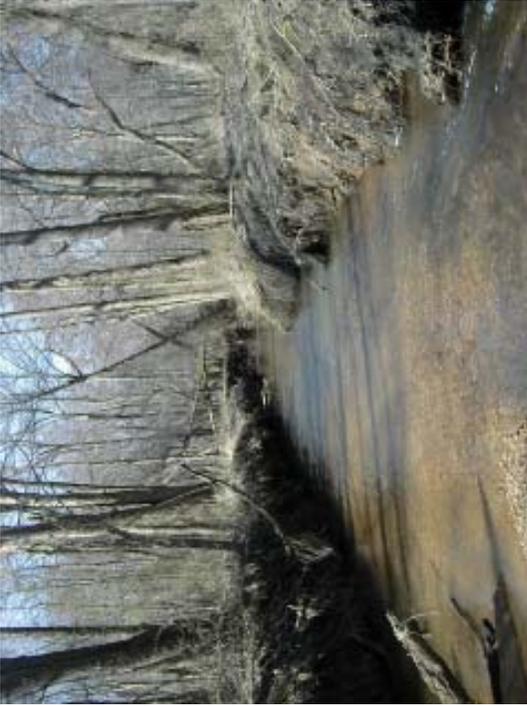
Figure 14: Location: Approximately 3,000 Feet Downstream of Research Road (X-42): Moderate Streambank Erosion

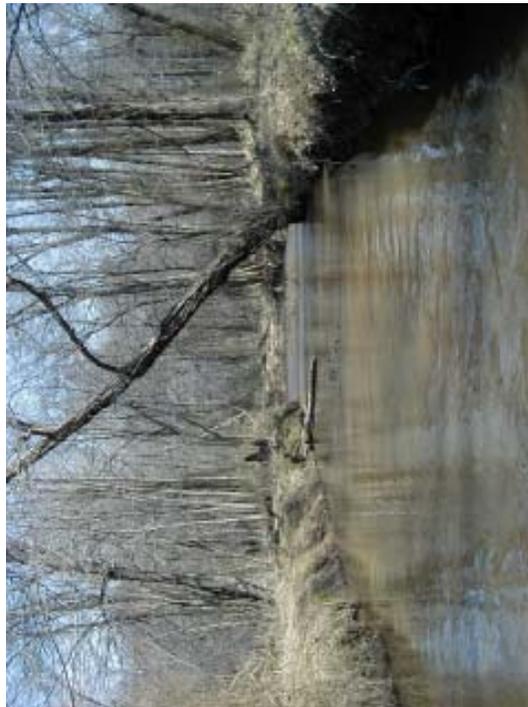
Figure 15: Location: Approximately 2,000 Feet Upstream of Edmonston Road (X-46): Slight Streambank Erosion

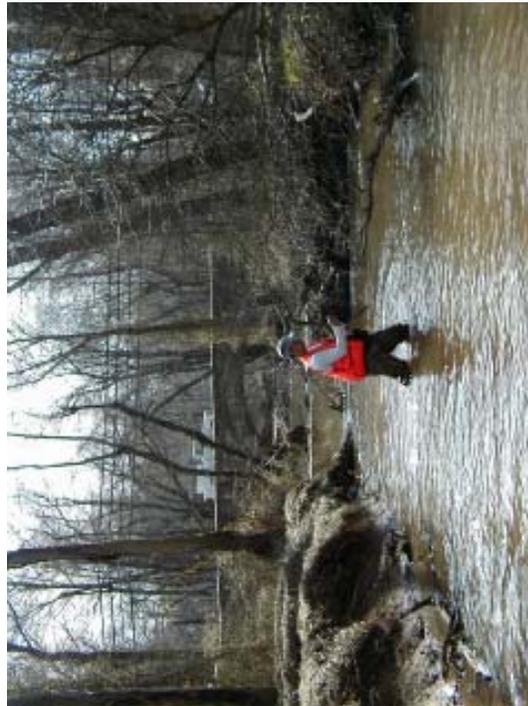
Figure 16: Location: Approximately 150 Feet Upstream of Edmonston Road (X-50): Moderate Streambank Erosion

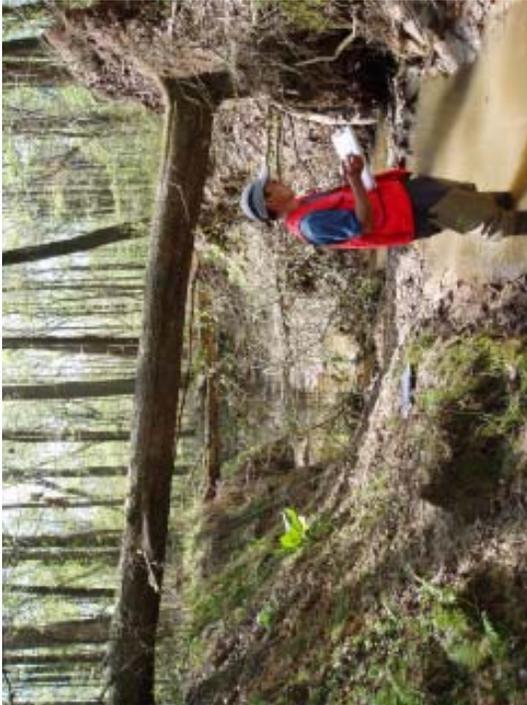
Figure 19: Location: Approximately 5,500 Feet Upstream of Springfield Road (X-2): Moderate Streambank Erosion

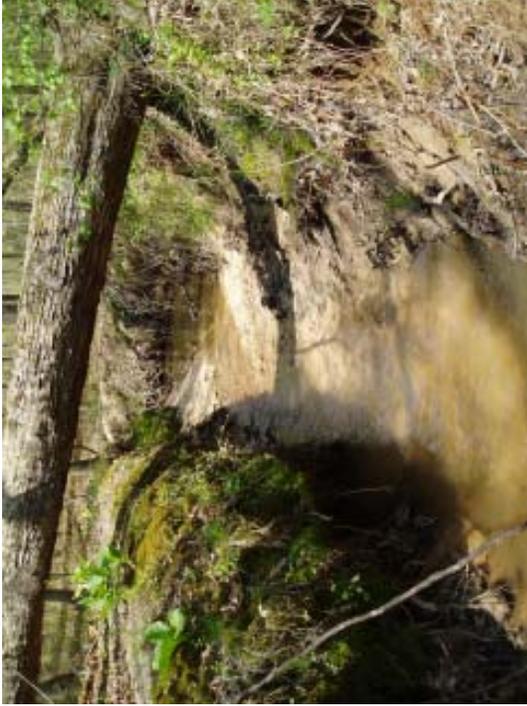
Figure 20: Location: Approximately 4,500 Feet Upstream of Springfield Road (X-4): Moderate Streambank Erosion

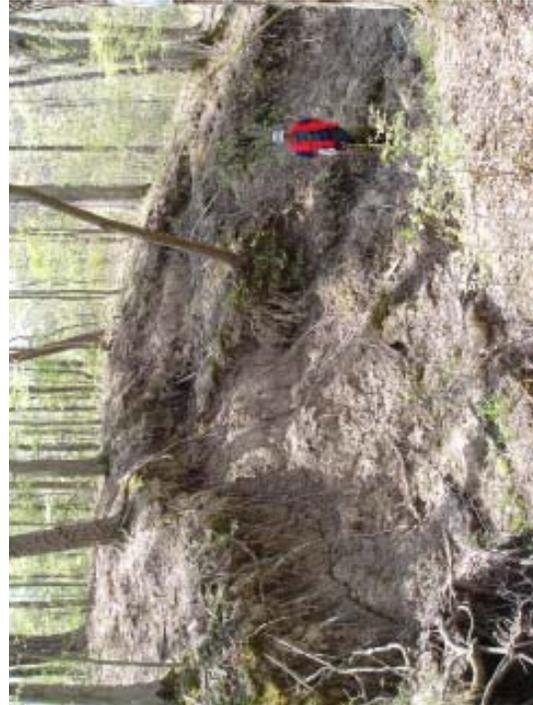
Figure 21: Location: Approximately 4,000 Feet Upstream of Springfield Road (Upstream X-5): Severe Streambank Erosion

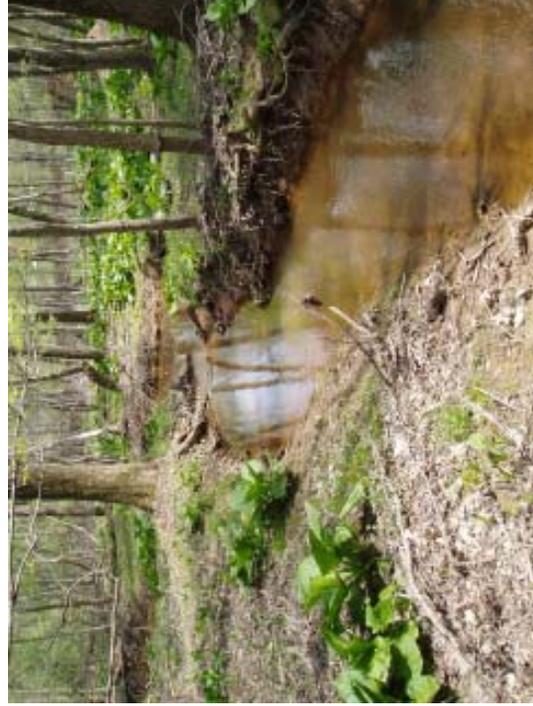
Figure 22: Location: Approximately 400 Feet Upstream of Springfield Road (X-17): Slight Streambank Erosion

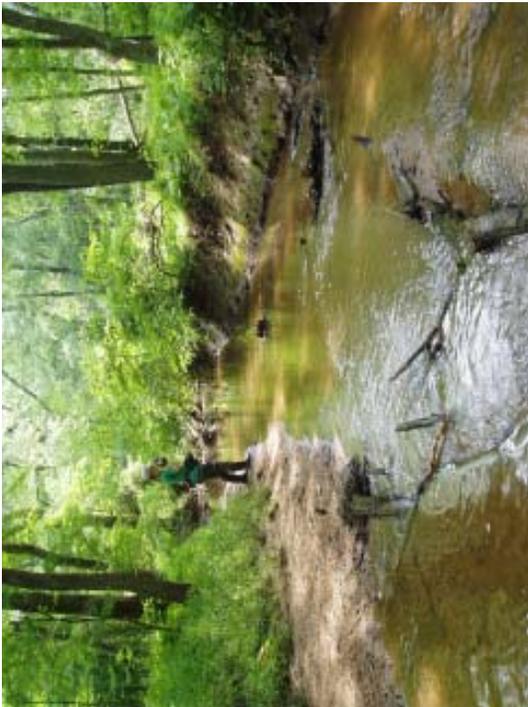
Figure 23: Location: Approximately 1,200 Feet Downstream of Powder Mill Road (X-22): Slight Streambank Erosion

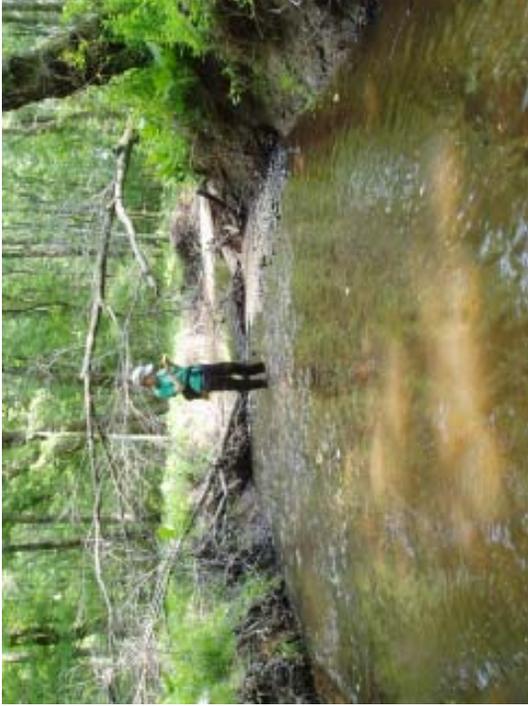
Figure 24: Location: Approximately 3,500 Feet Downstream of Powder Mill Road (X-30): Slight/Moderate Streambank Erosion

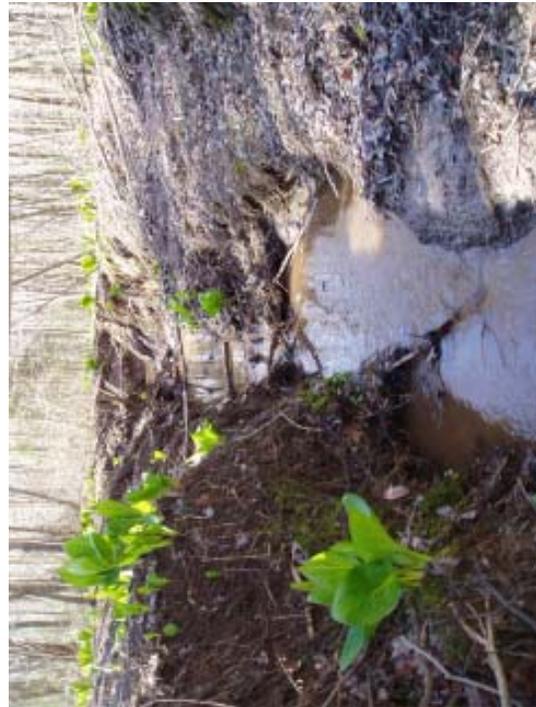
Figure 25: Location: Approximately 300 Feet Downstream of Springfield Road (X-2): Moderate Streambank Erosion

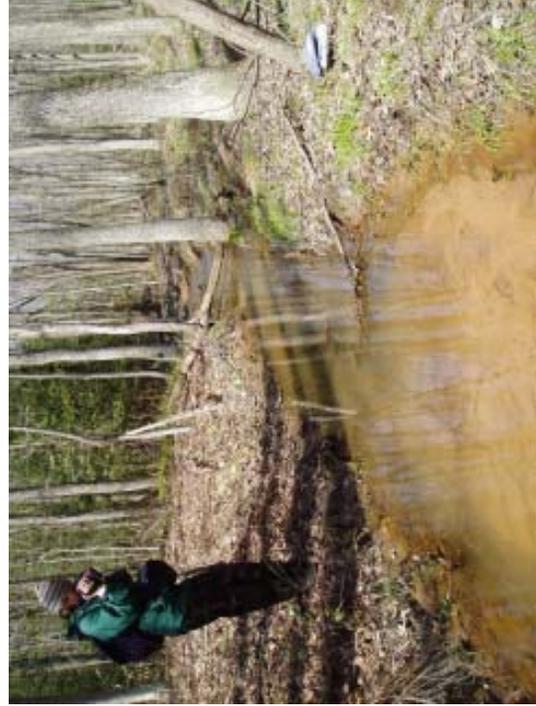
Figure 26: Location: Approximately 3,200 Feet Downstream of Springfield Road (X-10): Stable Streambank

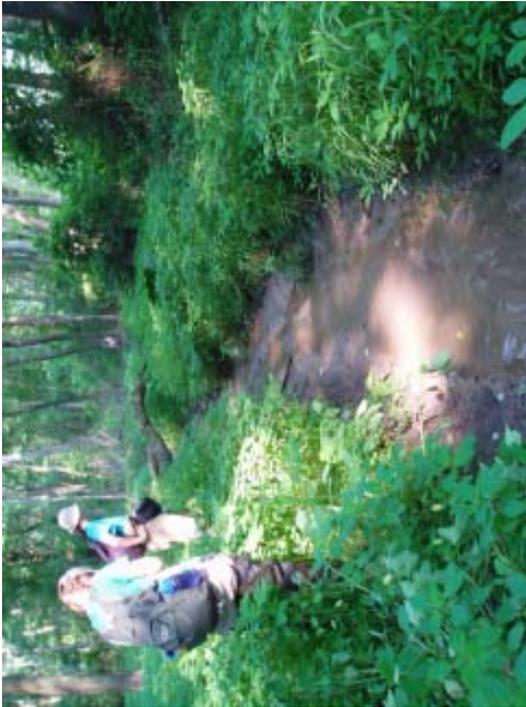
Figure 27: Location: Approximately 5,500 Feet Upstream of UBC Mainstem (X-2): Stable Streambank

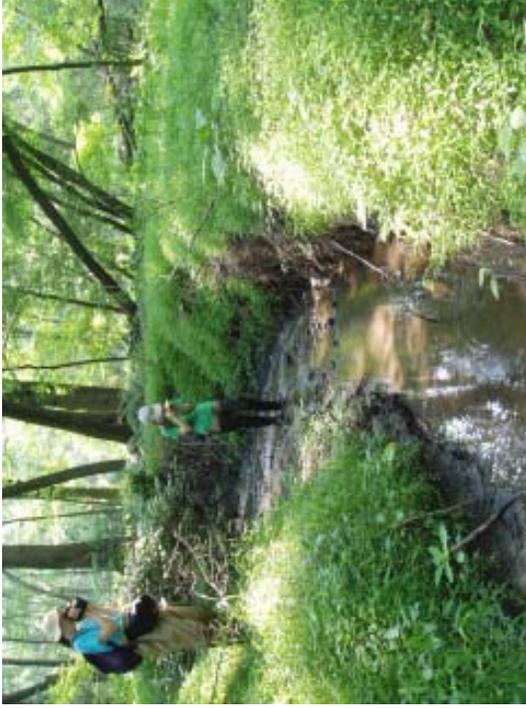
Figure 28: Location: Approximately 4,225 Feet Upstream of UBC Mainstem (X-6): Moderate Streambank Erosion

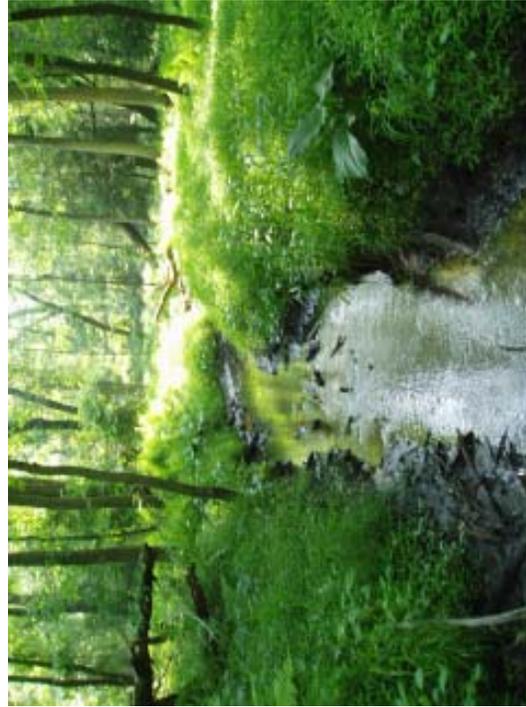
Figure 29: Location: Approximately 2,830 Feet Upstream of UBC Mainstem (X-10): Stable Streambank

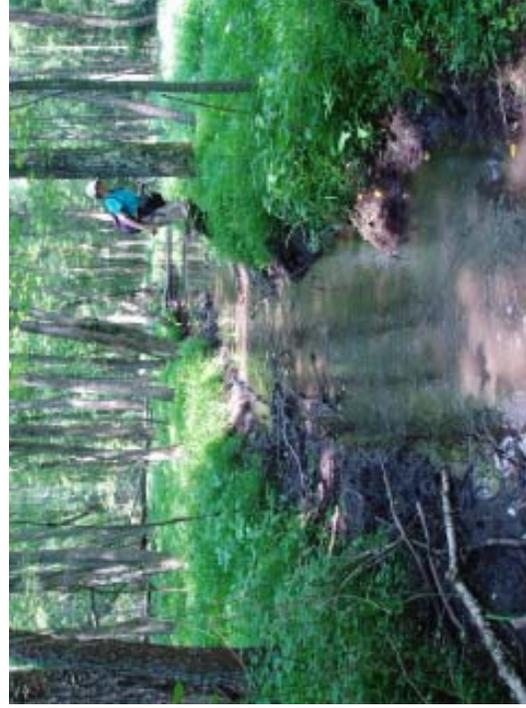
Figure 30: Location: Approximately 243 Feet Upstream of UBC Mainstem (X-16): Stable Streambank

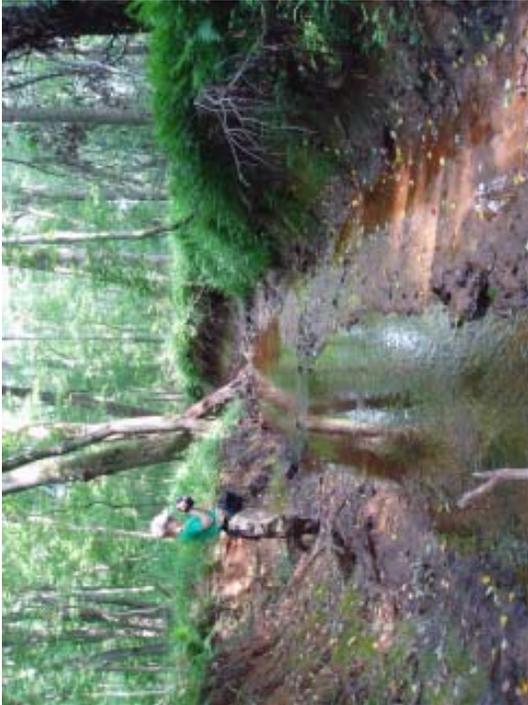
Figure 31: Location: Approximately 1,460 Feet Downstream of Soil Conservation Road (X-4): Slight/Moderate Streambank Erosion

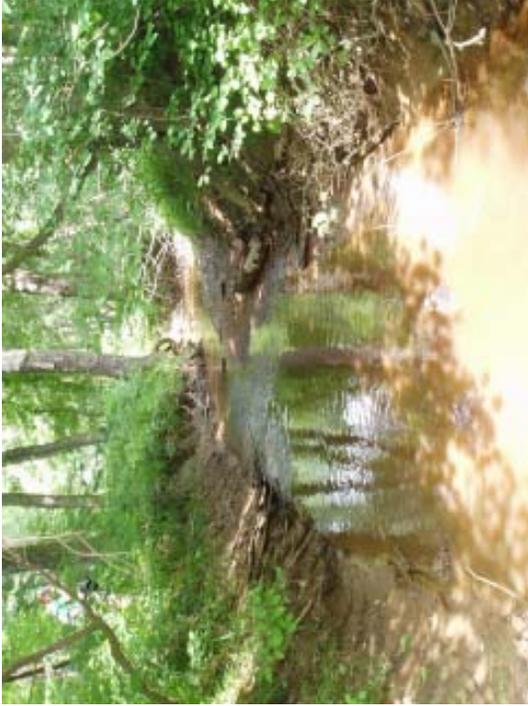
Figure 32: Location: Approximately 900 Feet Downstream of Baltimore/Washington Parkway (X-10): Slight/Moderate Streambank Erosion

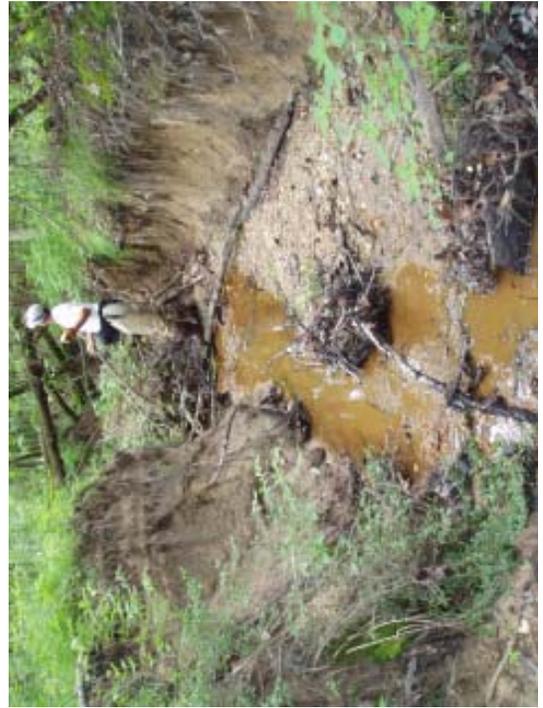
Figure 33: Location: Approximately 750 Feet Upstream of Beaverdam Road (Upstream of X-4): Severe Streambank Erosion

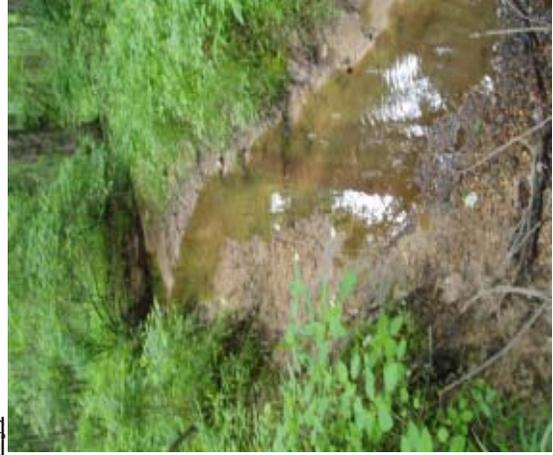
Figure 34: Location: Approximately 560 Feet Downstream of Beaverdam Road (X-7): Stable Streambank

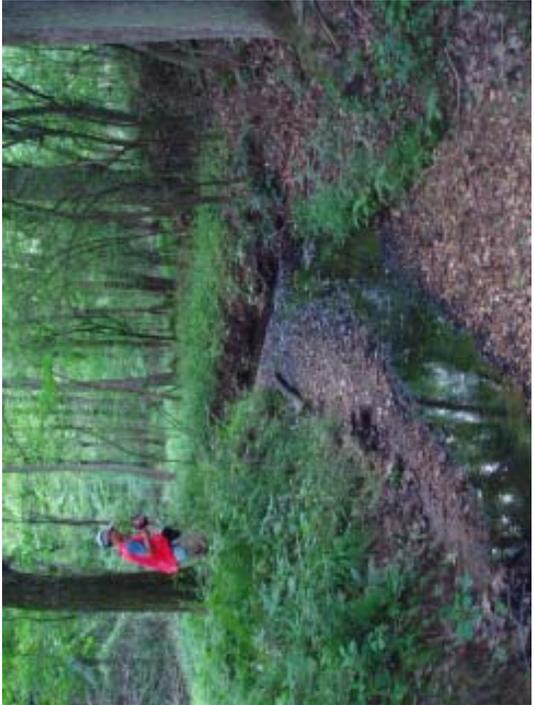
Figure 35: Location: Approximately 2,500 Feet Upstream of Powder Mill Road (X-1): Slight/Moderate Streambank Erosion

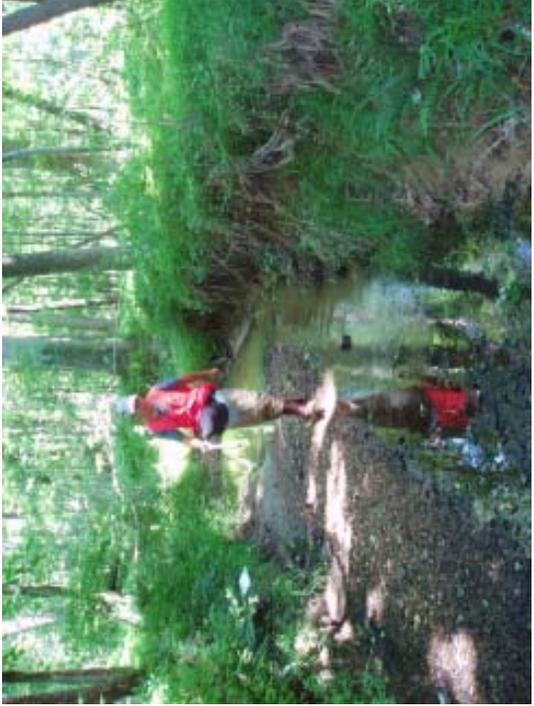
Figure 36: Location: Approximately 235 Feet Downstream of Powder Mill Road (X-8): Slight/Moderate Streambank Erosion

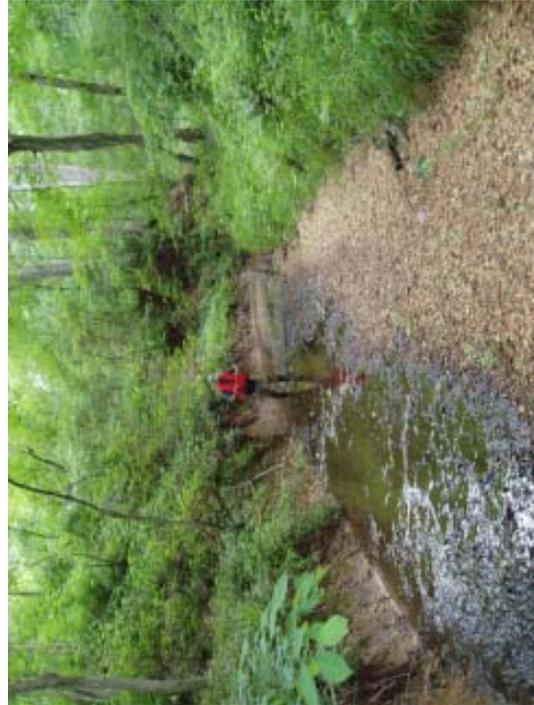
Figure 37: Location: Approximately 250 Feet Upstream of Beaverdam Road (X-13): Moderate Streambank Erosion

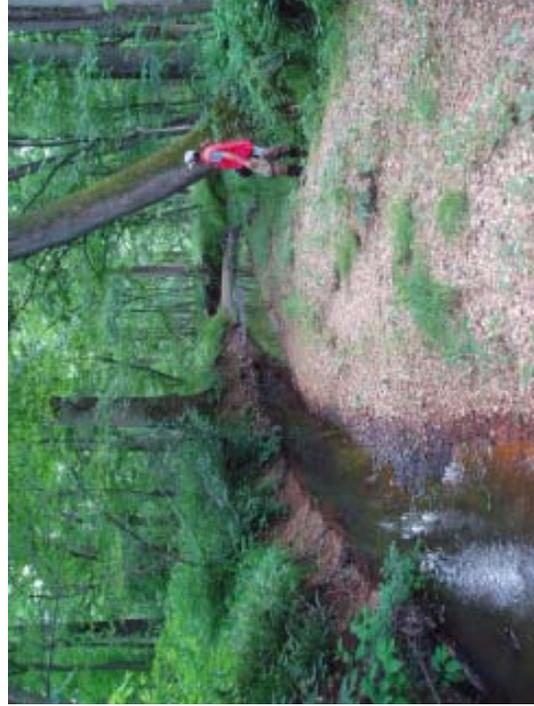
Figure 38: Location: Approximately 1,110 Feet Downstream of Beaverdam Road (X-16): Slight/Moderate Streambank Erosion

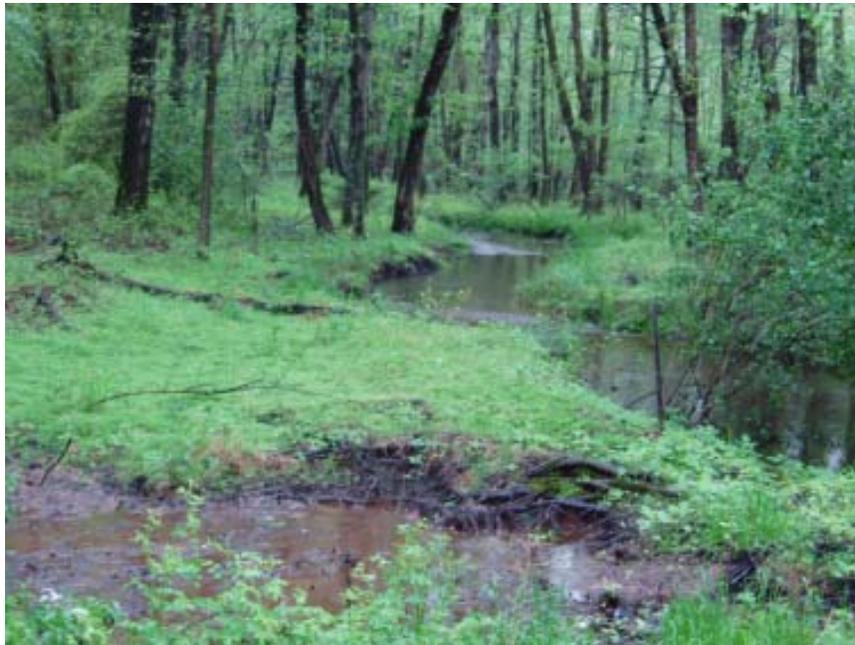
Figure 49: Location - Upper Mainstem Immediately Downstream of Springfield Road: Excellent Stream Canopy Coverage

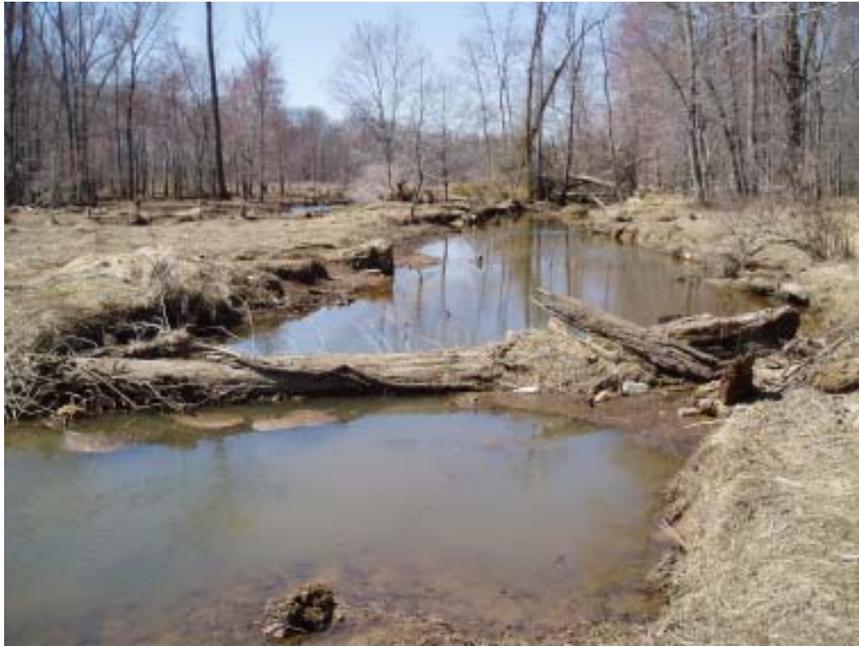
Figure 50: Location - Middle Mainstem Immediately Upstream of Research Road: Poor Stream Canopy Coverage (wetland area)

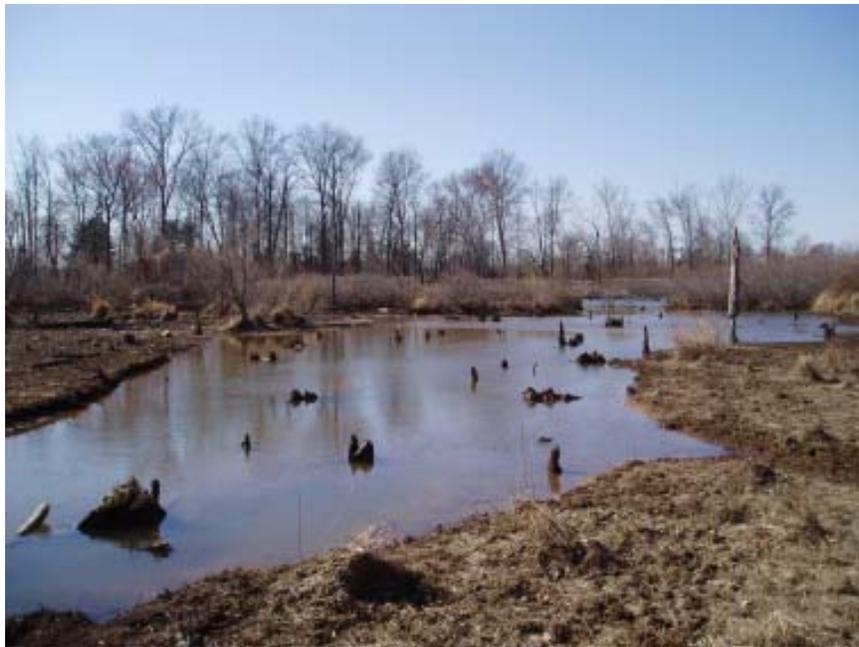
Figure 51: Location - Lower Mainstem Approximately 700 Feet Downstream of Research Road: Poor Stream Canopy Coverage (wetland area)

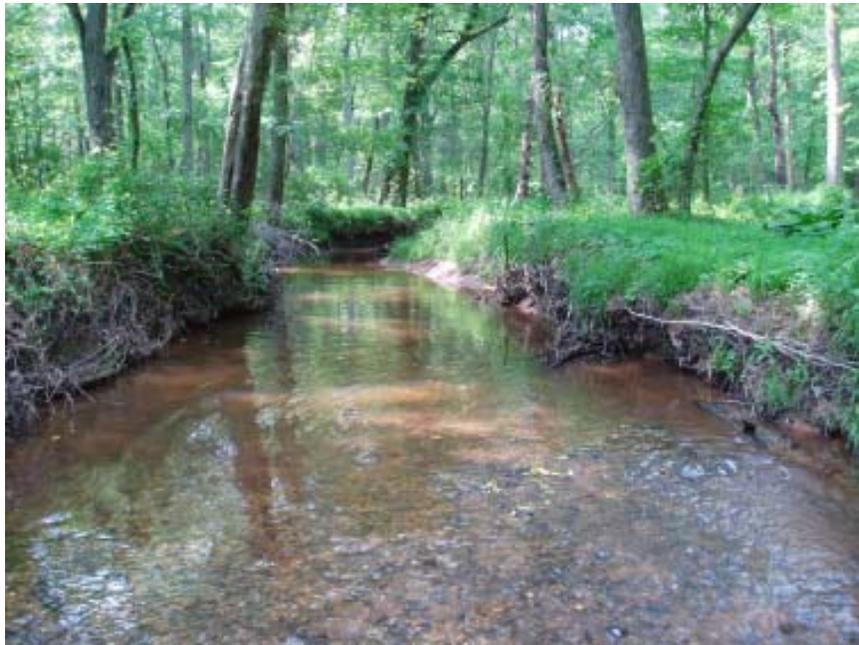
Figure 52: Location - UBC-2 (Lower North Branch) Mainstem Below Powder Mill Road: Excellent Stream Canopy Coverage

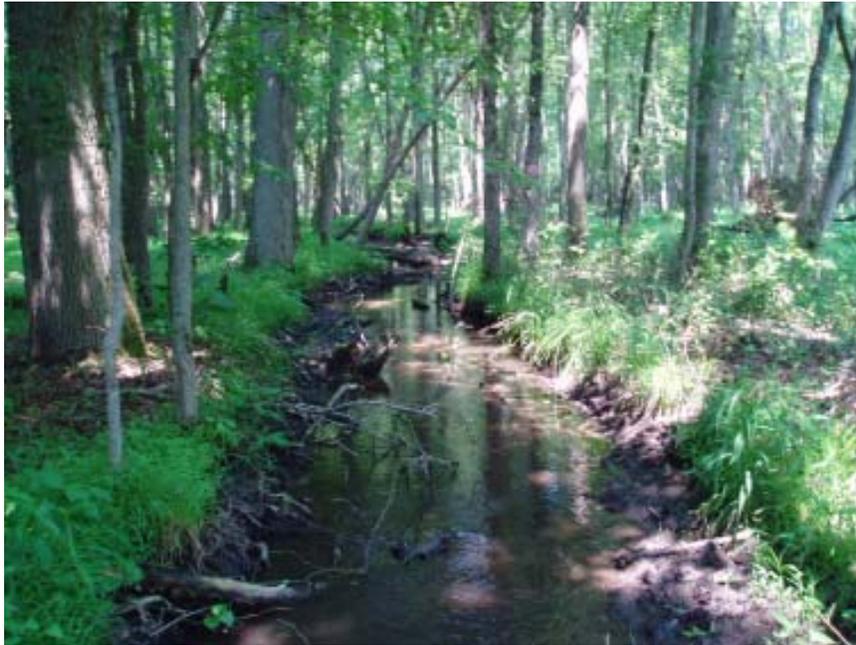
Figure 53: Location - UBC-4 (Clear Creek) Downstream of Soil Conservation Road: Excellent Stream Canopy Coverage

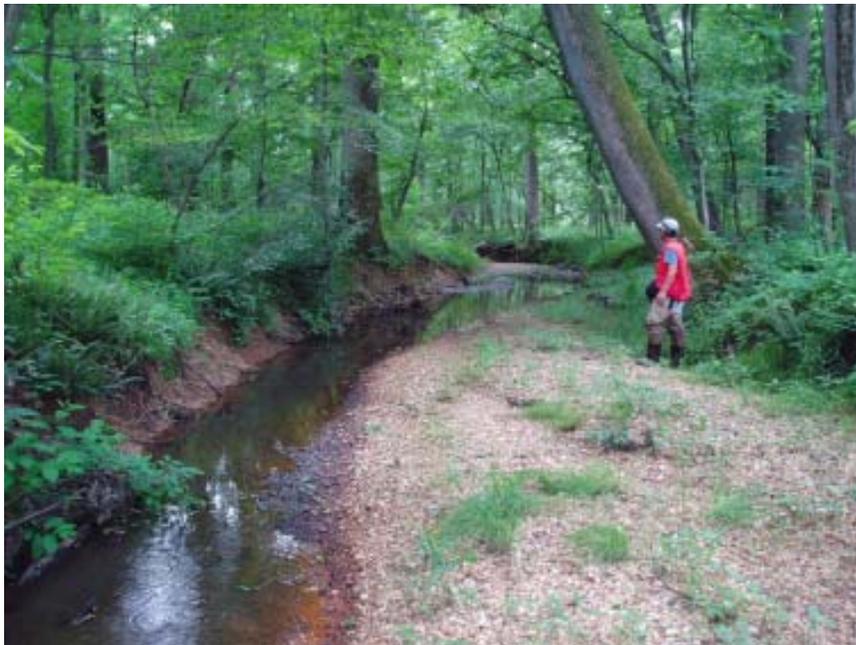
Figure 54: Location - UBC-5 (Entomology Tributary) Downstream of Powder Mill Road: Excellent Stream Canopy Coverage

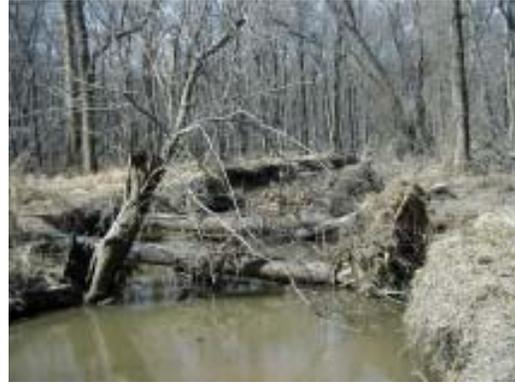
Figure 57: Location - Upper Beaverdam Creek - Lower Mainstem Above Edmonston Road - Moderate/Severe Streambank Erosion

6) The relatively small, isolated pockets of Upper Beaverdam Creek mainstem ‘moderate/severe’ (Figure 57) and ‘severe’ streambank erosion should (where feasible) be stabilized using bioengineering techniques similar to those recently employed at both the BARC Spray Irrigation and Sleepy Creek tributaries (i.e., bank slope regrading, stabilization with bio-logs, erosion matting, live fascines and native plant materials).

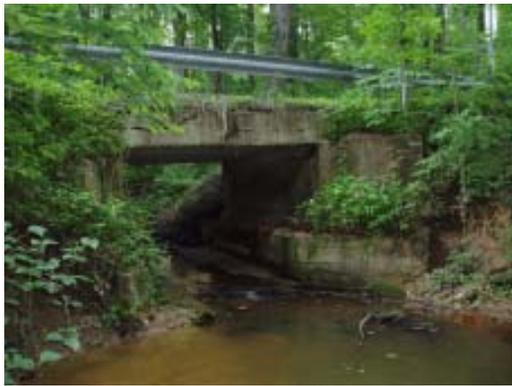
Figure 58: Location - UBC-7 (Entomology Tributary) - Below Beaverdam Road - Fish Barrier

7) At a minimum, a thorough structural integrity evaluation of the Beaverdam Road culvert over the UBC-7 tributary (Entomology) should be performed by a certified structural engineer as soon as possible. It should be noted that COG staff’s visual inspection revealed the presence of several large cracks and exposed and rusted rebar in the culvert’s concrete deck and superstructure.
