**DC-WASA Combined Sewer Overflow Anacostia River
Trash Reduction Demonstration Project:
Fresh Creek Netting TrashTrap™ System**

**CSO Control Program
District of Columbia Water and Sewer Authority**

**Department of Environmental Programs
Metropolitan Washington Council of Governments
777 North Capitol Street, NE
Washington, DC 20002**

October 2001

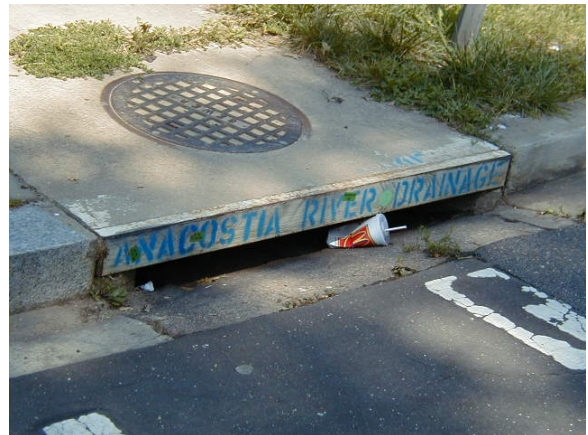
Figure 1. Roadside Trash in the Anacostia CSO 018 Sewershed

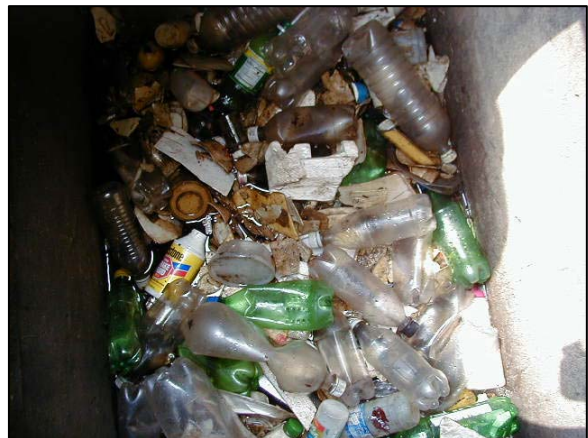
Figure 2. Anacostia CSO 018 Sewershed Storm Drain Inlet Filled with Trash and Debris

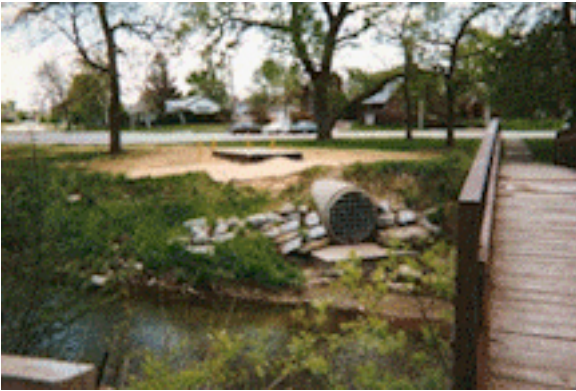
Figure 5. In-Line Fresh Creek Netting System

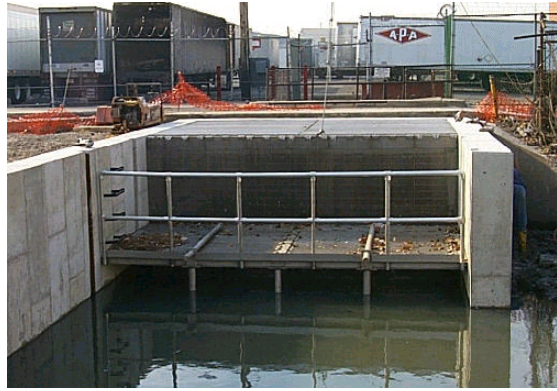
Figure 6. End-of-Pipe Fresh Creek Netting System

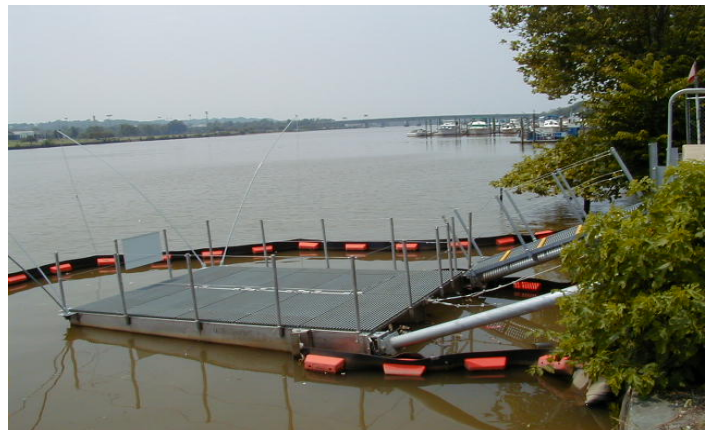
The floating, end-of-pipe Netting TrashTrap™ design utilized at the CSO 018 site supports two nets within a floating frame of aluminum, stainless, and galvanized steel. Two galvanized steel retainer arms with hinged couplings secure the system to the concrete outfall. Two steel pilings immediately adjacent to the seawall feature vertical rollers attached to two heavy-duty PVC coated polyester fabric floating boom/skirt sections, which direct CSO effluent into the nets. Together, the hinged retainer arms and vertical rollers allow the netting system platform and boom to rise and fall with the tides. Surrounding the entire system is a second floating boom. This outer boom was added (per DC-WASA recommendations) to capture ‘fugitive’ floatables that circumvent the nets. The outer boom is secured to the floating platform via six flexible fiberglass ‘outriggers’.

Figure 7. Floating Fresh Creek Netting System at CSO 018

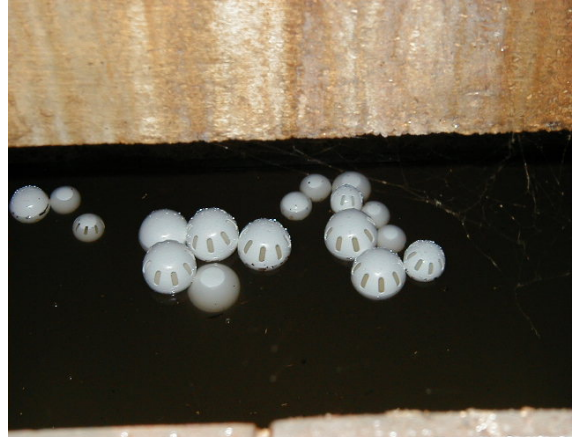
To further address the question of capture efficiency COG staff performed a 'mark-recapture' experiment involving the release (into the CSO system) and recapture (from the netting system) of floating plastic balls of various sizes representing the approximate diameters and floatation characteristics of observed floatable materials. The experiment involved the March 2001 release of a total of 108 balls, each (36 each of plastic balls approximately 2, 3, and 4 inches in diameter) into the CSO 018 outfall housing just 'upstream' from the hinged flood-gate, following a change of the TrashTrap nets by the maintenance contractor (Figure 14).

Figure 14. Mark-Recapture Balls Following Release into CSO 018 System

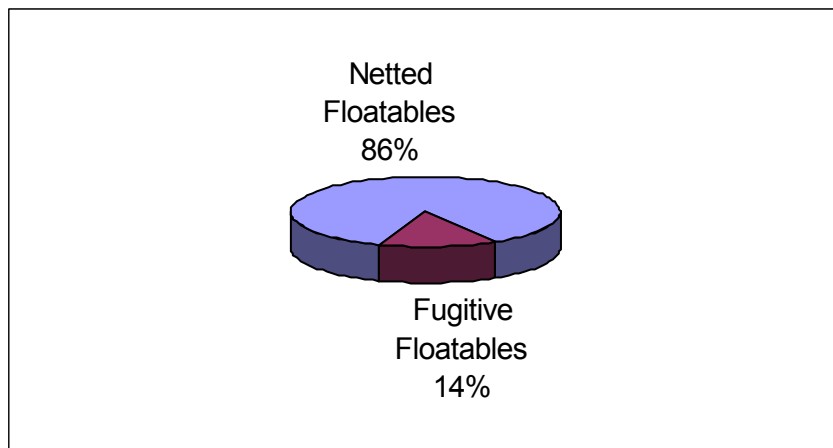
effluent and the TrashTrap™ net contents, respectively, while Figure 22 shows the composition of fugitive floatables. Figure 23 shows overall floatables capture efficiency of the system, which is based on the amount of floatables retained by the netting system as a percentage of the total net contents plus the ‘fugitive’ materials captured by the outer boom (i.e., capture efficiency = netted fraction ÷ netted fraction + fugitive fraction x 100; e.g., 3504 lbs ÷ 4078 lbs x 100 = 85.9%).

Figure 23. TrashTrap™ CSO Capture Efficiency (86%)

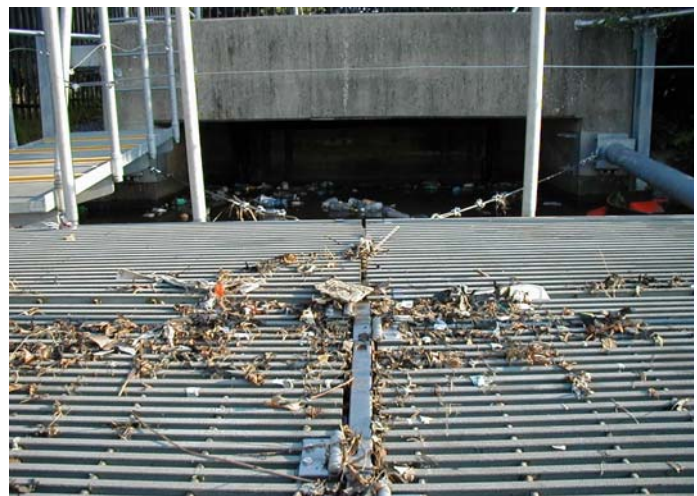
The observation by COG staff of CSO-related debris on the netting system deck suggested its partial or complete submergence during periods of heavy CSO flow. Additional evidence resulted from the temporary installation of a simple submergence indicator consisting of a section of PVC pipe containing a wooden yardstick and featuring drilled water inlet holes. In an effort to further elucidate the potential submergence of the netting system deck attributable to large CSO discharges and/or tidal activity, COG staff attached a Global System Model WL-14 Water Level Logger pressure transducer to the netting system deck (operational as of 12/8/2000) (Figure 15). COG staff downloaded its pressure transducer data on a monthly basis.

Figure 26. Debris on Upper Surface of Netting System Deck as Evidence of Submergence During Periods of Heavy CSO Flow and/or Tidal Action

6. Consider modifications to the system to prevent submergence of the deck. Possible causes of this include:
 - Failure of the relief curtain to lift. Large sections of the curtain were observed folded at the bottom and covered with silt during low tide. This may make it difficult for the curtain to lift during high flows.

- Low freeboard and high turbulence during wet weather.
 - Inadequate distance between outfall face and netting system.

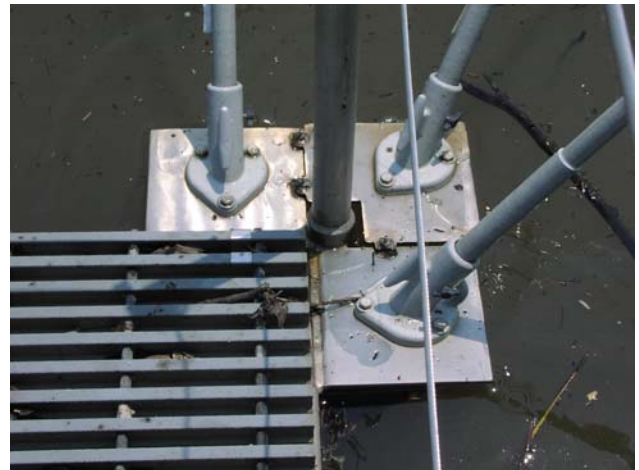
It should be noted that, during the study period, the netting system incurred some minor storm-related damage. The first known incidence involved one of the hinged, non-skid net access grates, which was forced open and subsequently damaged during a period of heavy CSO flow. To reduce the likelihood of such occurrences in the future, each of the access grates could be fitted with a stainless steel hasp and locked with a weather resistant padlock (Figure 28). This would also reduce the potential for access by unauthorized individuals. In a separate storm-related incident, one of the two corner stainless steel support brackets for the fiberglass 'outrigger' attachments designed to hold the outer boom in place broke loose and fell into the river. Although the bracket in question was re-welded (Figure 29), modification and/or reinforcement of the other bracket may be warranted.

Figure 29. Vulnerable 'Outrigger' Mounting Brackets

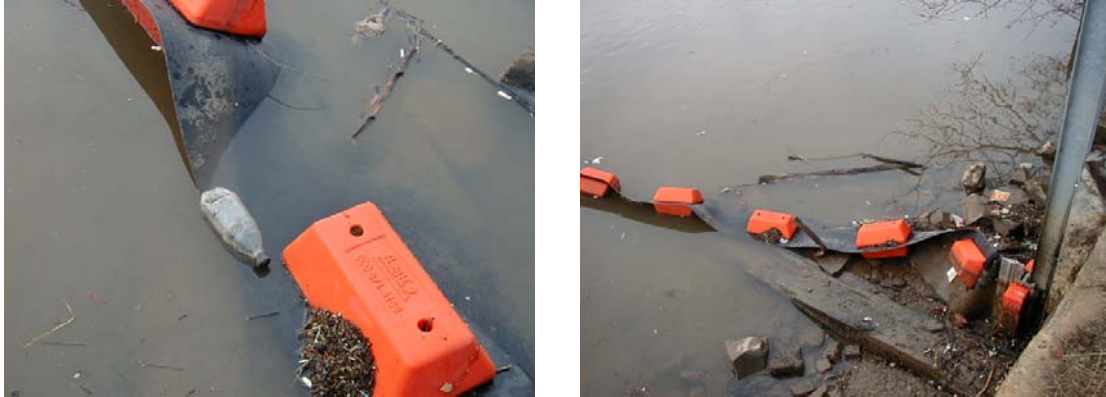
As a result of both the exposure of the riverbed at low tide and its irregular contour, a section of the outer floating boom adjacent to the sea wall often rests on its side during low tide. As observed on several occasions by COG staff this condition allows the periodic movement of 'fugitive' floatables over the boom and into the river (Figure 30). This potential for loss of fugitive floatables, which, according to the monitoring results, represents approximately 14 percent of the known floatables from CSO 018, warrants corrective measures. Possible solutions might include the addition of reinforcement to the existing boom to enable it to maintain its vertical position during low tide or experimentation with water filled or inflatable booms.

Figure 30. Floatables Breaching Flexible Floating Boom During Low Tide

- Increase the rigidity of the outer boom skirt to reduce excessive flexing/deformation between the integrated floatation blocks as observed under low tide conditions. Alternatively, replacement of the existing clam shell boom with a boom of the smooth, inflatable type might increase floatables retention at low tide while also facilitating the removal of fugitive floatables by maintenance personnel (Note: the clam shell floats have a tendency to trap certain types of floatables, thereby hindering their removal with hand nets).
