**Fort Dupont Subwatershed Restoration:
1999 Baseline Stream Assessment Study –
Physical, Chemical and Biological Conditions**

Prepared for:
U.S. Geological Survey
Biological Resources Division
Patuxent Wildlife Research Center
Laurel, Maryland

Prepared by:
Department of Environmental Programs
Metropolitan Washington Council of Governments

April 2000

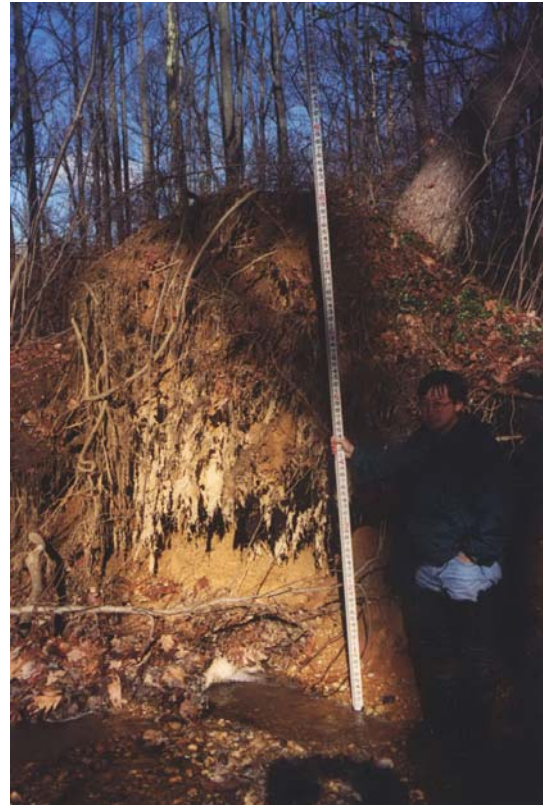
Figure 4. Upper Mainstem: Moderate Stream Channel Erosion (X - 9)

With the exception of the first 3,000 linear feet of the upper mainstem, the Fort Dupont tributary appears to be relatively stable. Results from the channel stability portion of the study revealed that out of a total RSAT-surveyed stream length of 11,088 feet, only 116 linear feet, representing approximately 1.0 percent is experiencing severe bank erosion. An additional 1,285 linear feet (15.9 percent) exhibited moderate stream bank erosion conditions. No pockets of moderate/severe erosion were observed during the RSAT survey. Stream areas experiencing moderate or severe stream bank erosion conditions were generally limited to fairly short (i.e., typically 50-100 feet), isolated pockets. As illustrated by Figure 4, these pockets were frequently associated with the outside banks of meanders and/or with recent tree falls. Cross-sectional analysis results (Figure 5) indicated that the mean cross-sectional area of the upper mainstem (41.2 ft²) is, relative to those of the middle mainstem (29.9ft²) and lower mainstem (20.1 ft²), 37.87 percent and 105.0 percent greater, respectively.

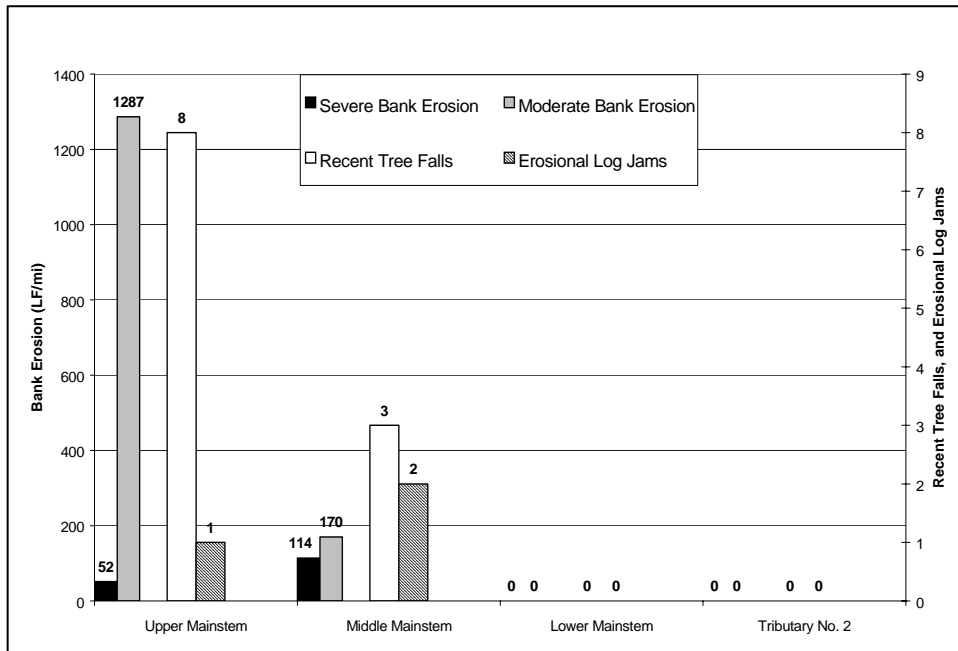
Figure 6. Fort Dupont Stream Channel Erosion-Related Conditions¹

Additional stream channel stability results (Figures 6 and 7 and Table 3), revealed that the upper mainstem had the highest moderate stream bank erosion rate (1287 lf/mi). As seen in Table 3, both the number (8 total) and rate of recent tree falls (8.7/mi) was highest in the upper mainstem. No recent tree falls or erosional log jams were recorded in either the lower mainstem or Tributary No. 2.

¹ Actual numbers appear above each bar for recent tree falls and erosional log jams. LF/mi. rate shown above each bar for severe and moderate stream bank erosion.

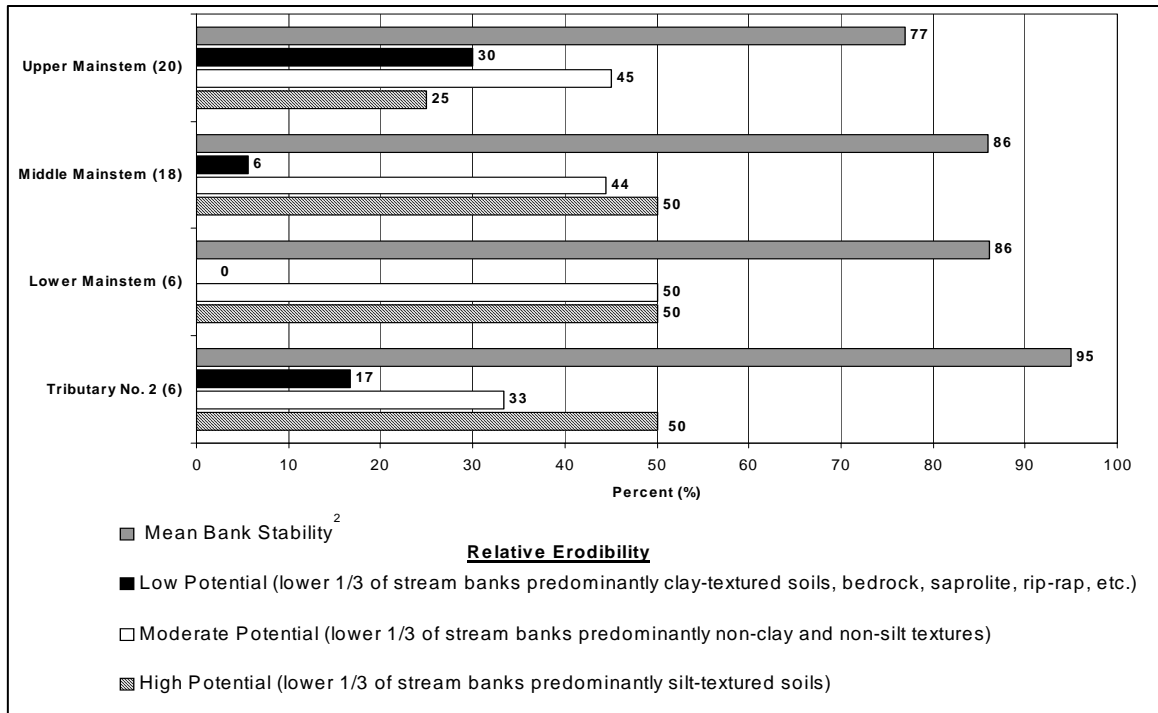
Figure 8. Summary: Mean Stream Bank Stability and Relative Erodibility (%)¹

¹ Total number of observations to determine average bank stability and relative erodibility appear in parentheses.

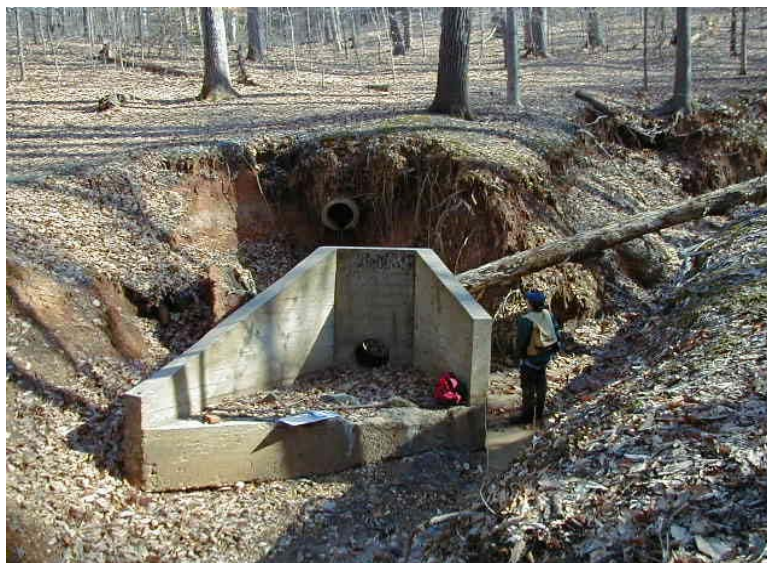
Figure 9. Upper Mainstem: Broken Concrete Storm Drain Outfall Apron (X-2 area)

Road). It also discharges directly into the Fort Dupont tributary approximately 800 feet downstream of the previously described outfall. The chronic erosion problem is so severe that the concrete outfall apron (designed to dissipate erosive storm drain outfall velocities) has been completely undermined and, along with the first few sections of reinforced concrete pipe, lies in the middle of the channel uselessly detached from the balance of the storm drain line. This additional four acres of uncontrolled stormwater runoff (from a much more impervious catchment area) further exacerbates the stream channel erosion problems.

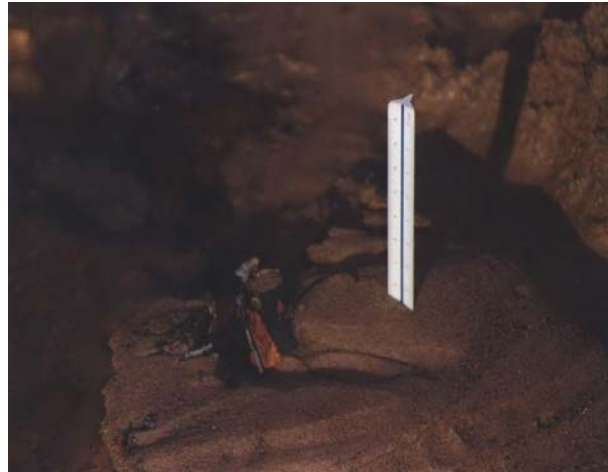
Figure 10. Upper Mainstem: In-Channel Sand Deposit (X-6 area)

Not surprisingly, the lowest number and rate of large, unstable point bars (i.e., devoid of any vegetation), as well as the lowest observed level of in-channel sand deposits were recorded in the highly stable Tributary No. 2 (Table 5). As depicted by Figure 10, vis-à-vis Tributary No. 2 and both the middle and lower mainstem, slightly higher levels of in-channel sand deposits (i.e., low/moderate range) were noted in the upper mainstem. This finding is consistent with earlier observations which indicated that, overall, the upper mainstem is generally experiencing higher levels of stream channel erosion.

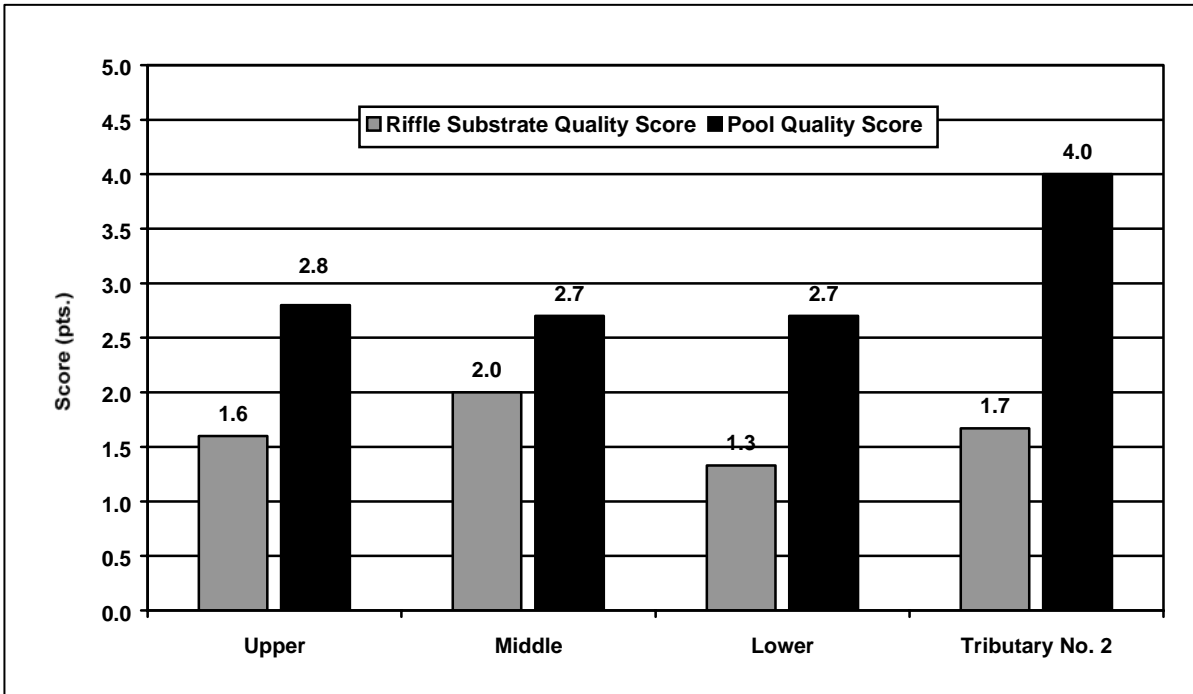
Figure 12. Fort Dupont: Mean Riffle Substrate¹ and Pool Quality²

As seen in Figure 12, mainstem riffle substrate quality was marginally better in the middle mainstem, whereas pool quality remained relatively equal throughout the mainstem.

¹ Riffle substrate quality point scale interpretation: 3.25-4.00 = Excellent, 2.50-3.24 = Good, 1.75-2.49 = Fair, 1.00-1.74 = Poor.

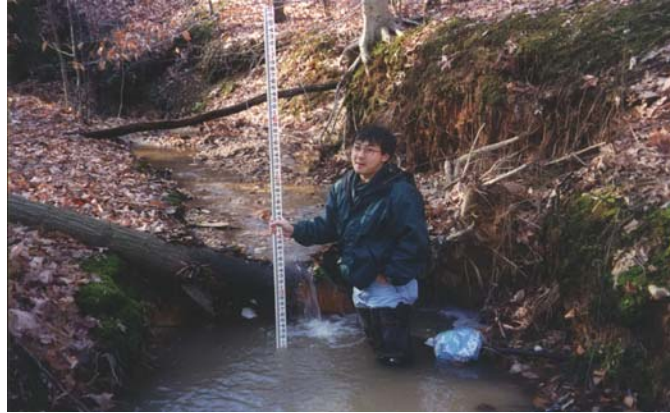
Figure 13. Upper Mainstem: High Quality 2-Foot Deep Pool (X-7 area)

It should, however, be noted that: 1) the middle mainstem had the highest number (5 total) of “deep” pools rated good or better (Table 7), 2) pool depths measured during the study were, owing to the drought, probably one to two inches shallower than under more normal baseflow conditions, 3) the majority of the pools surveyed featured large amounts of highly unstable sandy material and 4) as illustrated in Figure 13, approximately one-half of the deep pools observed were associated with large, woody debris such as tree falls.

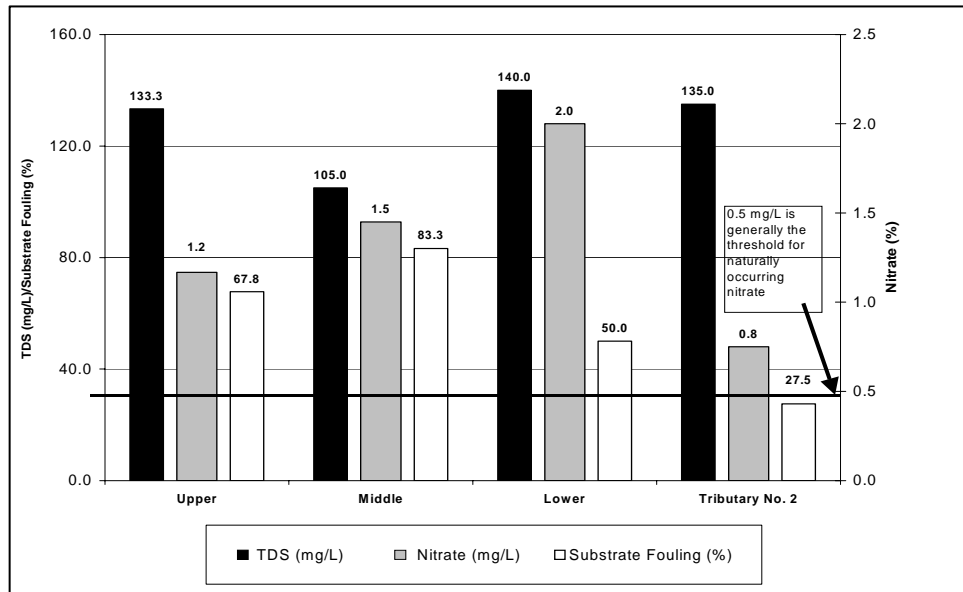
Figure 17. Fort Dupont: Mean TDS¹, Substrate Fouling² and Nitrate³

As seen in Figure 17, TDS levels in all four stream reaches surveyed were in the fair range (i.e., 101-150 mg/l). TDS levels were lowest in the middle mainstem (105 mg/l) and highest in the lower mainstem (140 mg/l).

¹ TDS interpretation: <50 mg/L = Excellent, 50-100 mg/L = Good, 101-150 mg/L = Fair, >150mg/L = Poor.

With regard to mainstem nitrate levels, all were in the moderate range (i.e., 1.1-2.9 mg/l). Also, a distinct downstream increase was observed, with NO₃⁻ levels increasing from a low of 1.2 mg/l in the upper mainstem to 1.5 mg/l in the middle mainstem and finally, to 2.0 mg/l in the lower mainstem. Nitrate concentrations in Tributary No. 2 were in the low range (i.e., <1.0 mg/l). Substrate fouling levels were rated as being poor in both the upper and middle mainstem (i.e., >50 percent of the bottom side of cobble-sized stones covered by an organic film) and fair in both the lower mainstem (50 percent fouling) and Tributary No. 2 (27.5 percent fouling).

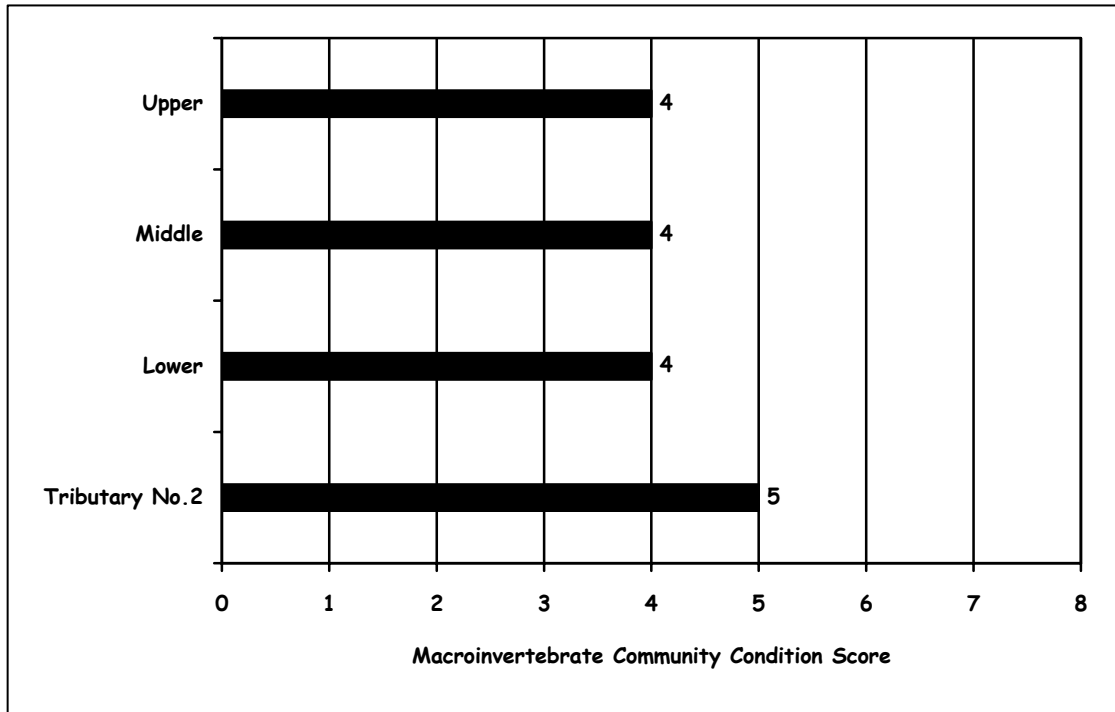
Figure 18. Fort Dupont: RSAT Voucher Collection Macroinvertebrate Community Condition¹

¹ Macroinvertebrate scale interpretation: 7.0-8.0 pts. = Excellent, 5.0-6.9 pts. = Good, 2.1-4.9 pts. = Fair, 0.0-2.0 pts. = Poor.

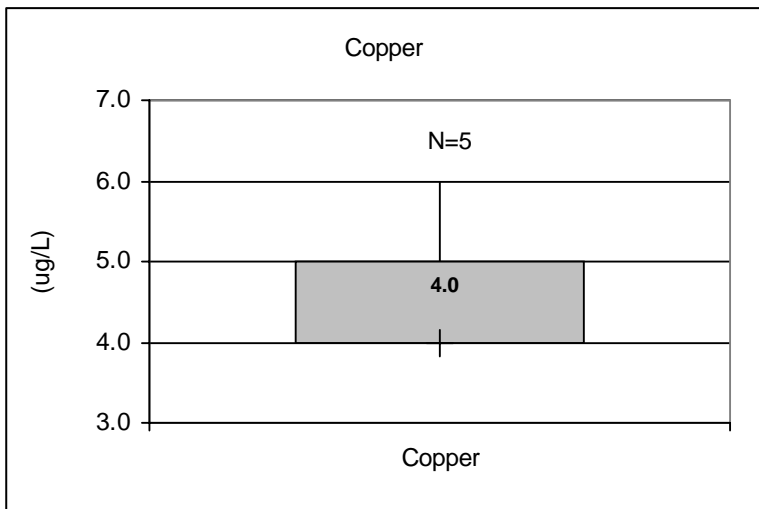
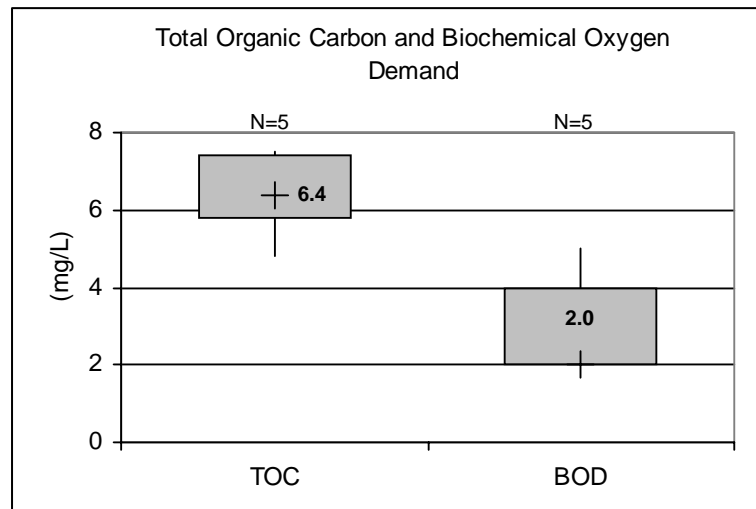
Figure 21. Fort Dupont - Middle Mainstem (X-16) Baseflow Nitrate, Total Phosphorus, Copper, Iron, Total Organic Carbon and Biochemical Oxygen Demand (Sept. - Dec. 1999)

Baseflow water chemistry analysis results (Figure 21; Appendix 6: Table 1) for the Fort Dupont middle mainstem (X-16) revealed that: 1) both nitrate (NO₃) and total phosphorus (TP) concentrations were low, 2) iron (Fe) levels violated the DC-DOH/EHA Class 'C' 1.0 mg/l criterion for the protection of aquatic life 71.4 percent of the time, 3) the maximum observed copper (Cu) concentration (6 µg/l) was well below the generally recommended 'instantaneous' concentration limit of 18-20 µg/l established by EPA (1986); and MDE (1995) and 4) both total organic carbon (TOC) and biochemical oxygen demand (BOD) levels were slightly elevated.

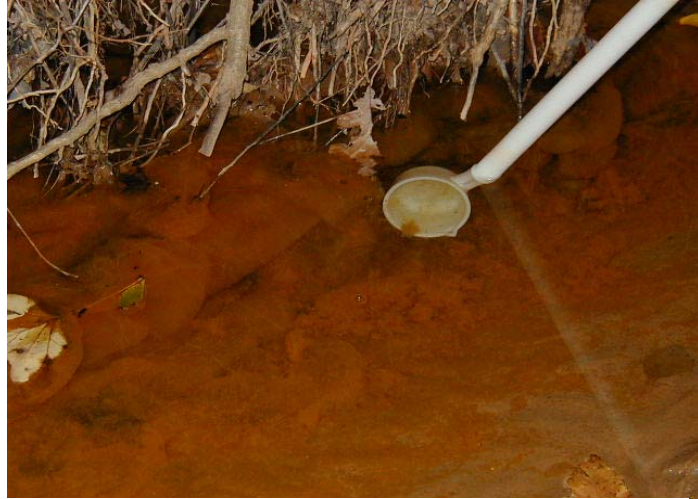
Figure 22. Episodic Iron Floc Coating of Mainstem Streambed (X-13 area)

Stormflow Fe concentrations ranged from 5.8 mg/l to 140 mg/l (Hurricane Floyd), with a median of 51.0 mg/l. This median concentration was approximately 25 times greater than that observed for baseflow conditions, and is reflective of both the high iron content of the soils of the Fort Dupont subwatershed, and their mobility during storm events. While the preceding concentrations and exposure periods may not in themselves be toxic, they would appear to be a major stressor on the Fort Dupont aquatic community. For example, macroinvertebrate and fish toxicity studies (Skyora et al., 1972; Ebeling, 1931; Roback, S. in Hart and Fuller, 1974) suggest that the preceding Fe levels could cause reproductive impairment, reduced emergence, reduced growth and even serious injury or death for certain sensitive species. It should, however, be noted that other factors such as pH, hardness, temperature and the presence of ligands affect the solubility of iron, and therefore its toxicity.

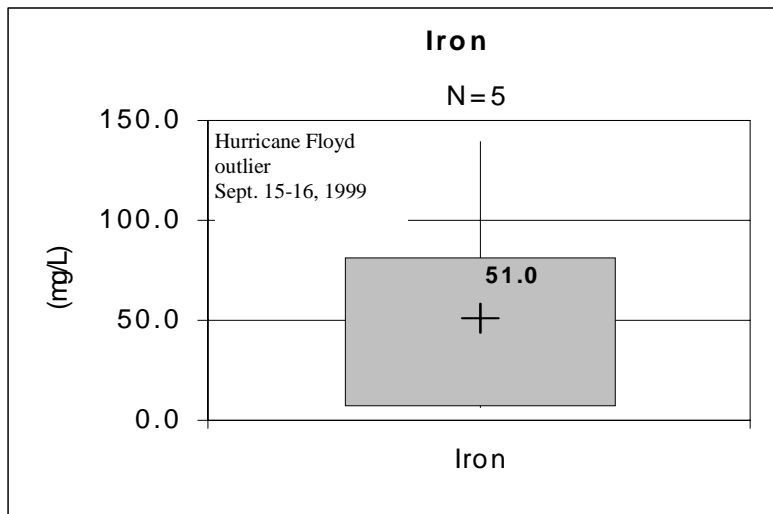
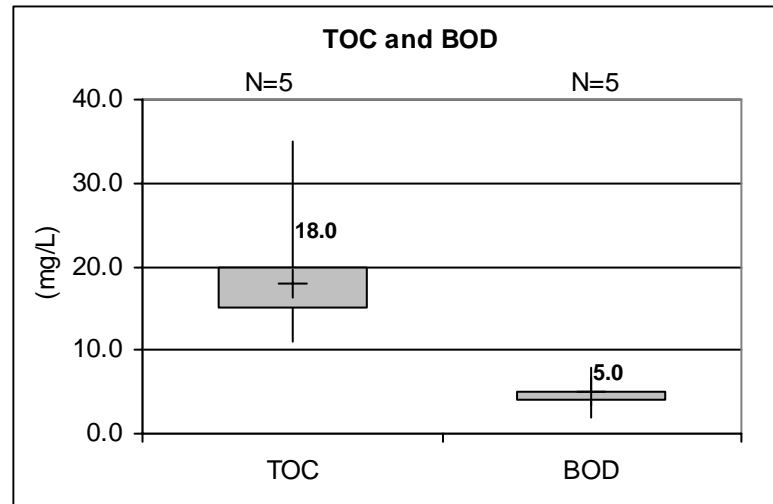
Figure 24. Fort Dupont - Middle Mainstem (X-16) Stormflow Nitrate, Total Phosphorus, Copper, Iron, Total Organic Carbon and Biochemical Oxygen Demand (Sept. - Dec. 1999)

Not surprisingly, NO_3 , TP, Fe, Cu, TOC and BOD levels all experienced marked increases under stormflow conditions. In addition, Hurricane Floyd (9/16/99) produced major outlier spikes in associated concentration levels for all six preceding water quality parameters. As seen in Figure 24, median stormflow NO_3 and TP concentrations were, compared to baseflow conditions, approximately two and four times higher, respectively.

With regard to Cu, stormflow concentrations ranged from 9.0 $\mu\text{g/l}$ to 230.0 $\mu\text{g/l}$ (Hurricane Floyd). The median stormflow Cu concentration was 14.0 $\mu\text{g/l}$. This median level was more than three times greater than the median baseflow concentration (i.e., 14.0 $\mu\text{g/l}$ versus 4.0 $\mu\text{g/l}$).

According to EPA (1986), in order to protect most aquatic organisms, hourly copper concentrations should not (at a hardness level of 100 mg/l) exceed 18 µg/l. This 'instantaneous' 18 µg/l level is currently used by the State of Maryland for its acute freshwater copper toxicity criterion (MDE, 1995). It should be noted that Fort Dupont stormflow hardness concentrations ranged from 52 to 91 mg/l (Appendix 6: Table 2). Conversely, DC-DOH/EHA water quality standards currently employ an alkalinity-adjusted copper criterion. Based on the observed Fort Dupont stormflow alkalinity levels, the hourly maximum allowable DC-DOH/EHA Cu concentrations for the five sampled storms would have been 16.0, 9.0, 17.0, 12.5 and 12.5 µg/l, respectively. Actual corresponding stormflow Cu concentrations were 230 (Hurricane Floyd), 43, 9, 10 and 14 µg/l, respectively. While copper is readily adsorbed by suspended matter and does not bioaccumulate, the preceding findings are of concern and suggest that copper concentrations could also be limiting to the Fort Dupont aquatic community. Finally, given that the stormwater samples were collected upstream of the maintenance facility's storm drain outfall, the preceding results indicate an upstream source(s) for Cu, Fe and other pollutants.

As seen in Figure 24, stormflow TOC concentrations ranged from 11 to 35 mg/l, with a median of 18 mg/l. Somewhat to the surprise of COG staff, stormflow BOD levels remained well below the typical mean 11.9-30 mg/l concentration range reported by Schueler (1987) and Novotny and Olem (1994) for urban stormwater runoff. In fact, the maximum stormflow BOD concentration observed during the study was only 8.0 mg/l (Figure 24). The preceding results, together with relatively low fecal coliform concentrations recorded during the study strongly suggest that much of the organic load to the stream is of the natural, background variety as opposed to anthropogenic sources such as sewage.

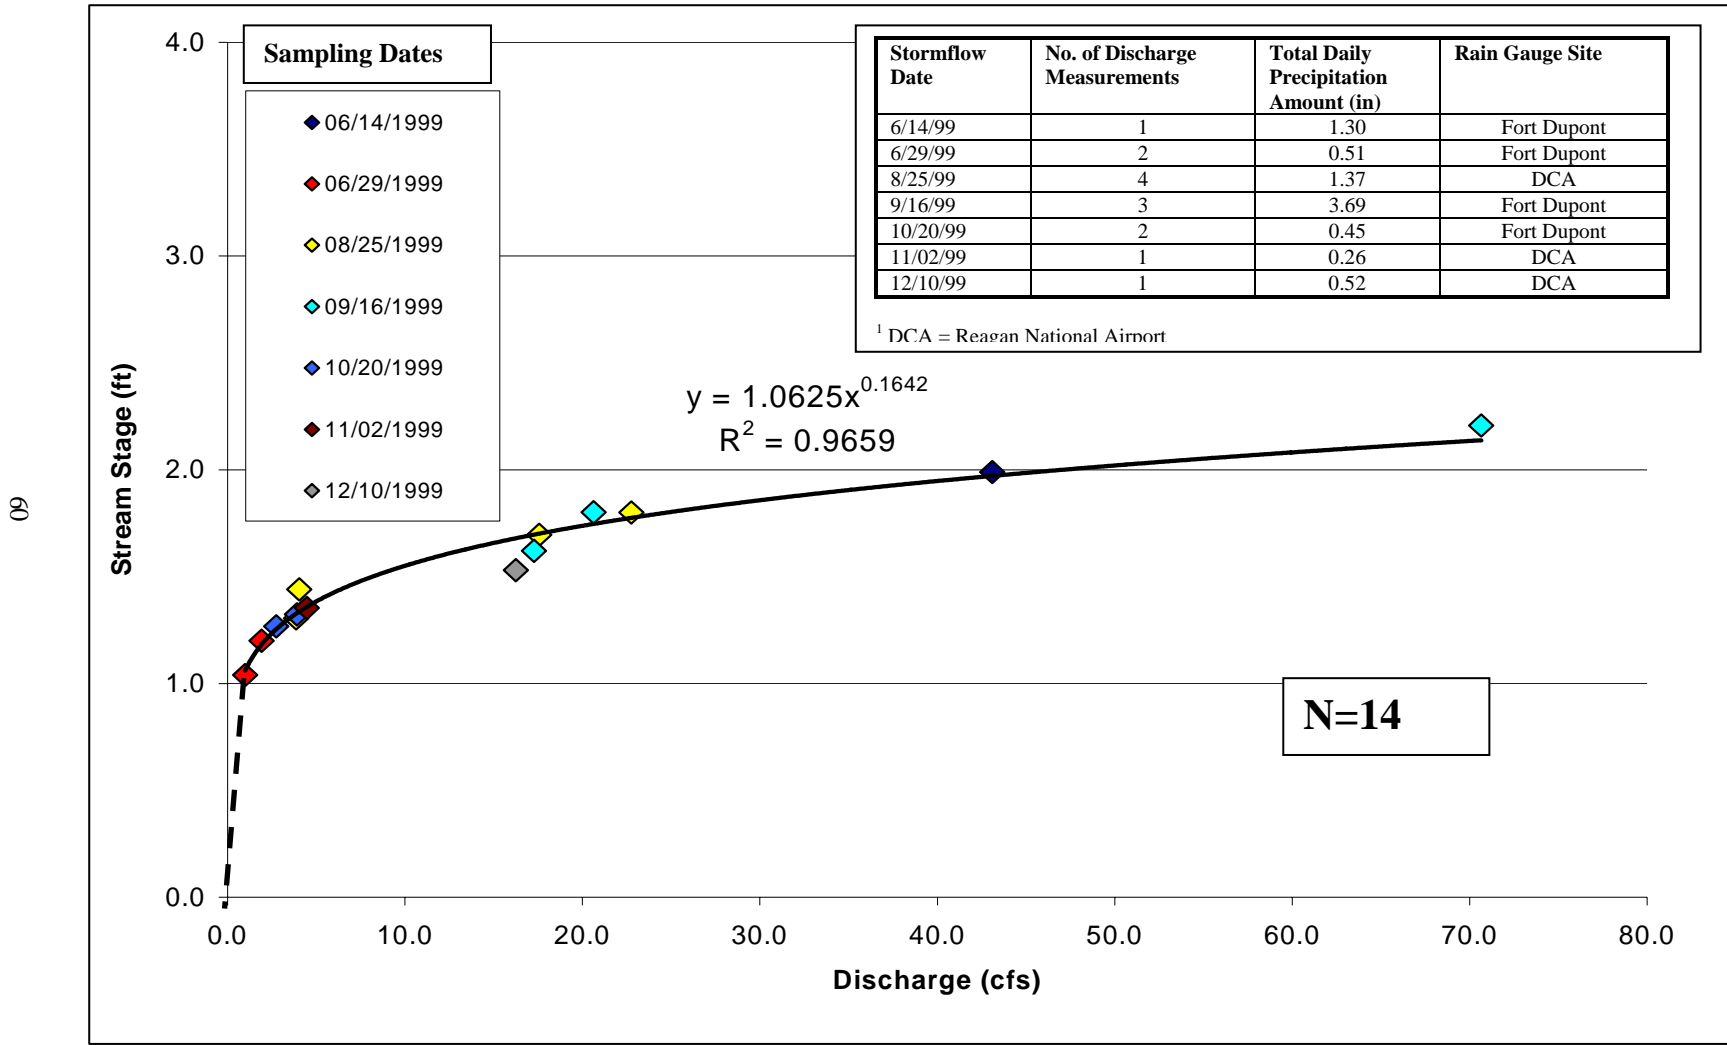
Figure 28. Fort Dupont: Middle Mainstem– Stage-Discharge Rating Curve (June – December 1999)¹

¹ Discharge measurements were taken during the ascending limb of the storm hydrograph.
