Fort Chaplin Subwatershed Restoration: 2003 Baseline Stream Assessment Study – Physical, Chemical, and Biological Conditions

Prepared for:
District of Columbia
Department of Health/
Environmental Health Administration
Watershed Protection Division

Prepared by:
Department of Environmental Programs
Metropolitan Washington Council of Governments

October 2004

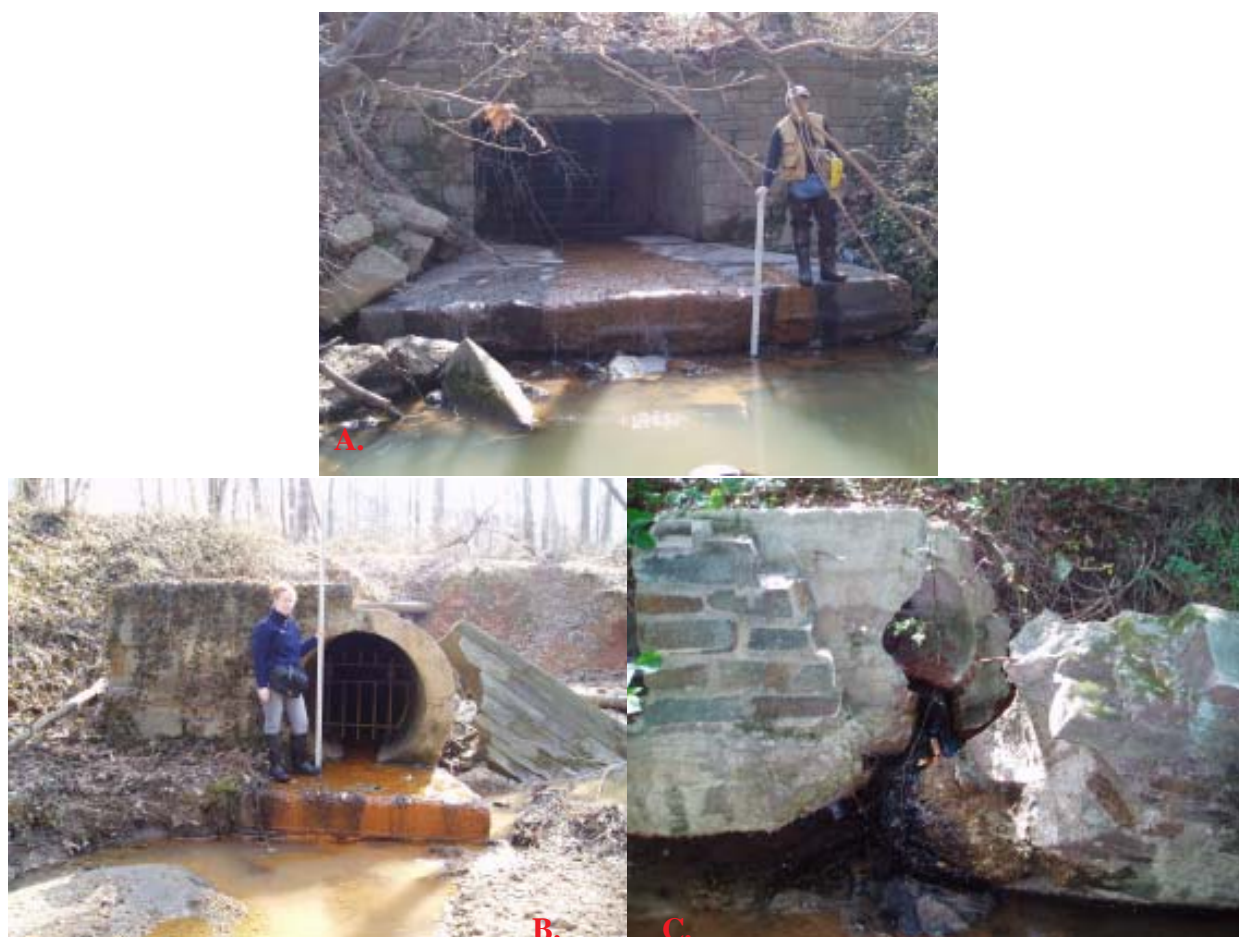
Figure 2 - Fort Chaplin Tributary - A. Texas Avenue Storm Drain Outfall (4' high by 8' wide concrete box culvert); B. East 'D' Street Storm Drain Outfall (48" RCP); C. West 'D' Street Storm Drain Outfall (27" RCP)

- 2) At a minimum, the two following storm drain system outfall locations are either in need of major repair and/or the installation of more effective velocity dissipation features (i.e., east and west 'D' Street).

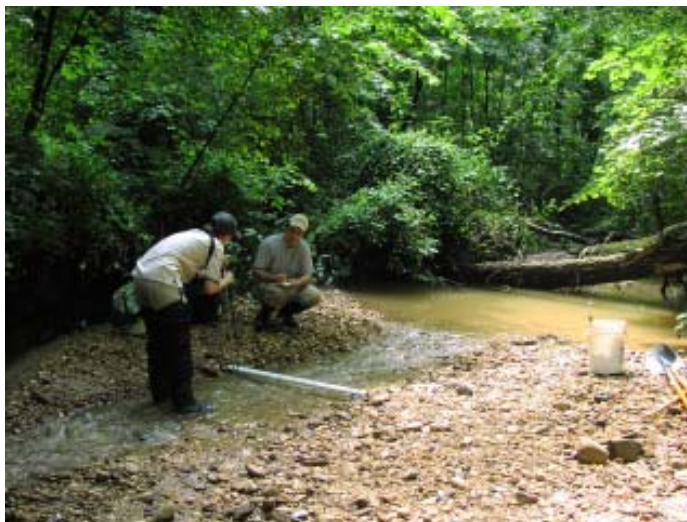
Baseflow discharges were measured at a riffle near transect X-9 (Figure 4). A total of 11 measurements were conducted using a Marsh-McBirney Incorporated, model 2000 Flowmate flow probe. Measurements were taken from different dates (i.e., at least three times a month between July and September 2003). Again, the time was recorded for each discharge measurement that corresponded to the time that a stage height was recorded by the water level data logger.

Figure 4 - Lower reach - COG Staff Measuring Baseflow

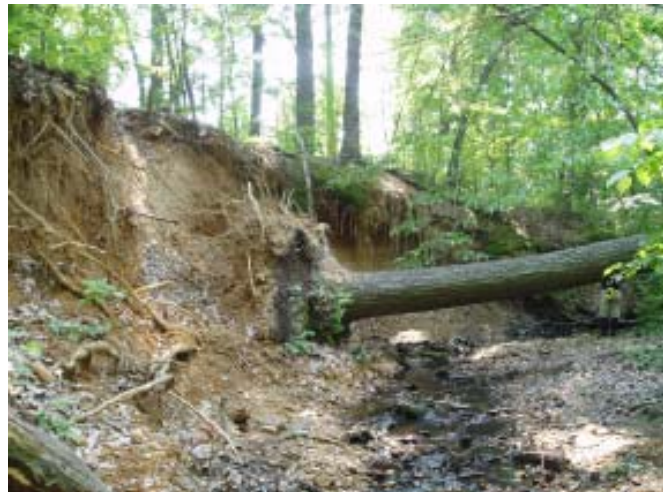
The Fort Chaplin streambank network appears to be actively eroding in its remaining open channel sections. Results from the channel stability portion of the study revealed that out of a total of 3,801.6 feet of RSAT-surveyed streambank network length (i.e., total length for both right and left bank areas combined), 690 linear feet, representing approximately 18.2 percent is experiencing severe erosion. Approximately 1,057 linear feet (27.8 percent) exhibited moderate/severe streambank erosion conditions. An additional 448 linear feet (11.2 percent) exhibited moderate bank erosion conditions (Figure 5). Stream areas experiencing moderate, moderate/severe or severe streambank erosion conditions were observed in both straight and meandering sections. As illustrated by Figure 5, these sections were frequently associated with recent tree falls lying across the stream channel. Cross-sectional analysis results (Figure 6) indicated that the mean cross-sectional area of both the Upper (187.9 ft²) and Lower (178.3 ft²) reaches are similar in area; whereas, the wider and more entrenched Middle reach cross-sectional area (267.81 ft²) is approximately forty percent greater.

Figure 5 - Upper reach - Severe Streambank Erosion

- 3) Given the major technical, institutional and financial challenges associated with the implementation of subwatershed-wide, stormwater management controls which significantly reduce runoff volumes entering Fort Chaplin, a Rosgen-based stream channel restoration project for the entire length of open channel (i.e., approximately 1,900 feet) is recommended.

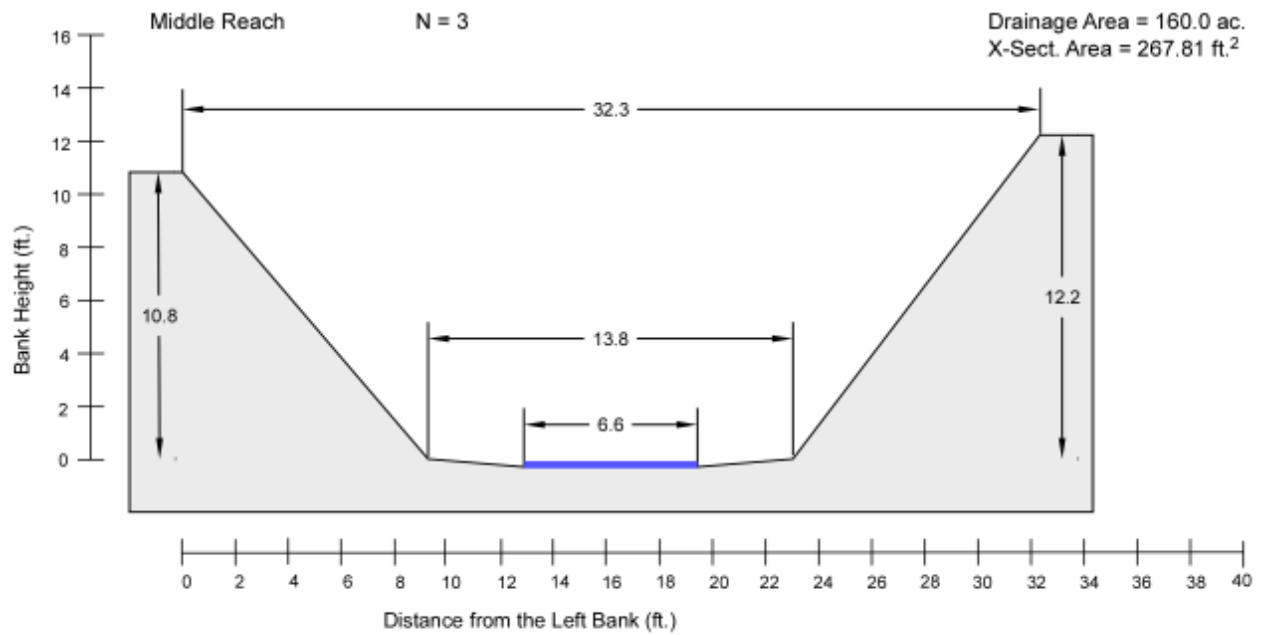
Based on previous COG staff surveys of comparably-sized Coastal Plain and Piedmont streams in the Washington metropolitan area, the generally expected Fort Chaplin bank height and channel width ranges are on the order of one to three feet and 10 to 12 feet, respectively (Galli et al., 1999; Trieu et al., 1998; Galli et al., 1996b; Corish et al., 1996; Galli and Trieu, 1994). The

Figure 6 - Representative Channel Cross-Sections ¹

¹ Top channel width, bottom channel width and wetted perimeter area (heavy black line) depicted.

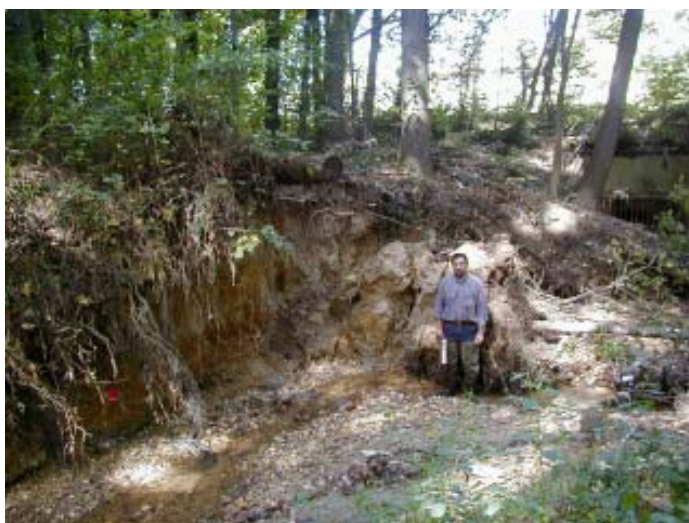
preceding results confirm that decades of uncontrolled stormwater runoff, beginning downstream of Texas Avenue (Figure 7) and extending all the way downstream to the piped entrance at 'C' Street has produced a Fort Chaplin stream channel, which is with respect to forested, reference stream conditions, markedly wider and more incised.

Figure 7 - Lower Reach ('C' Street Area) - Severe Channel Erosion

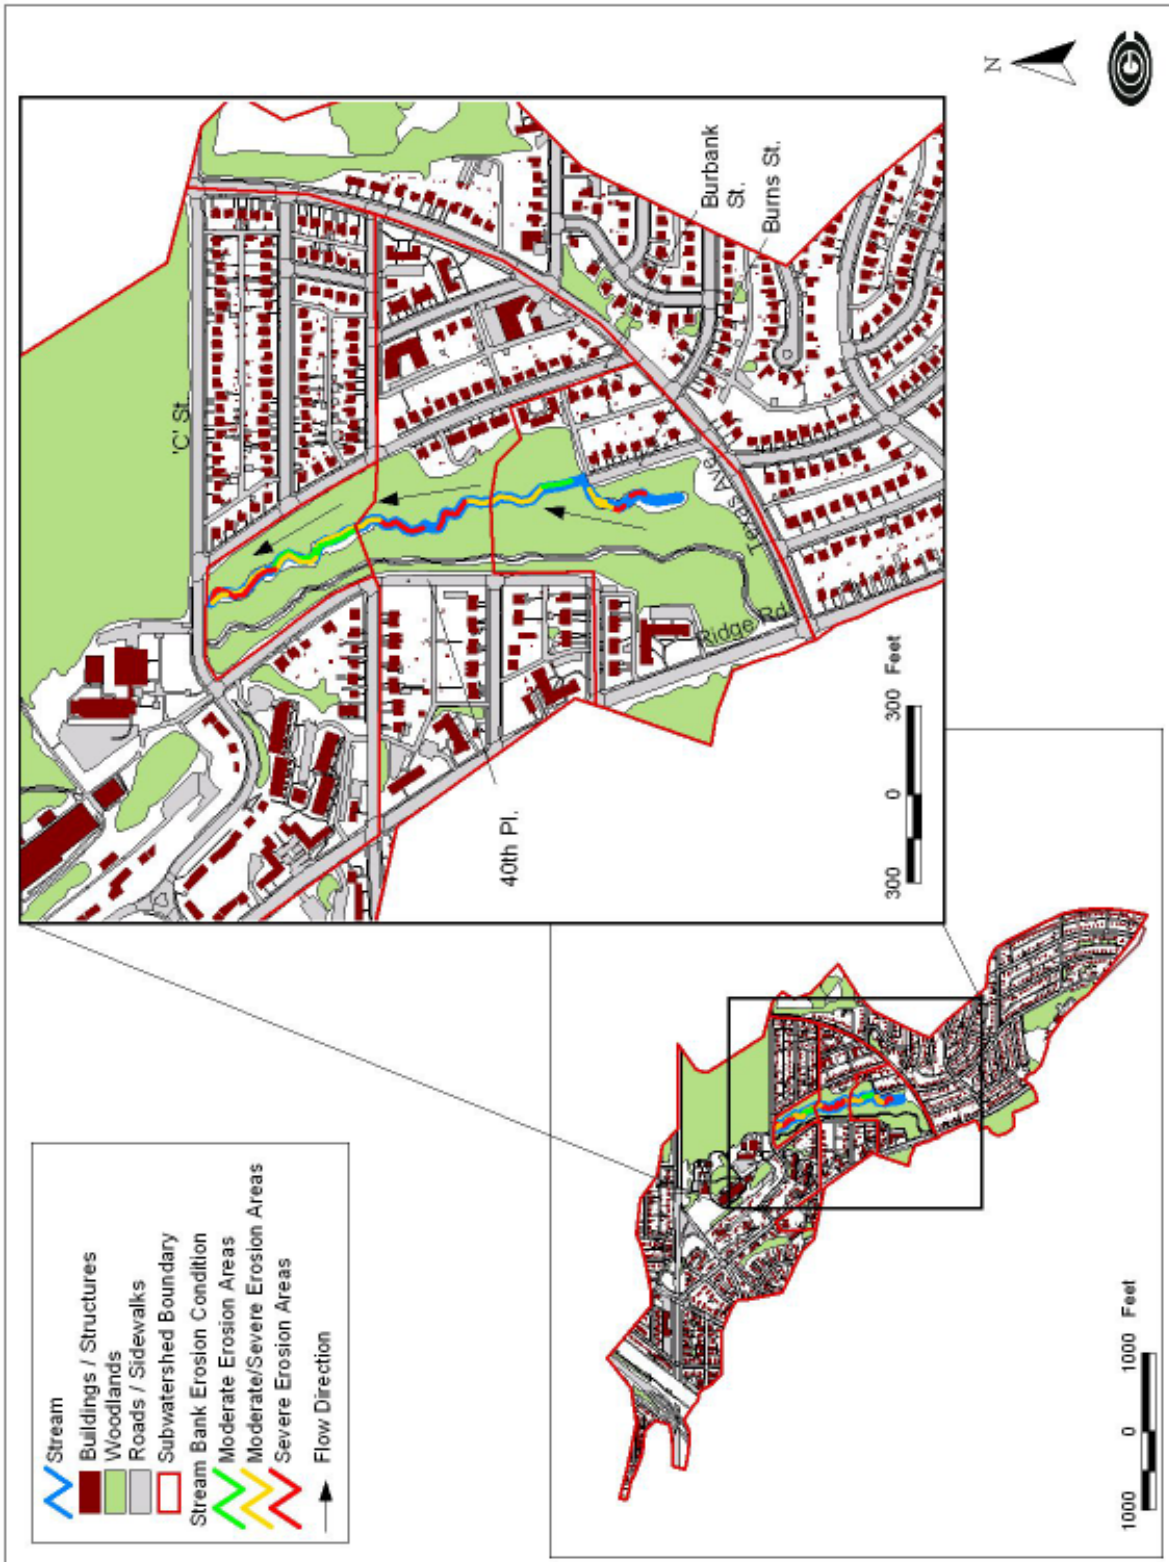
Figure 9 - Fort Chaplin - Moderate, Moderate/Severe and Severe Streambank Erosion Areas

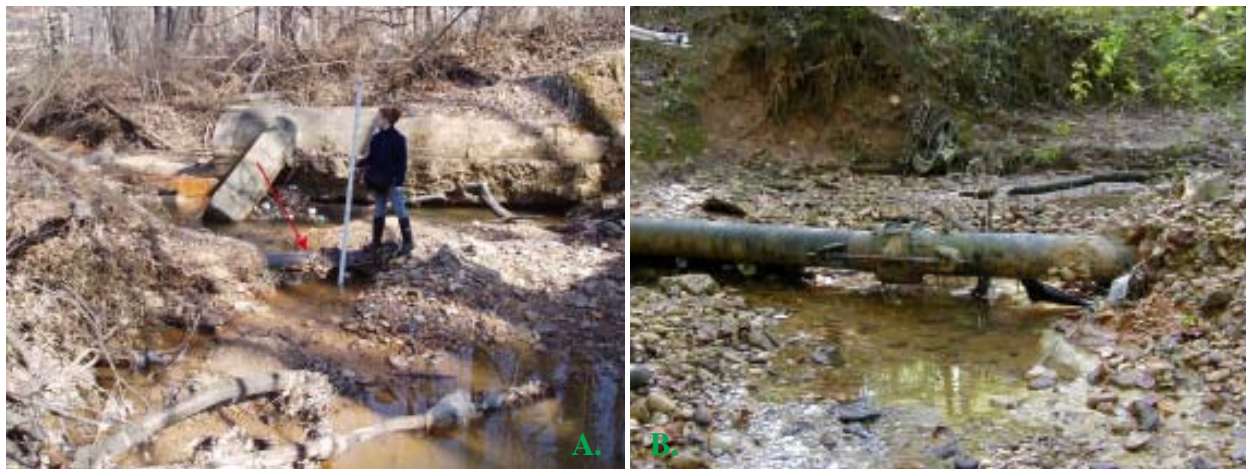
Figure 11 - A. Middle Reach - Exposed Three Foot Long 10" DIP Section, May 2004; B. Middle Reach - Exposed Eight Foot Long 10" DIP, October 2004

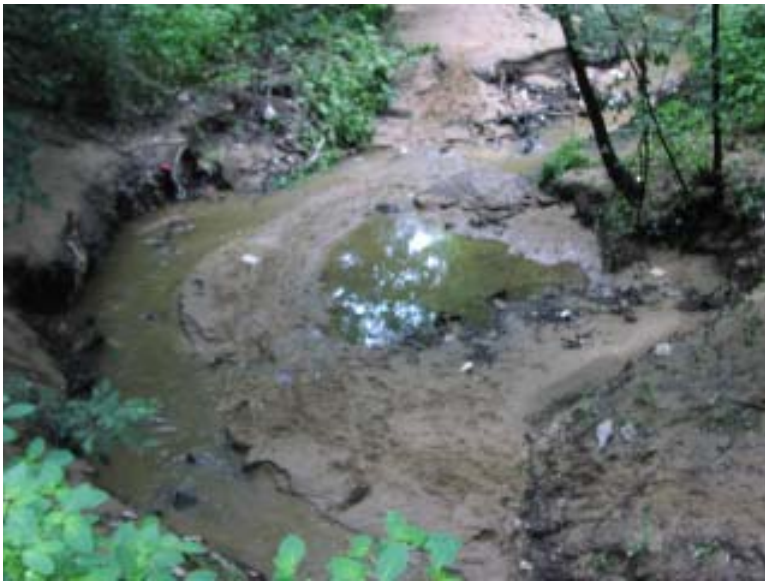
Figure 13 - Lower Reach - High In-Channel Sand Deposition at Transect X-9

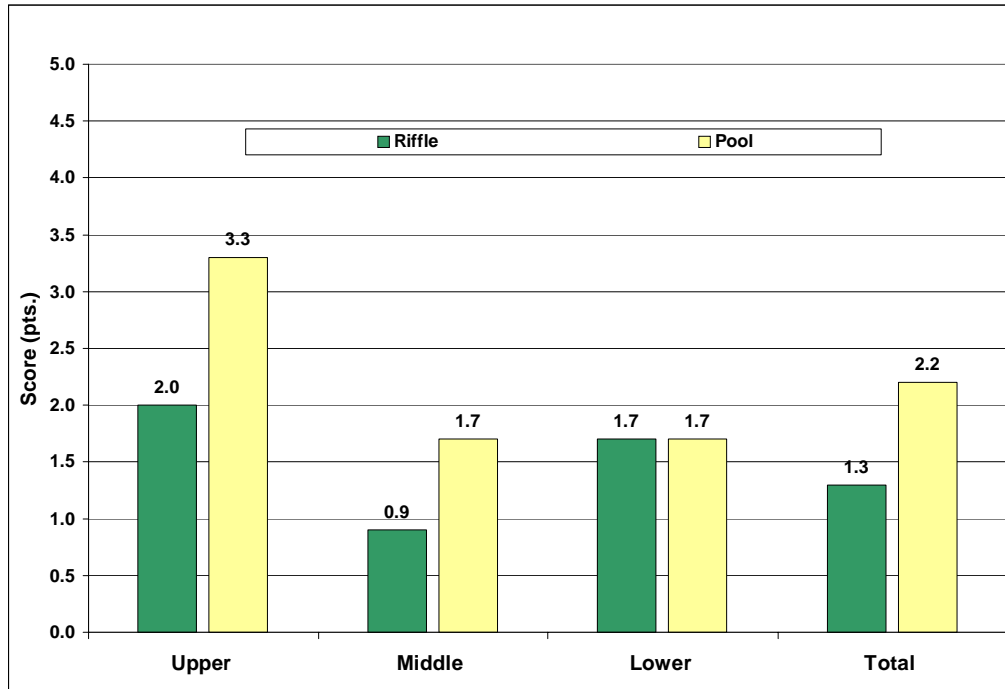
Figure 14 - Fort Chaplin Mean Riffle Substrate¹ and Pool Quality² Scores

¹ Riffle substrate quality point scale interpretation: 3.25-4.00 = Excellent, 2.50-3.24 = Good, 1.75-2.49 = Fair, 1.00-1.74 = Poor.

² Pool quality point interpretation: 4.5-5.0 = Excellent, 4.0-4.4 = Very Good, 3.0-3.9 = Good, 2.0-2.9 = Fair, 1.0-1.9 = Poor.

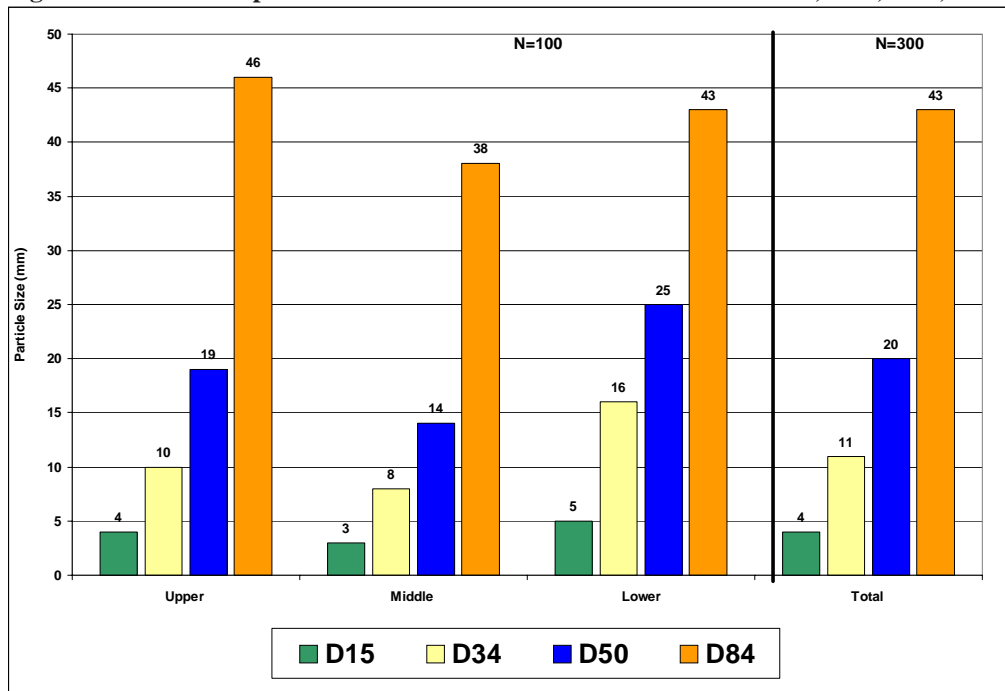
Figure 15 - Fort Chaplin - Substrate Particle Size Distribution³ - D15, D34, D50, and D84

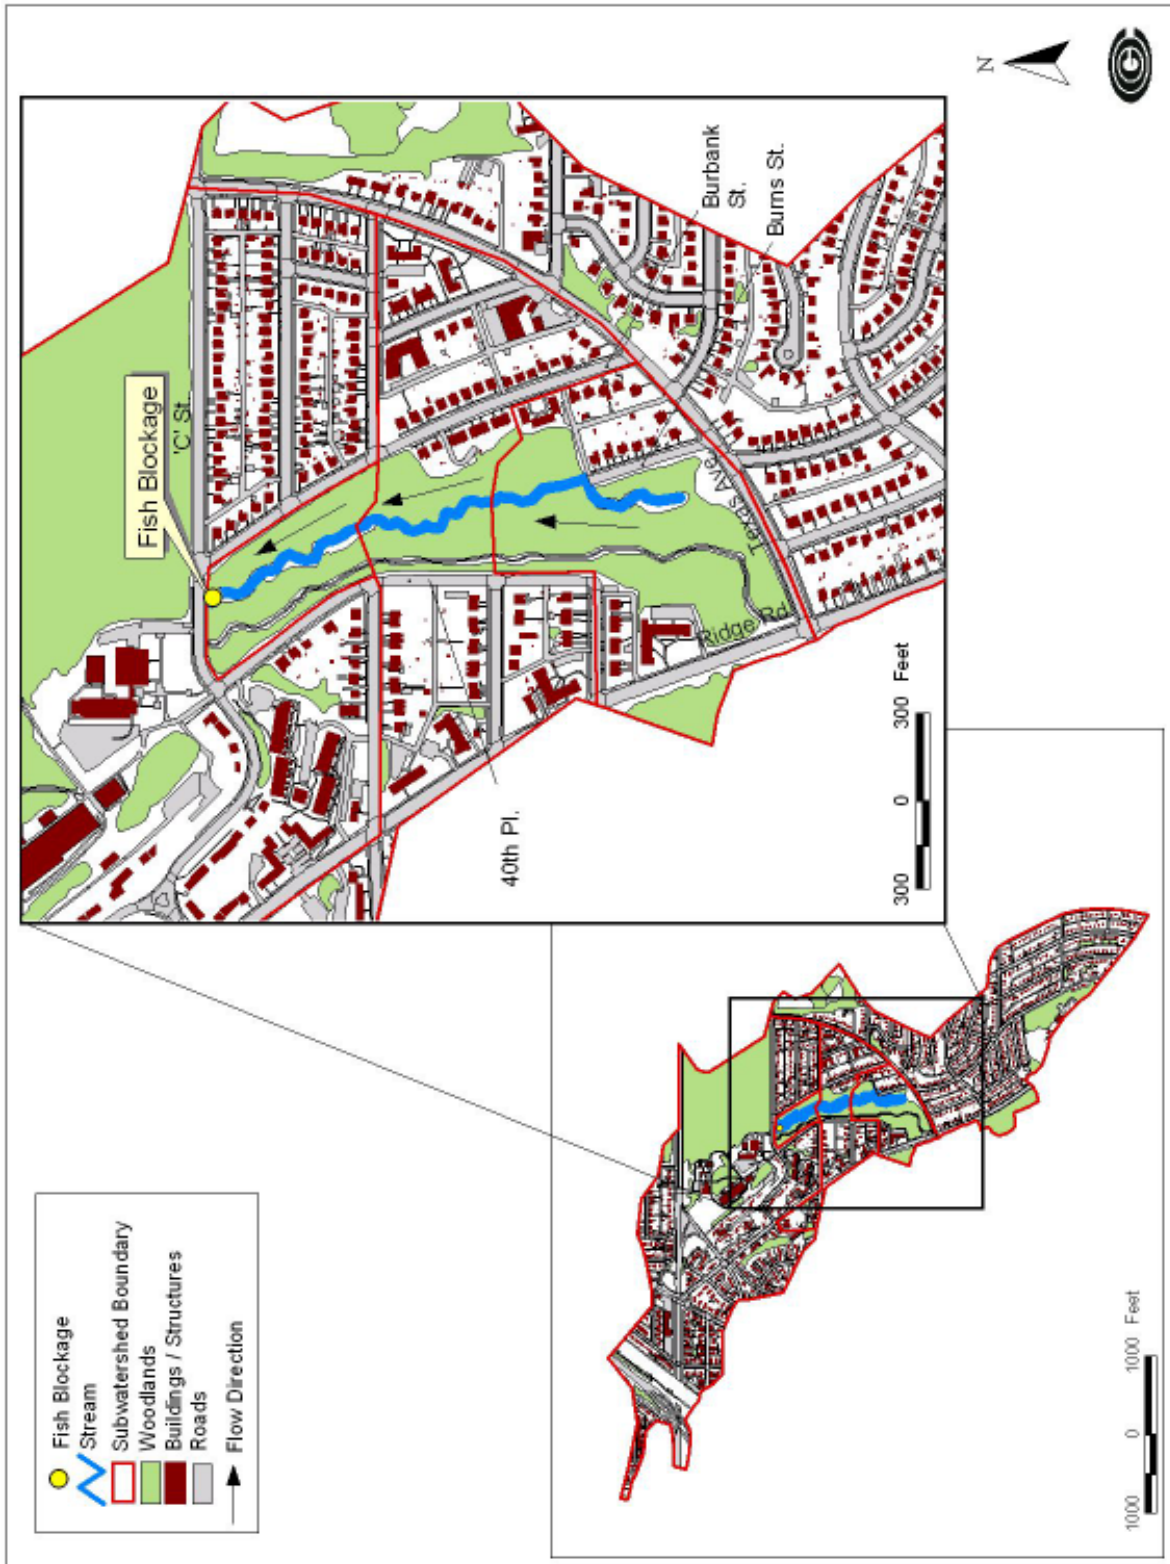
Figure 16 - Fort Chaplin Tributary - Fish Blockage

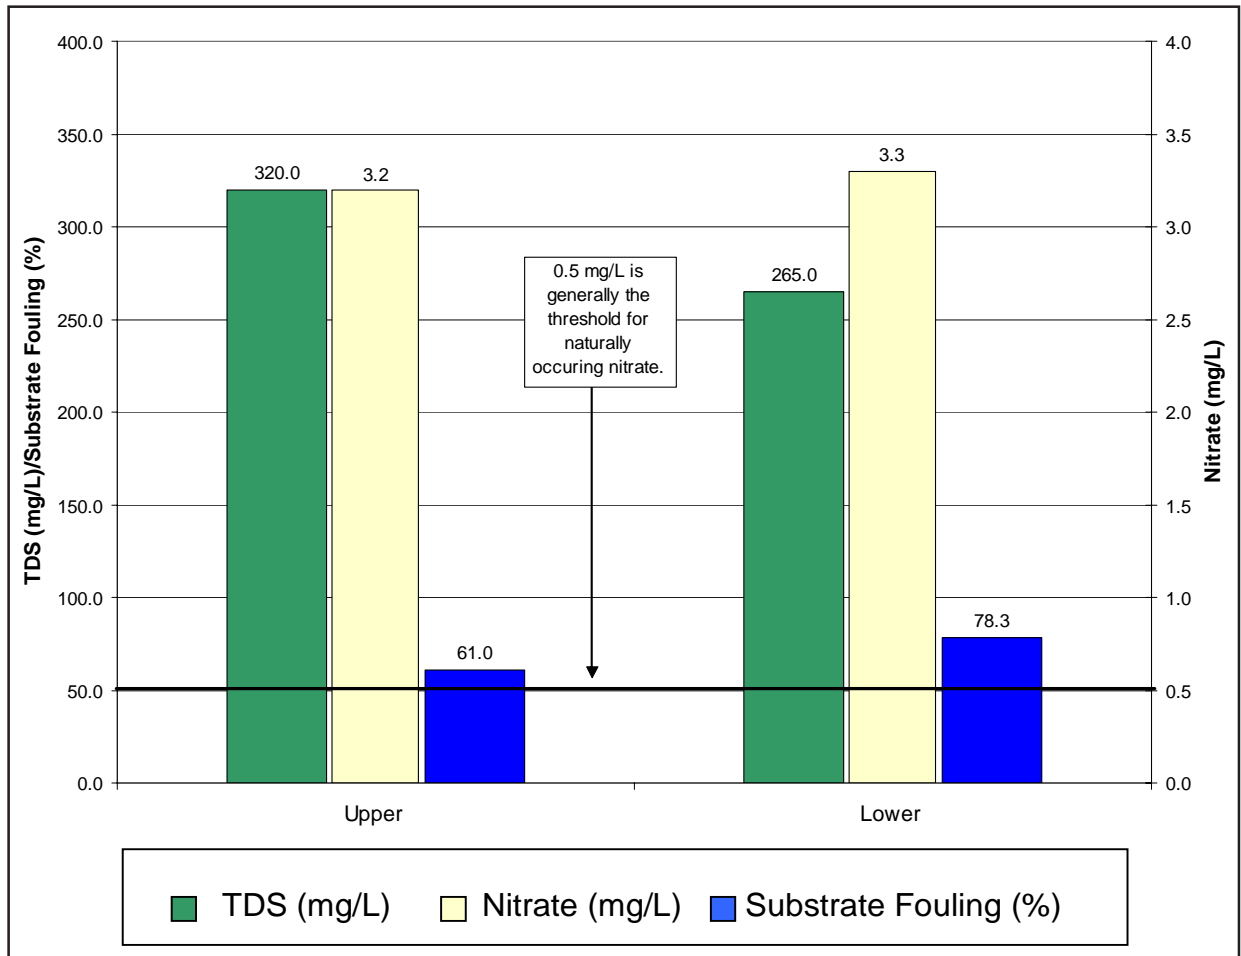
Figure 17 - Fort Chaplin - Mean TDS¹, Substrate Fouling² and Nitrate³

¹ TDS interpretation: <50 mg/L = Excellent, 50-100 mg/L = Good, 101-150 mg/L = Fair, >150 mg/L = Poor.

² Substrate fouling interpretation: 0-10% = Excellent, 11-20% = Good, 21-50% = Fair, >50% = Poor.

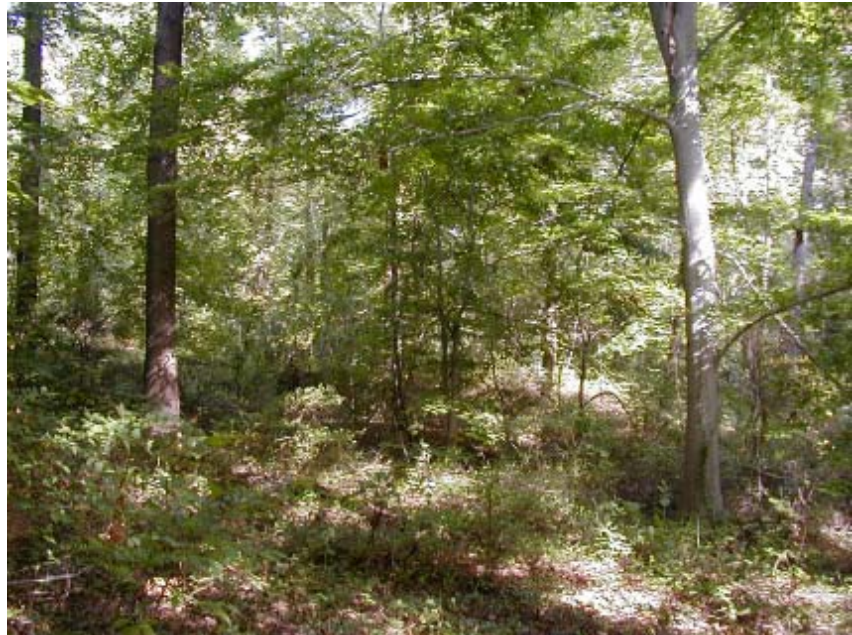
With the exception of the short stream length (i.e., ~ 360 feet) in the Upper reach along Burns Street, the riparian corridor was relatively wide (i.e., average 150 feet or greater) and heavily forested. As seen in Figure 18, a mature deciduous hardwood forest was the dominant vegetative community in the stream valley. In general, the mean left bank riparian buffer width (172 feet) was slightly wider than that of the right bank (149 feet). It should be noted that a 200 feet plus wide riparian buffer

Figure 18 - Middle Reach - Mature Hardwood Forest

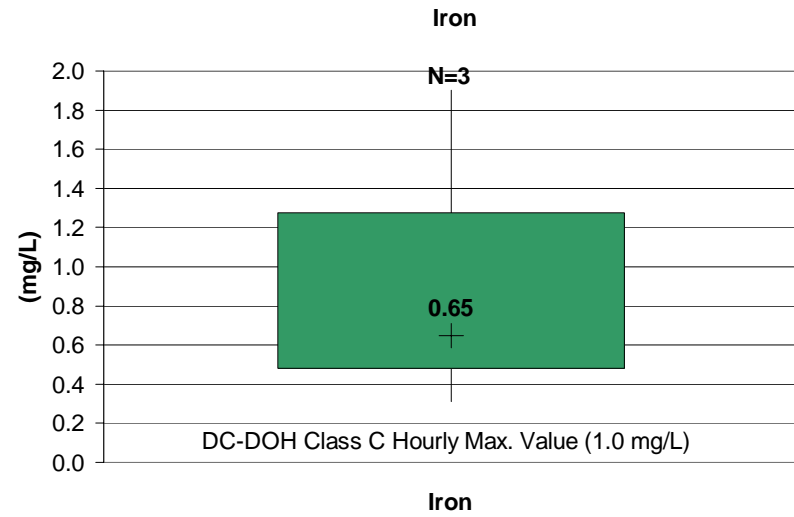
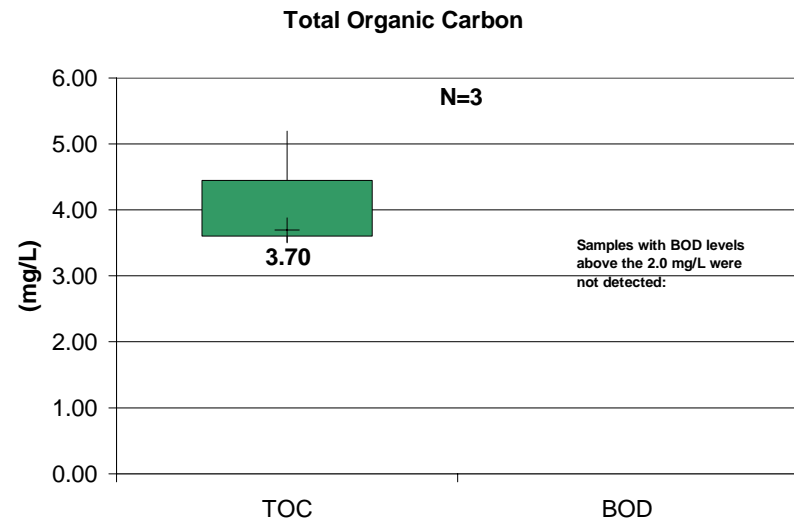
Figure 22 - Fort Chaplin Lower Reach Baseflow Nitrate, Total Phosphorus, Copper, Iron, Total Organic Carbon, and Biochemical Oxygen Demand (July – November 2002)

As seen in Figure 22, the maximum baseflow NO_3^- concentration recorded was 4.4 mg/l. The median baseflow TP level, at 0.12 mg/l, was slightly above the < 0.10 mg/l level recommended by EPA (1986) for the reduction and/or avoidance of nuisance plant growth in streams.

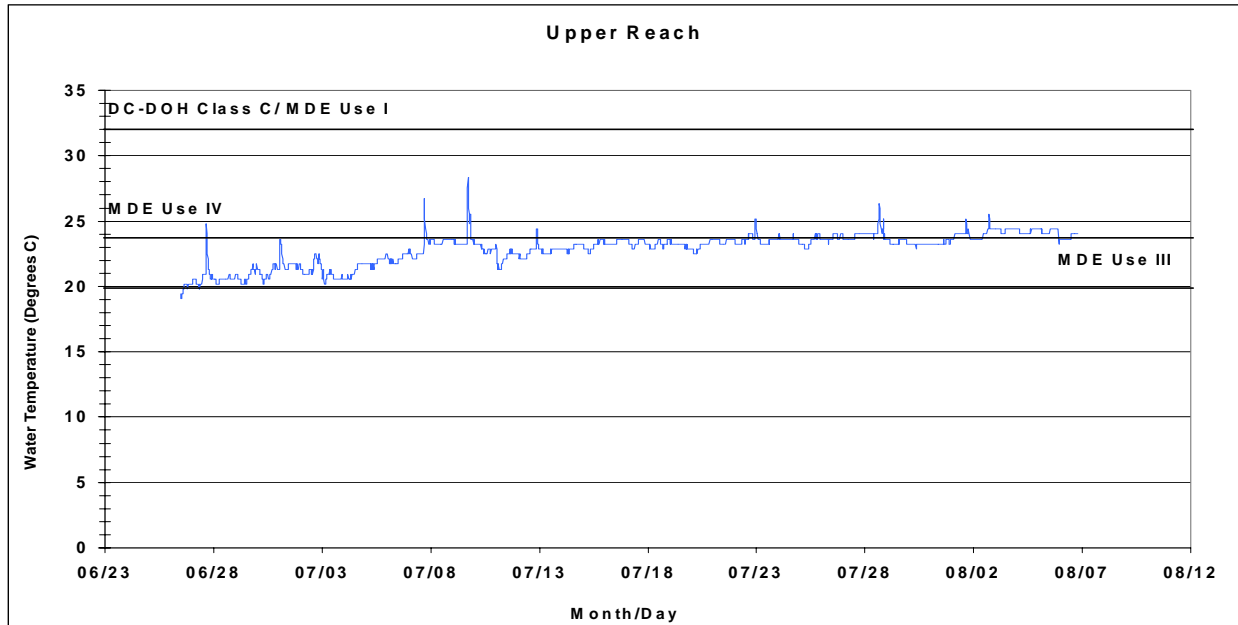
Figure 24 - Fort Chaplin - Upper And Lower Reaches Twenty-Minute Water Temperature Readings¹ (June 26-August 1, 2003)

¹ DC-DOH Maximum Water Temperature Standards: Class-Protection and propagation of fish, shellfish and wildlife = 32.2°C. MDE Maximum Water Temperature Standards: Use I (water contact recreation, aquatic life and water supply) = 32°C; Use III (natural trout waters) = 20°C; Use IV (recreational trout waters) = 24°C.

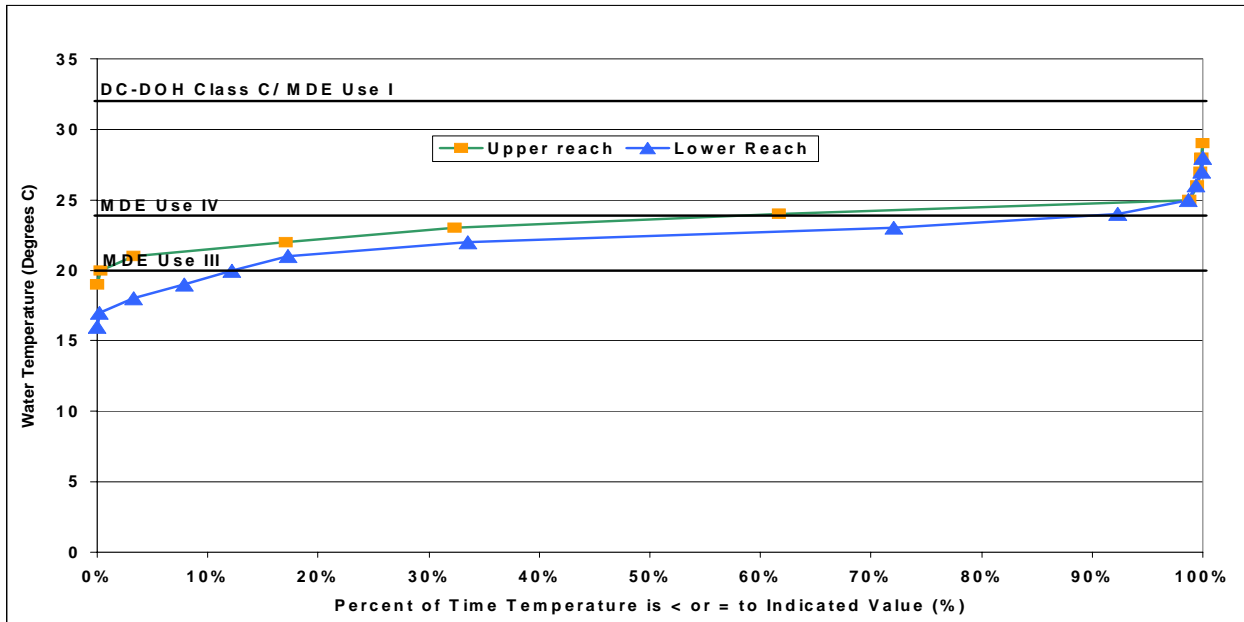
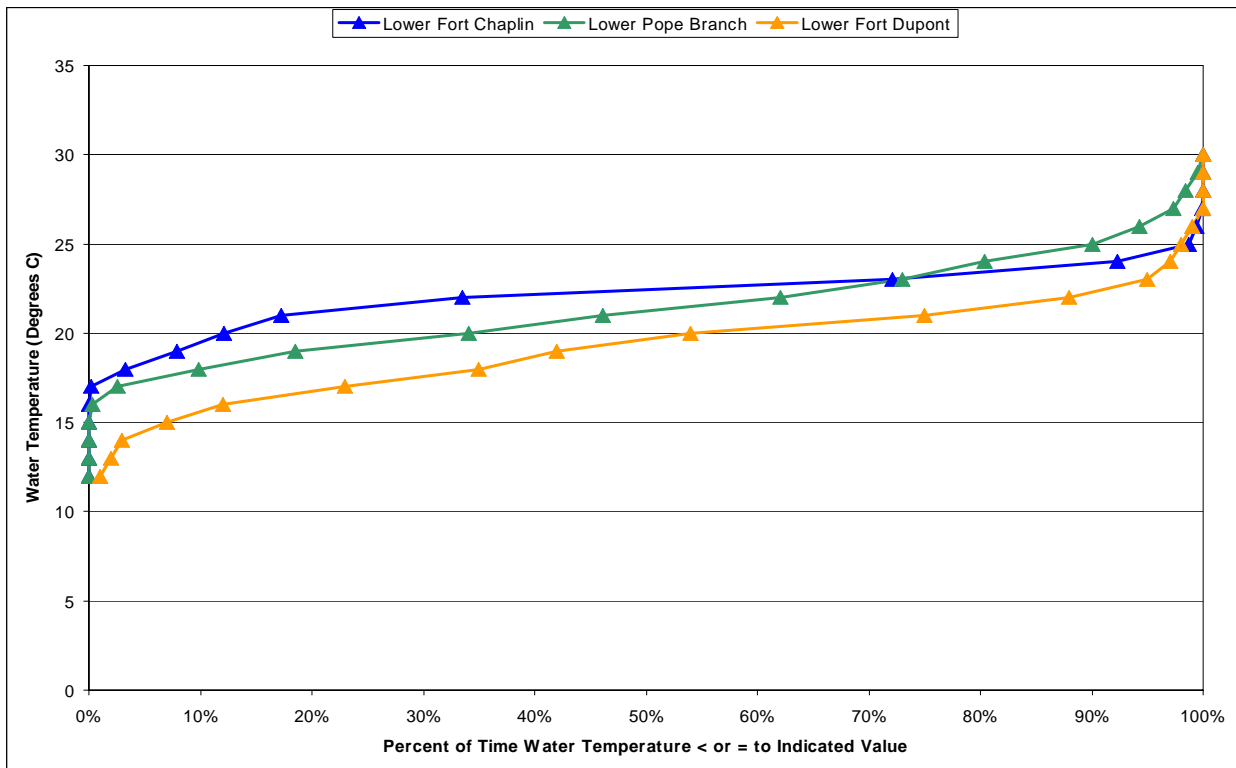
Figure 25 - Fort Chaplin Water Temperature Distribution: Upper and Lower Reaches; Fort Chaplin Tributary, Pope Branch and Fort Dupont Tributary Lower Reaches

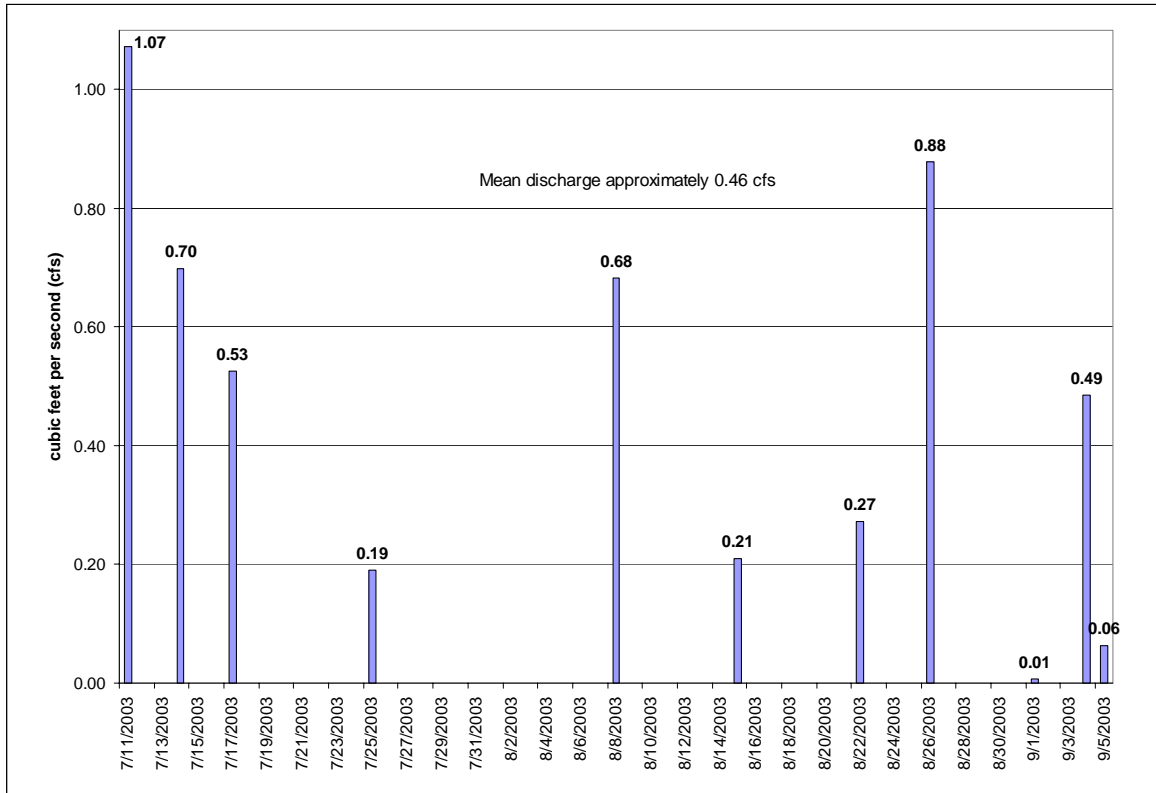
Figure 26 - Baseflow Discharge - Lower Reach (Transect X-9)

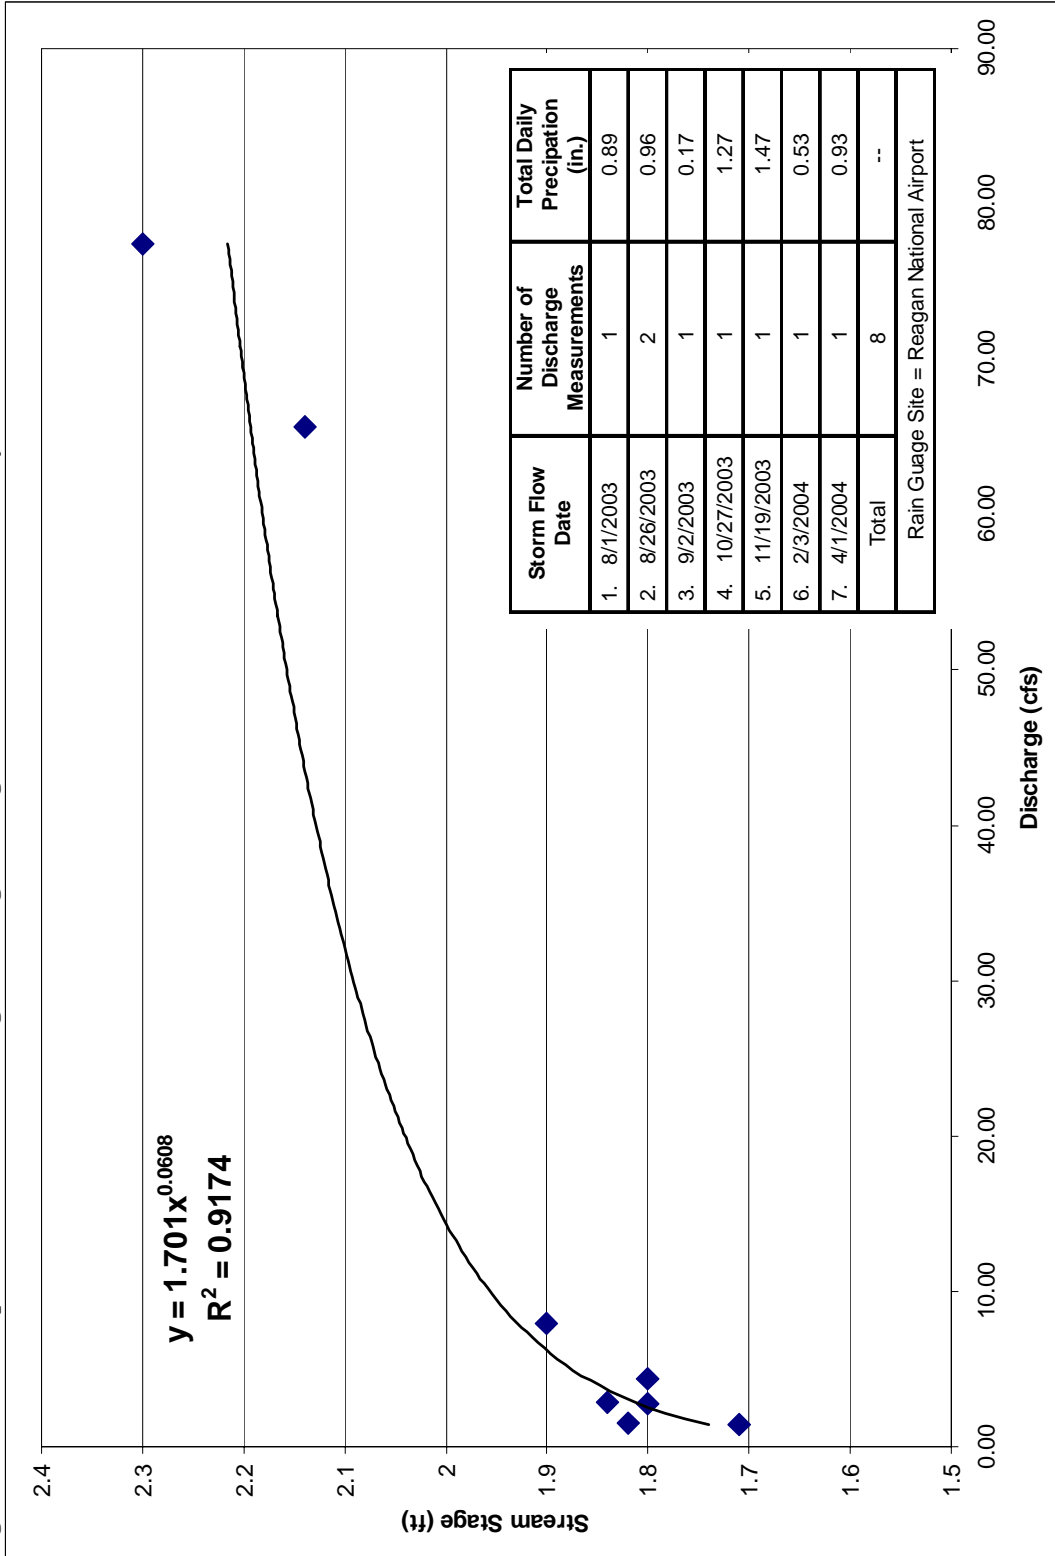
Figure 27 - Fort Chaplin - Lower Reach - Stage-Discharge¹ Rating Curve (June 2002 - January 2003)

¹ Discharge measurements were taken during the ascending limb of the storm hydrograph

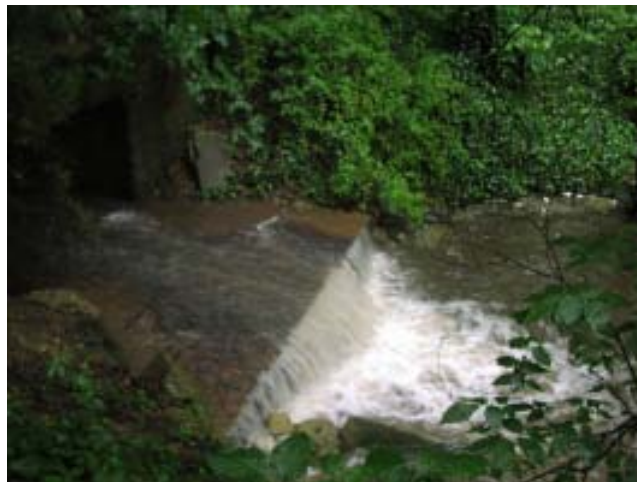
Among the priority stormwater runoff/storm drainage problem areas to consider for both future stormwater management and storm drain outfall retrofitting are the Texas Avenue (Figure 29) and the east and west 'D' Street sub-catchments. These drainage areas contribute significant volumes of uncontrolled runoff and pollutants to Fort Chaplin. Therefore, a comprehensive stream restoration approach which also includes major reconstruction of Fort Chaplin's stream channel morphology so as to better meet its altered urban stream flow and sediment transport regimes will also be required.

Figure 29 - Upper Reach - Texas Avenue Storm Drain Outfall (4'Hx8'W) Uncontrolled Runoff During a July 11, 2003 Afternoon Thunderstorm

- 6) To address the high trash conditions within the stream channel, investigate the possibility for the employment of either of an in-line or end of the pipe trash collection device (e.g., Fresh Creek Trash Netting System, or equivalent) within the Texas Avenue storm drain system.

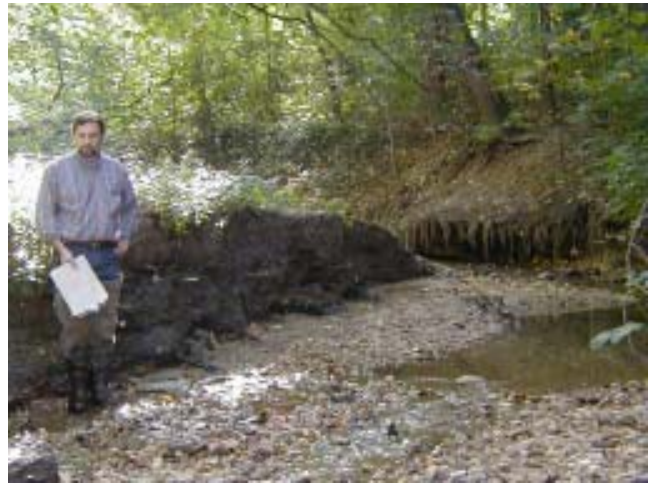
Figure 28 - Lower Reach - Severe Channel Erosion

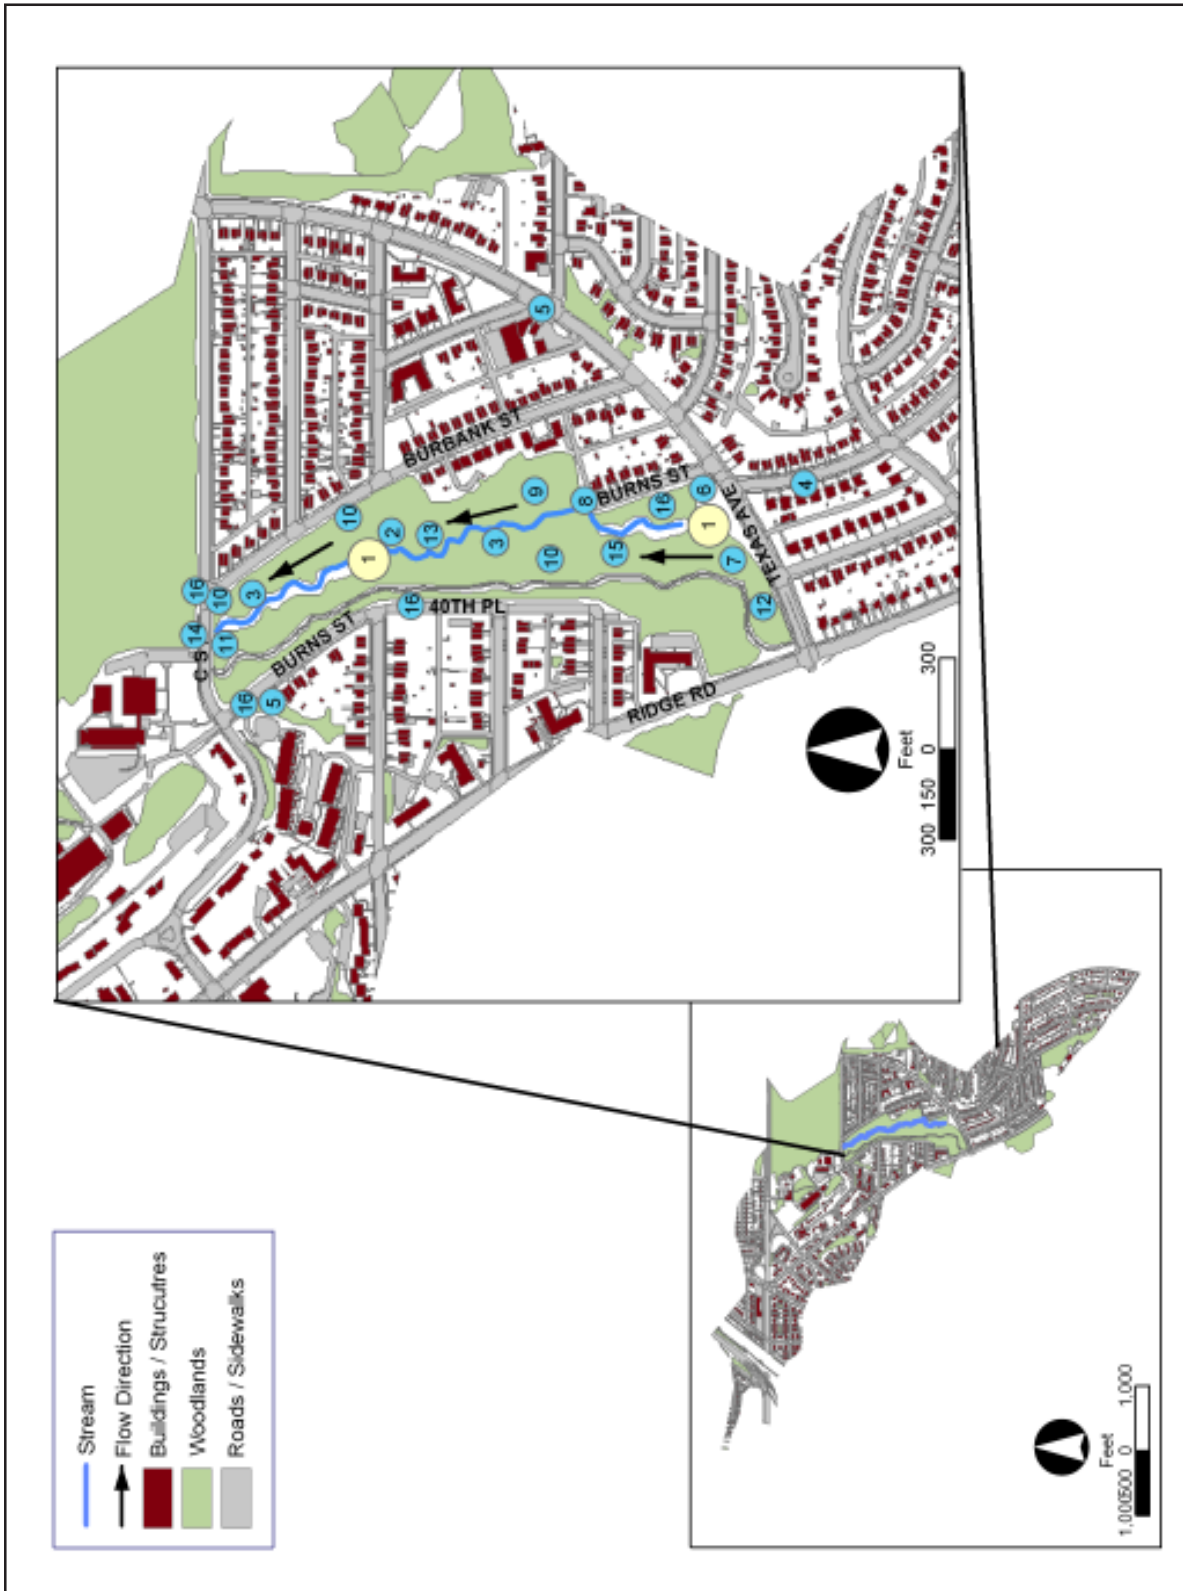
Figure 30 - Fort Chaplin Tributary - Project Recommendation Sites

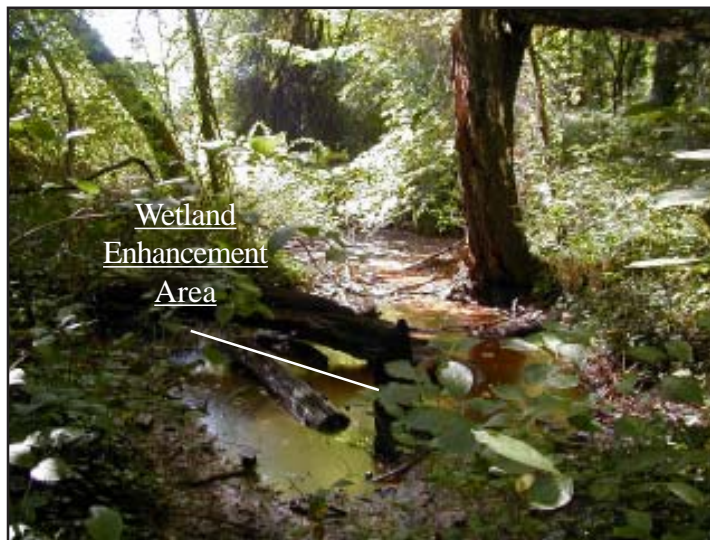
Figure 31 - Upper Reach (Texas Avenue Area) - Wetland Enhancement Habitat Area

- 7) Create one or more vernal pools for amphibian habitat in the following general area: Upper Reach (immediately below Texas Avenue) - excavate to deepen the existing vernal pools along the left hand bank (Figure 31). Note: several of these vernal pool sites can be excavated by hand using Earth Conservation Corps or other local volunteer labor. Also, in all likelihood the reintroduction of native amphibians such as spotted salamanders (*Ambystoma maculatum*), wood frogs (*Rana sylvatica*) and spring peepers (*Hyla crucifer*) will require the physical transplantation of eggs and/or larvae from other Anacostia sites.

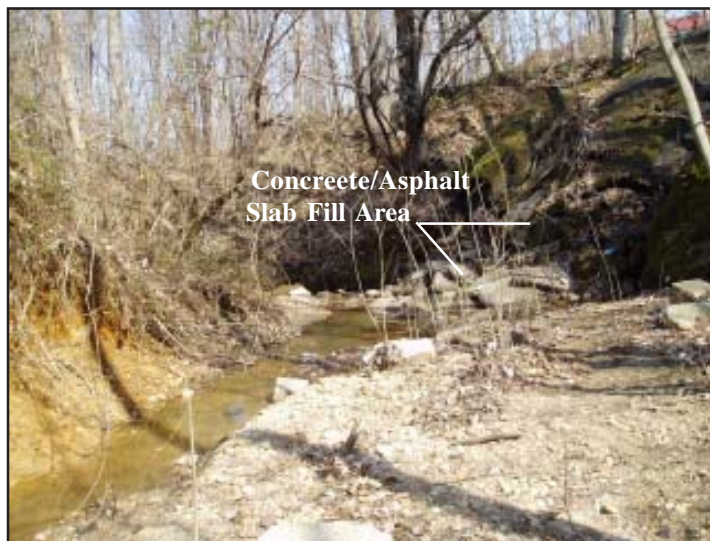
Figure 32 - Upper Reach - Right Bank Slope Failure Area

- 9) The loamy clay fill slope located along the right hand bank near the Upper Reach X-3 area is exhibiting signs of localized slope failure. In COG staff's opinion, a geotechnical study should also be undertaken in this area to determine its potential long-term stability.

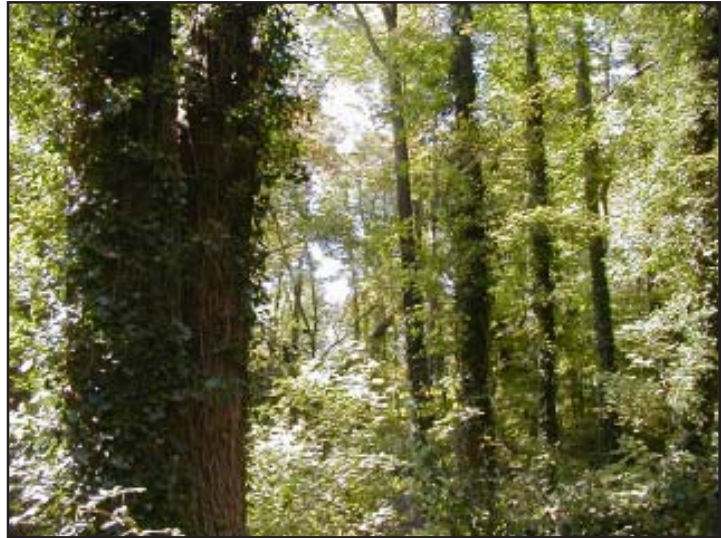
Figure 33 - Upper Reach - Recommended Exotic/Invasive Removal Area
