Fort Chaplin Subwatershed Restoration: 2003 Baseline Stream Assessment Study – Physical, Chemical, and Biological Conditions

Prepared for:
District of Columbia
Department of Health/
Environmental Health Administration
Watershed Protection Division

Prepared by:
Department of Environmental Programs
Metropolitan Washington Council of Governments

October 2004

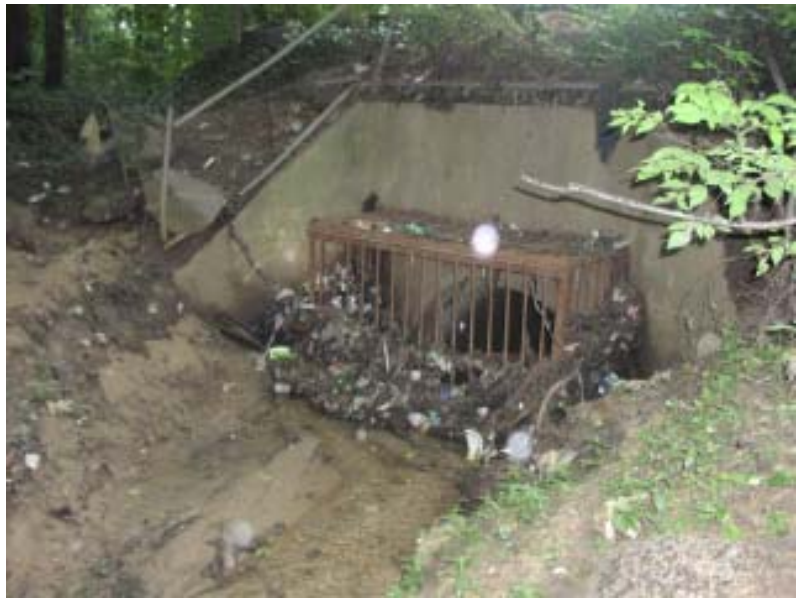
Figure 34 - Lower Reach - 'C' Street 48" RCP - Debris/Trash Filled Rack

14) DC-DOH/EHA should continue to work with the DC-Department of Public Works to maintain a relative trash/debris free rack at 'C' Street (Figure 34).

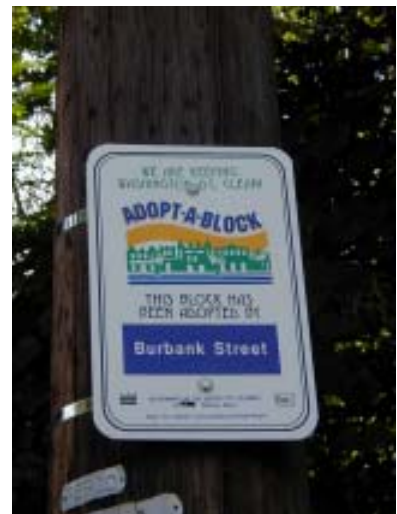
Figure 35 - Middle Reach - Burbank Street "Adopt A Block" Signage

16) COG staff recommends that the established District of Columbia's 'Adopt a Block' neighborhood clean streets program (Figure 35) be expanded to include Burns and 'C' Streets, as well as 40th Place.

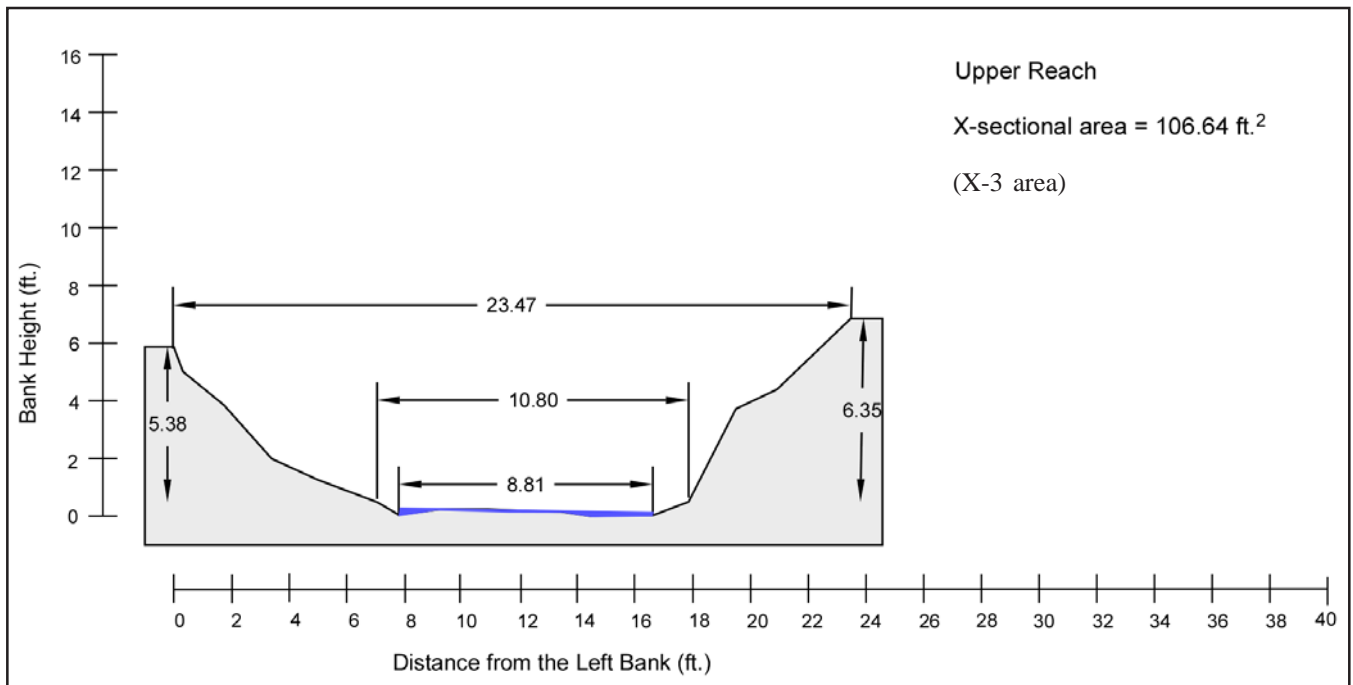
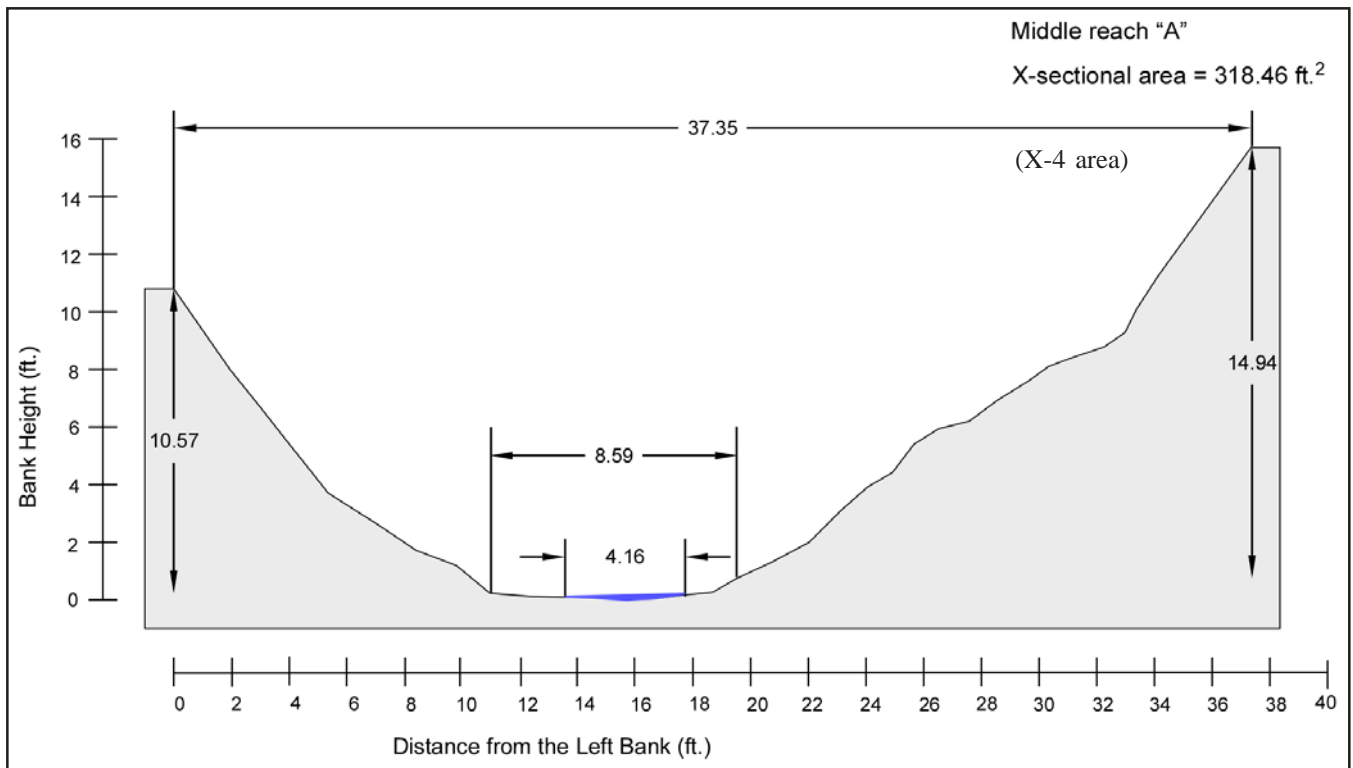
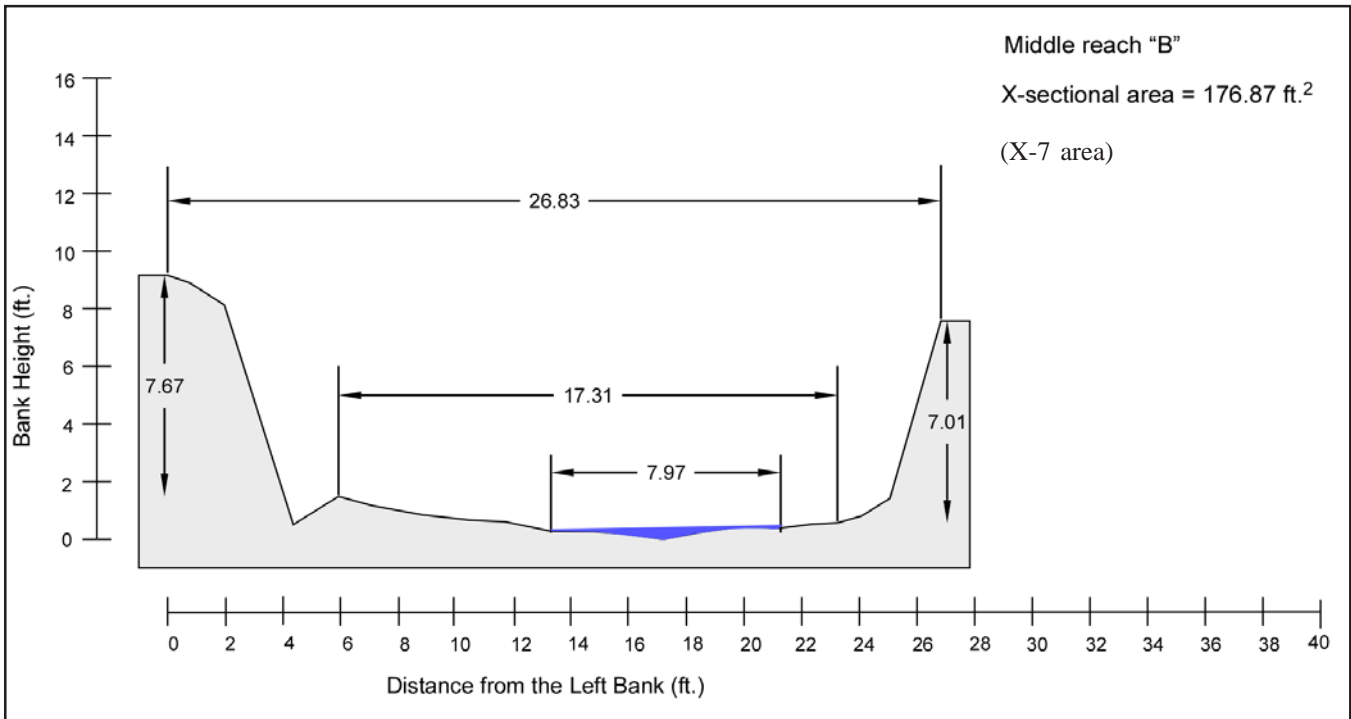
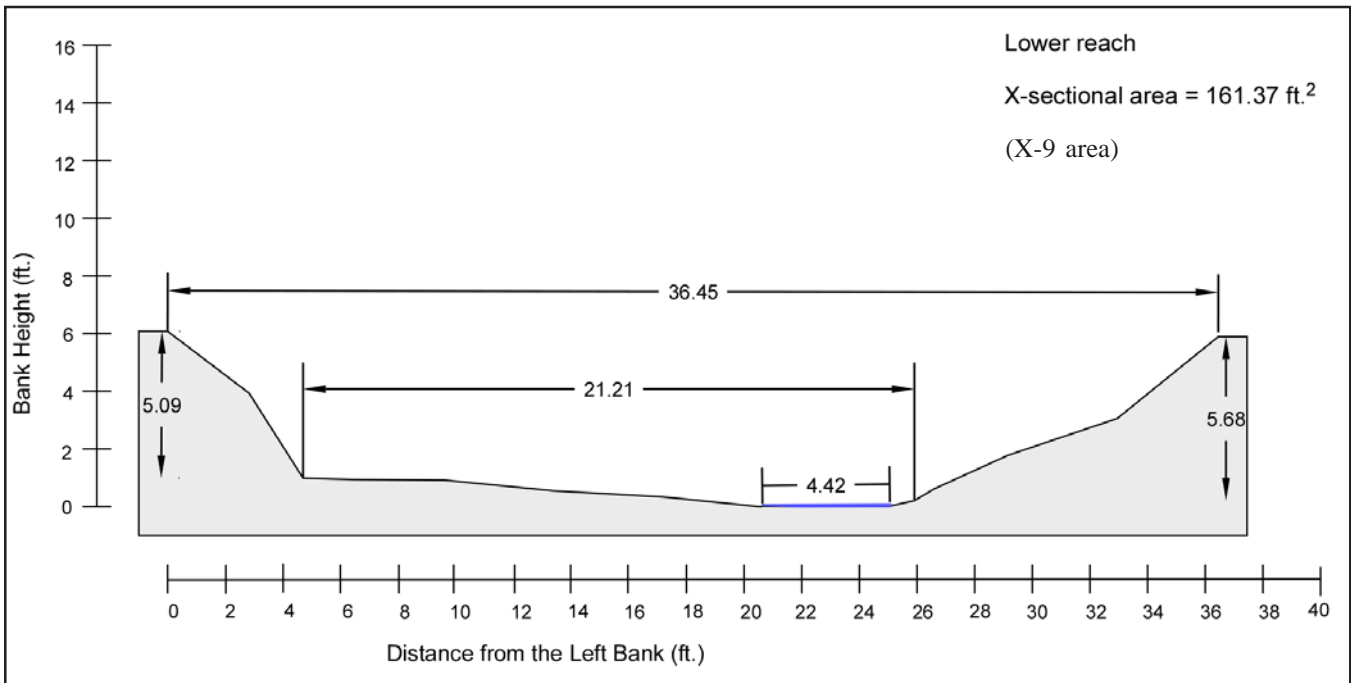
Figure 1 - Fort Chaplin - Permanent Channel Cross Sections¹

¹ Top Channel width, bottom channel width, and wetted perimeter (heavy blue line) area depicted.

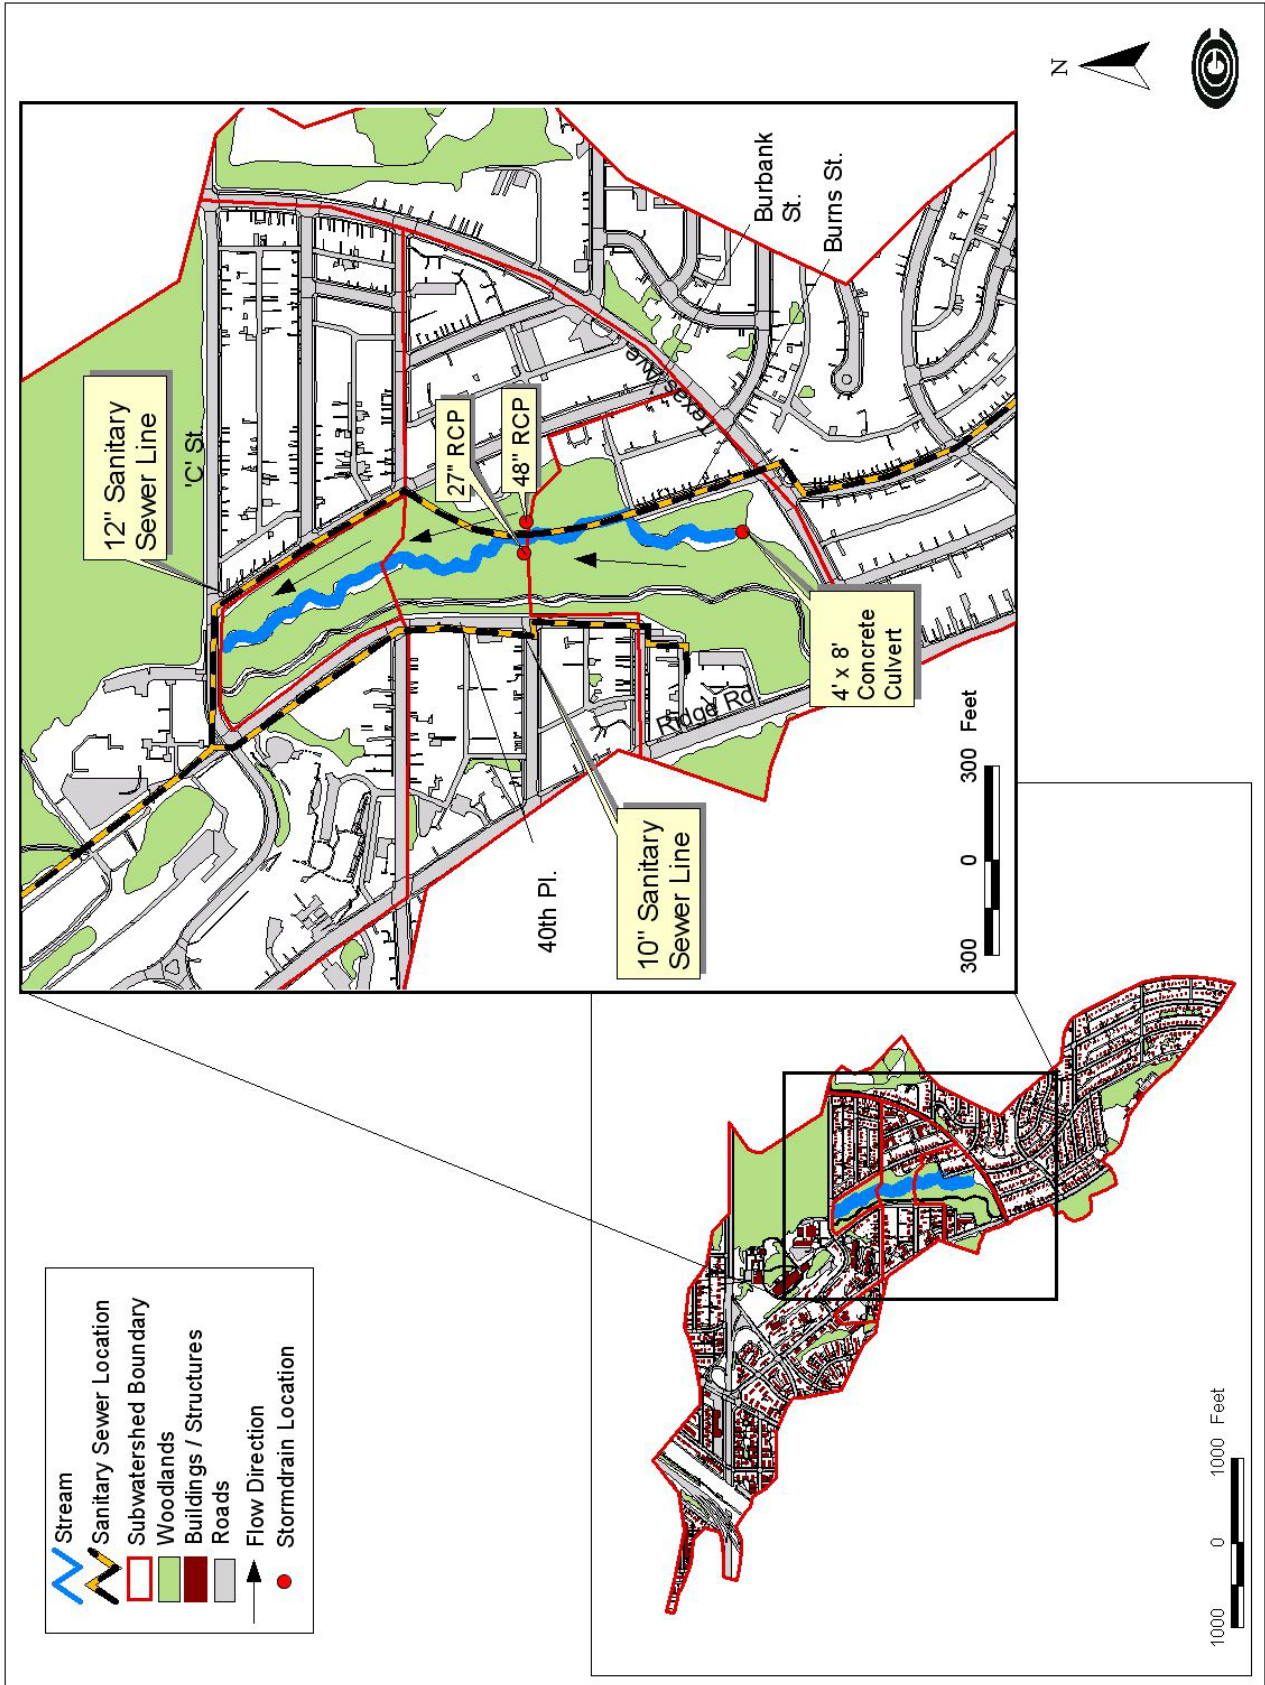
Figure 1 - Fort Chaplin - Sanitary Sewer Line Systems and Storm Drain Outfall Locations
