Technical Memorandum
Anacostia Tributary Streambank Erosion Pilot Study
Phase I
Upper Beaverdam Creek Subwatershed

Prepared for:
Maryland Department of the Environment

Prepared by:
Department of Environmental Programs
Metropolitan Washington Council of Governments

June 2004

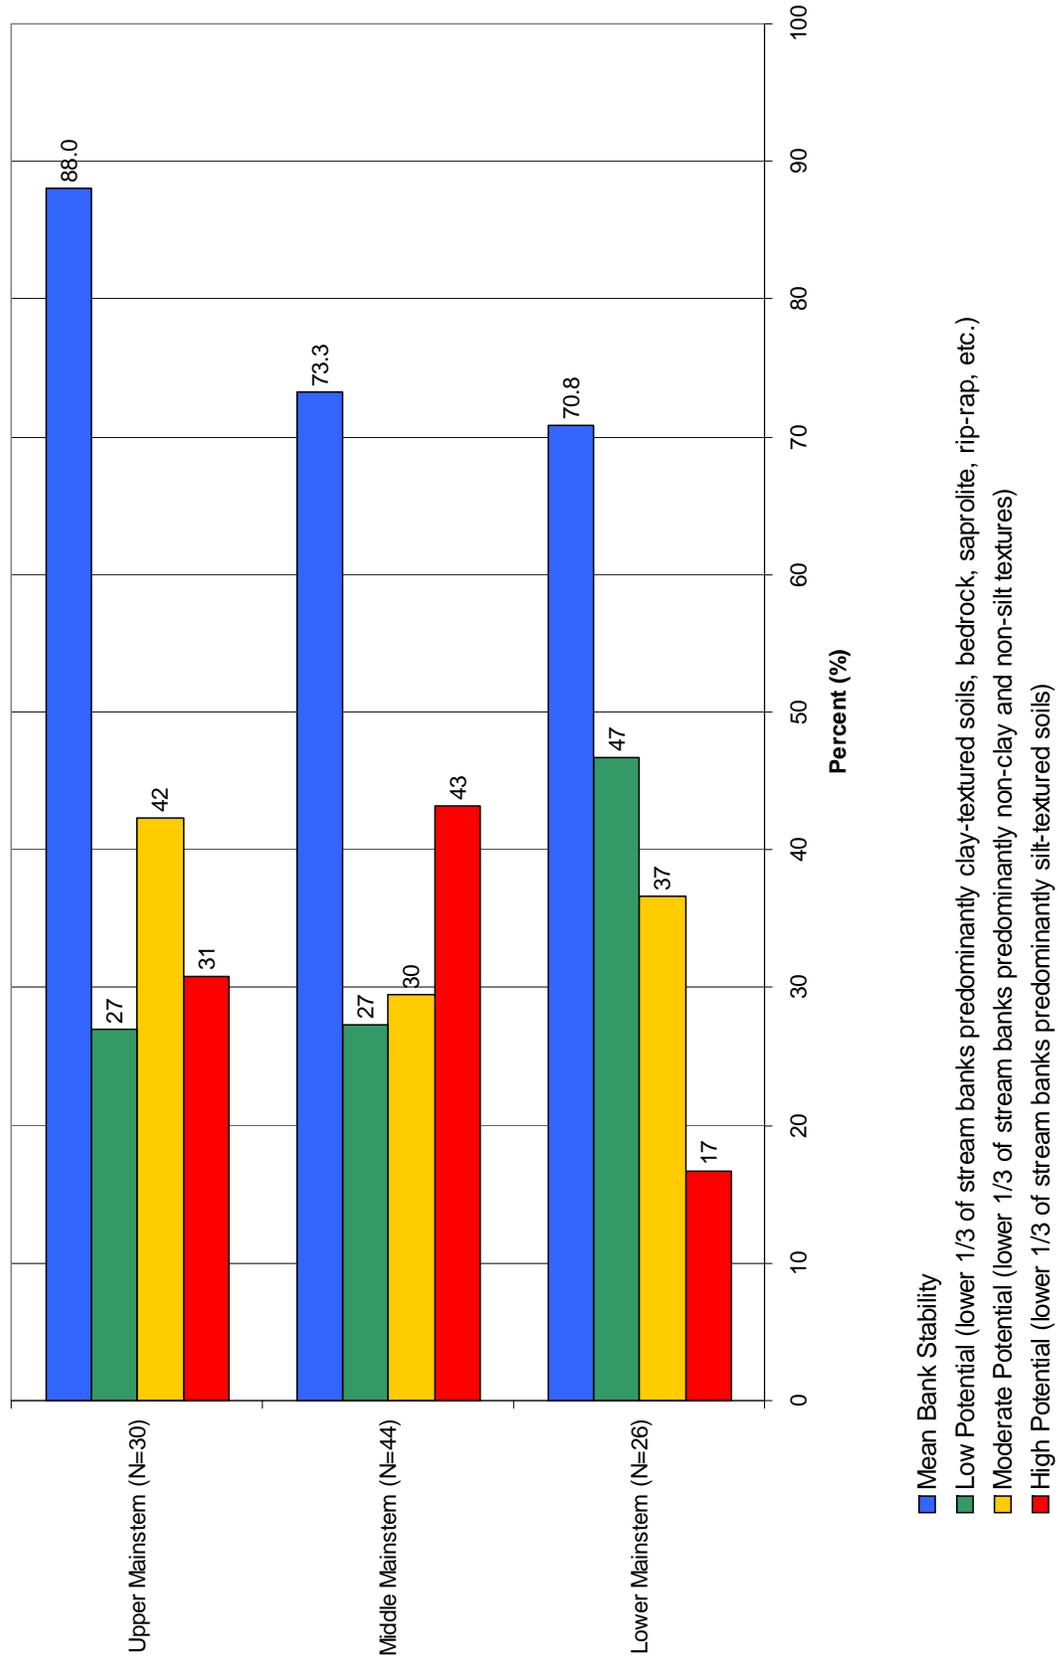
Figure 17: Upper Beaverdam Creek Mainstem Mean Streambank Stability¹ and Relative Erodibility (%)²

¹ Mean bank stability interpretation: >80% = Excellent, 71-80% = Good, 50-70% = Fair, <50% = Poor.

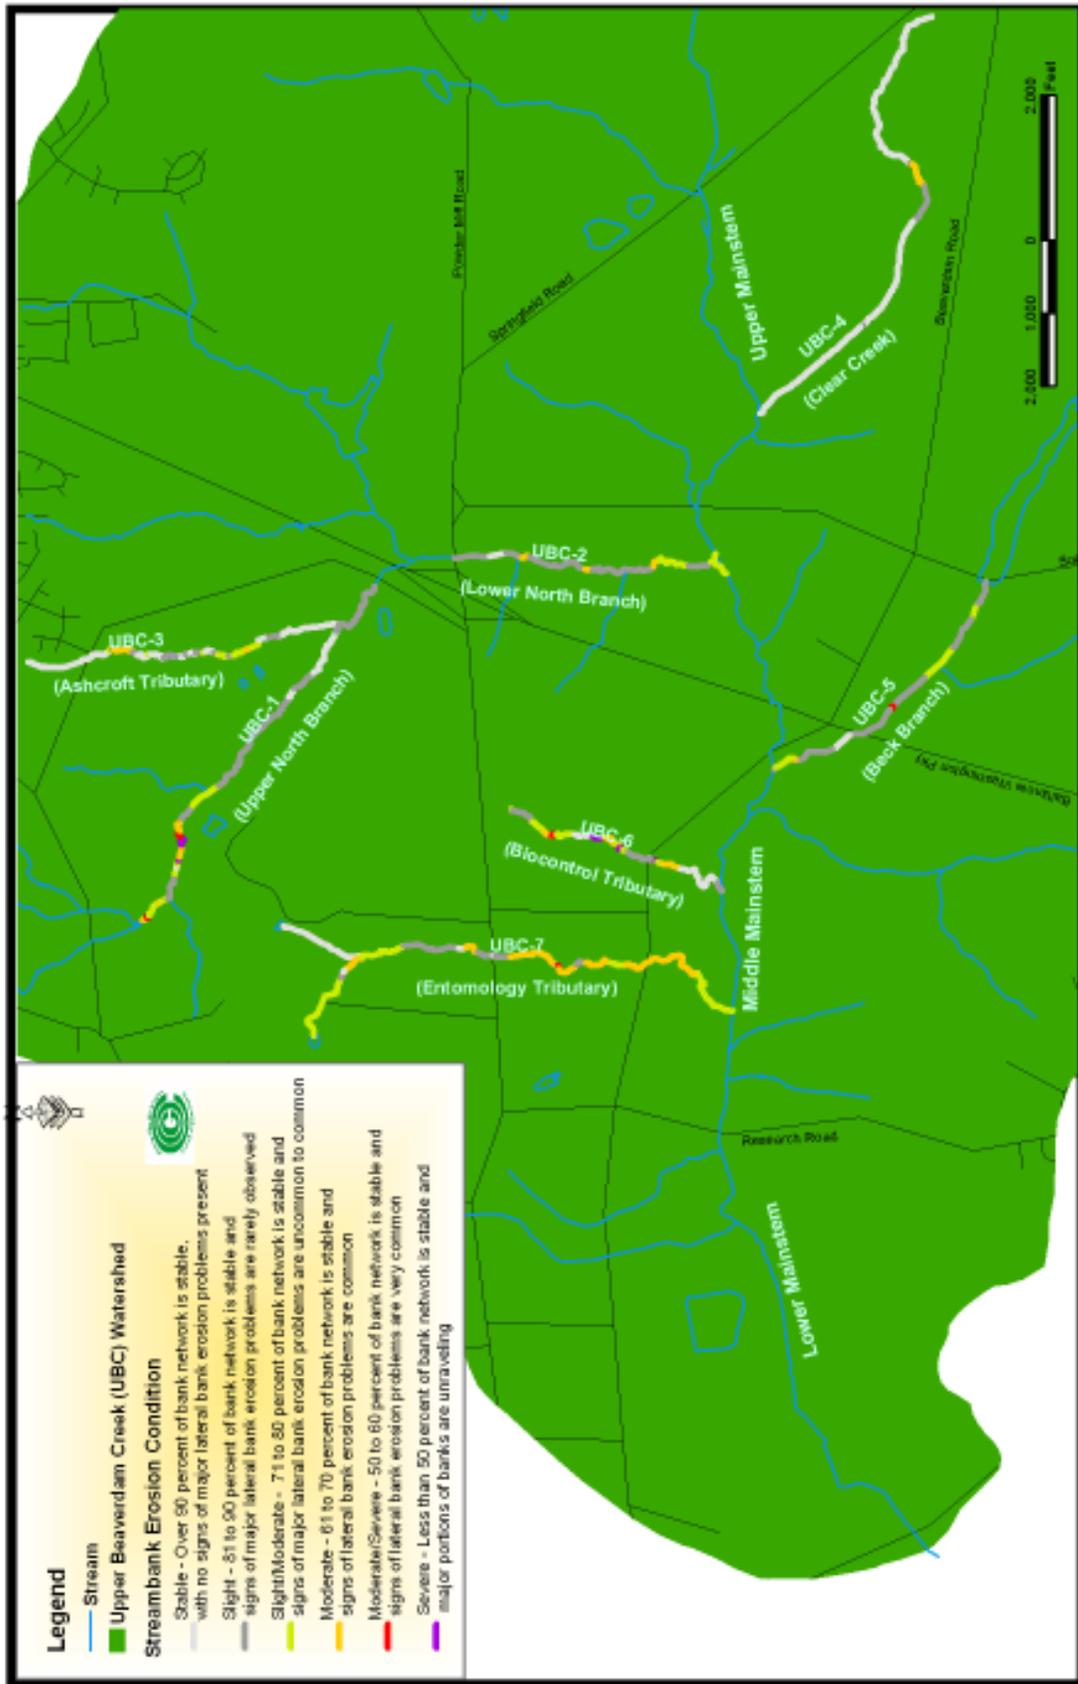
Figure 18: Summary: Upper Beaverdam Creek Tributary Streambank Erosion Condition

Streambank stability results are summarized in Table 3 and Figure 18. Also, representative photographs depicting bank conditions for the tributary areas are presented in Figures 19 through 38. Mean streambank stability for the Upper and Lower North Branch, Ashcroft tributary, Clear Creek, Beck Branch, and Biocontrol and Entomology tributaries (i.e., 78.0, 76.5, 87.5, 92.6, 75.8, 81.6, and 73.6 percent, respectively) were rated as being good to excellent.

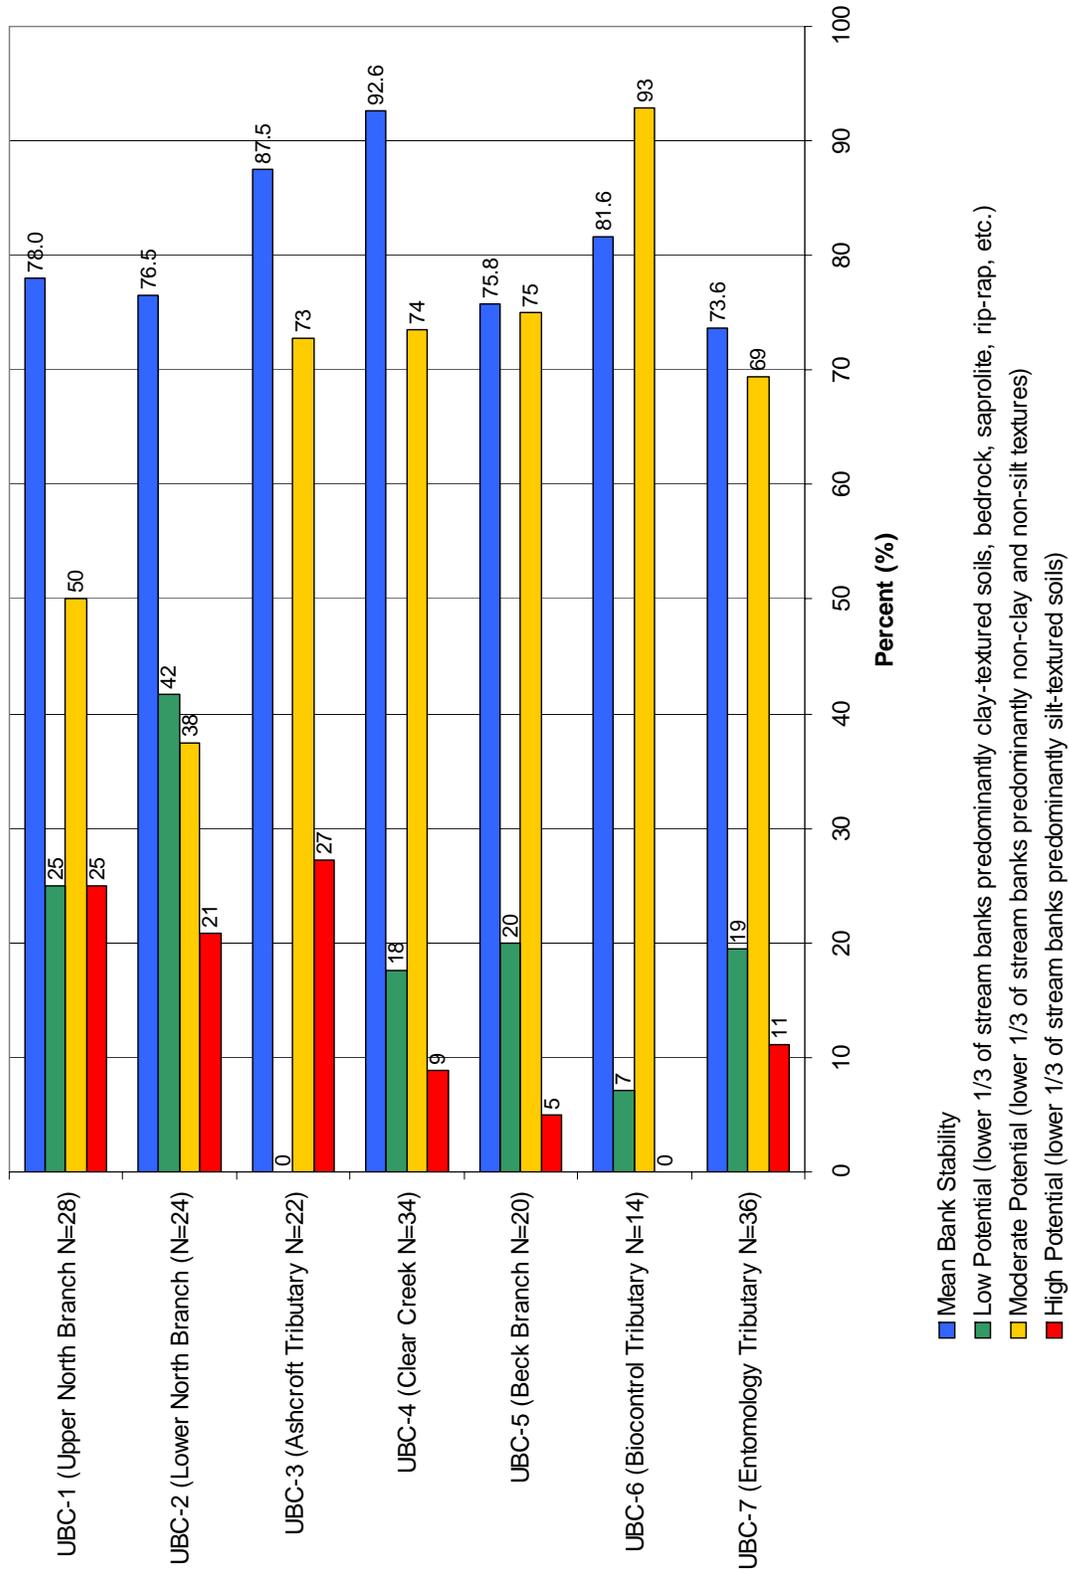
Figure 39: Upper Beaverdam Creek Tributary Mean Streambank Stability¹ and Relative Erodibility² (%)

RSAT streambank soil texture survey results for tributary system (Figure 39) revealed that the bank material present is predominantly moderately erodible soil types (i.e., generally loam-textured soils).

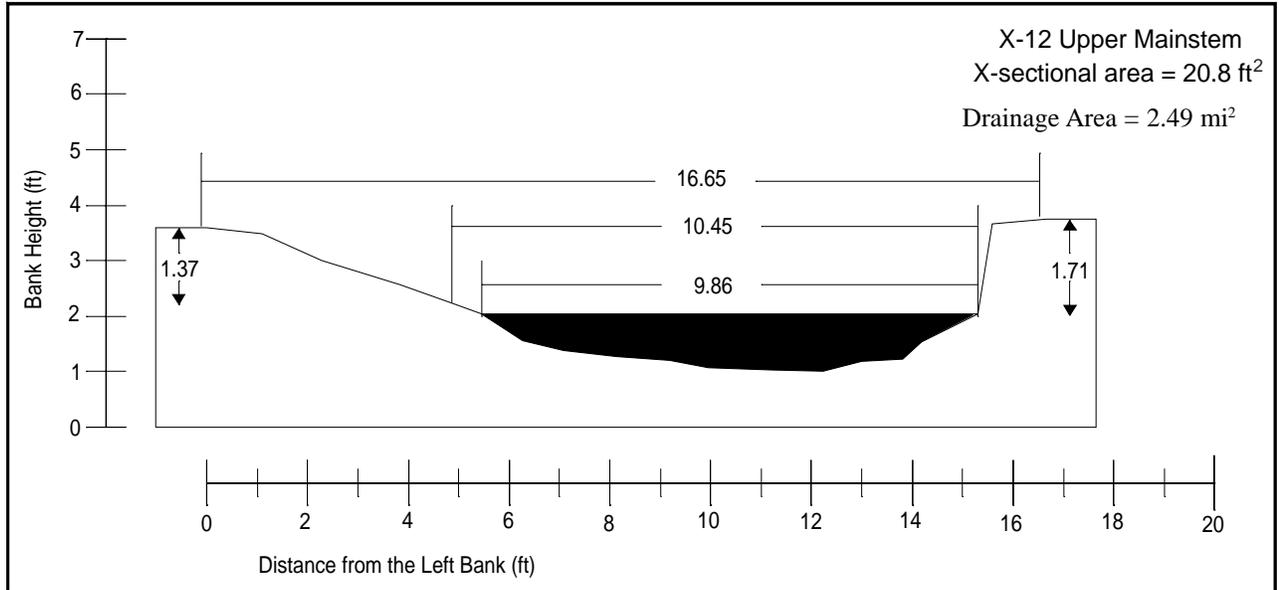
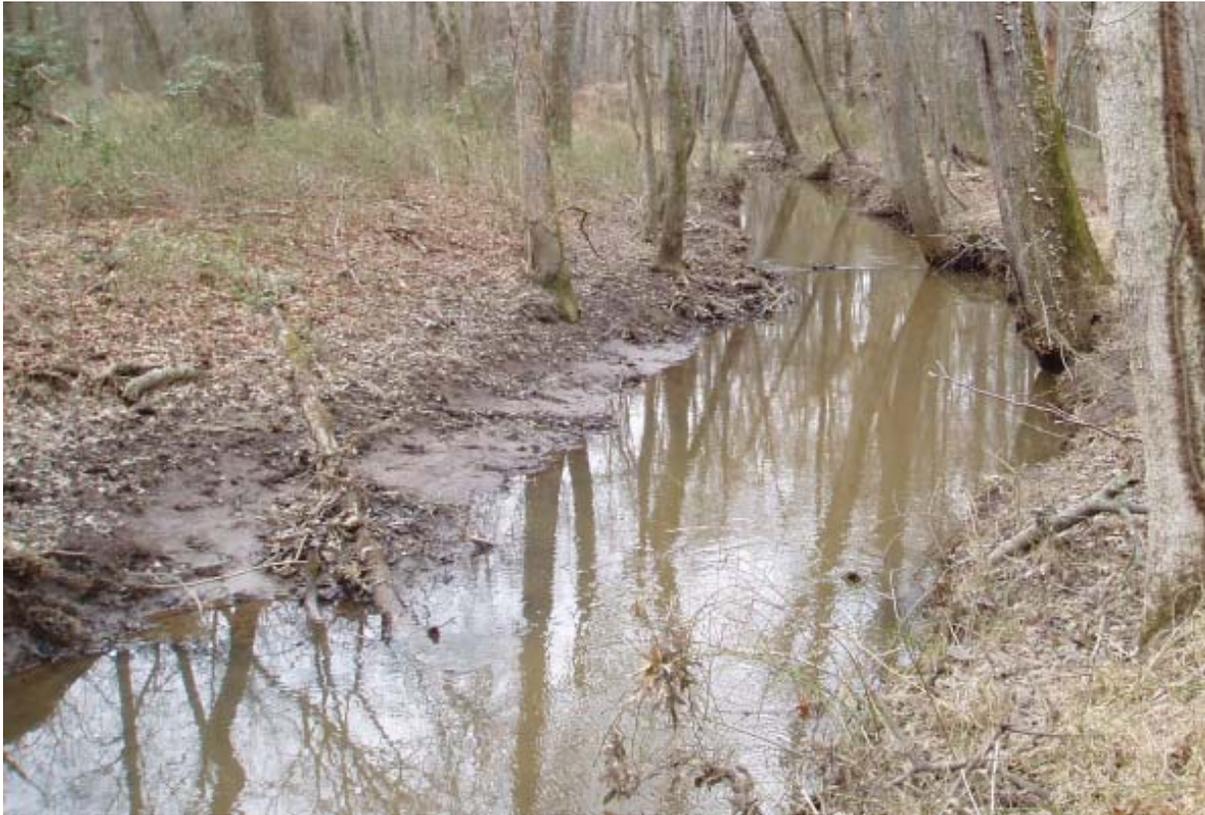
Figure 40: Representative Cross Section and Photograph for Upper Beaverdam Creek Upper Mainstem¹

Cross-sectional analysis results revealed that the mean cross-sectional area of the Upper Beaverdam Creek mainstem is as follows: Upper (15.5 ft²), Middle (66.4 ft²) and Lower (88.4 ft²). Bank heights for all three mainstem stream segments were well within the expected or reference condition ranges of 2-3 feet and 3-4 feet, respectively. These findings indicate that unlike most other Coastal Plain streams in the Anacostia River watershed, the Upper Beaverdam Creek mainstem has generally experienced relatively little channel widening or downcutting. Figures 40 through 42 illustrate selected mainstem cross-sections.

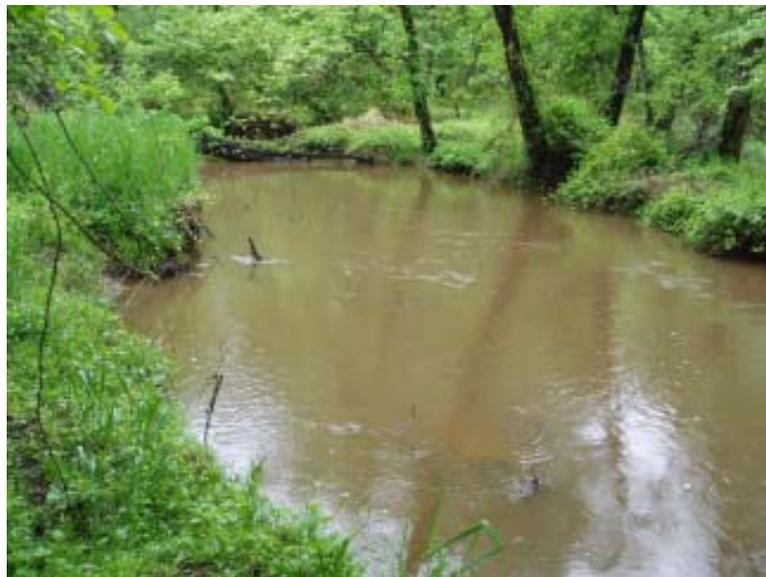
Figure 55: Location - Upper Beaverdam Creek - Lower Mainstem Below Edmonston Road - April 26, 2004 stormflow (BWI 24-hour rainfall = 0.70 inches)
